Manhole Inspection Report

Date:	04/13/2018	Weather:		Coding:	RZMACP
MH#:	M-809-011	Owner:	NA	Len. Surveyed:	9.3
P.O.#:		Surveyor:	John Kuglmaier	Rim to Invert:	9.8
Customer:		Cert. #:	U-1215-07002349	Wall Material:	Concrete (reinforced)

Street:	Grosbeak Ct. 358' North of Tanager	Project:	Hobart, IN
City:	Hobart, IN	GPS Northing:	2908912.956
Location:		GPS Easting:	2908912.956
Drain Area:	Southwest	GPS Accuracy:	Sub-Meter
Cover Shape:	Circular	Evidence of Surcharge:	No
Cover Size:	22.5	Potential for Runoff:	None
Comments:

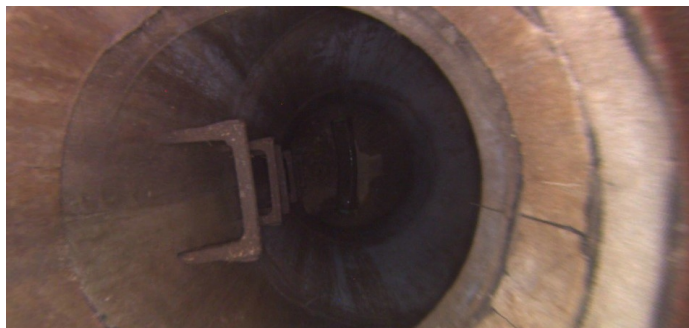
Code: **MGP**
Description: **General Photo**

Distance (ft): **.0**
Structural Grade: **0**
O&M Grade: **0**
Clock Start/From:
Clock To:
1st Value:
2nd Value:
Value Percent:
Step: **NO**
Remarks:

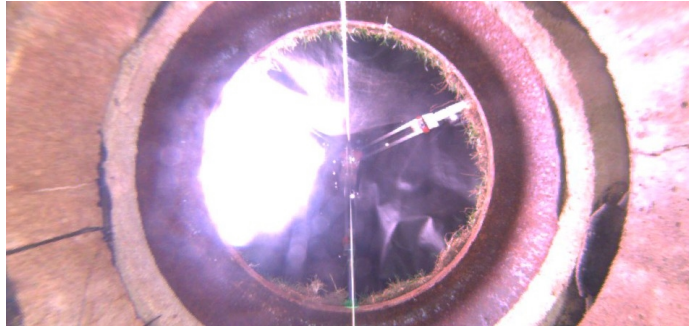
Code: **MGP**
Description: **General Photo**

Distance (ft): **2.2**
Structural Grade: **0**
O&M Grade: **0**
Clock Start/From:
Clock To:
1st Value:
2nd Value:
Value Percent:
Step: **NO**
Remarks:

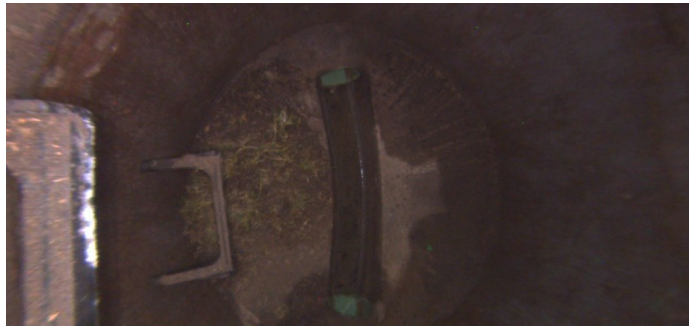
Code: **DAZ**
Description: **Deposits Attached Other**

Distance (ft): **6.0**
Structural Grade: **0**
O&M Grade: **2**
Clock Start/From: **8**
Clock To: **11**
1st Value:
2nd Value:
Value Percent: **5.000**
Step: **NO**
Remarks: **Mixed materials**

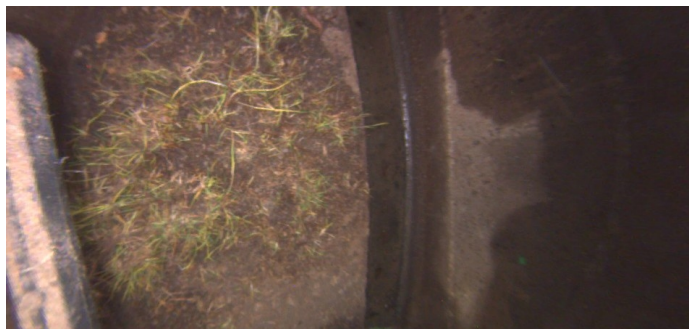
Code: **MGO**
Description: **General Observation**

Distance (ft): **7.7**
Structural Grade: **0**
O&M Grade: **0**
Clock Start/From:
Clock To:
1st Value:
2nd Value:
Value Percent:
Step: **NO**
Remarks: **Ins. Comp.**
