Manhole Inspection Report

Date:	04/13/2018	Weather:		Coding:	RZMACP
MH#:	M-809-015	Owner:	NA	Len. Surveyed:	6.3
P.O.#:		Surveyor:	John Kuglmaier	Rim to Invert:	6.7
Customer:		Cert. #:	U-1215-07002349	Wall Material:	Concrete (reinforced)

Street:	Tanager St. 348' South of Grosbeak	Project:	Hobart, IN
City:	Hobart, IN	GPS Northing:	2909367.929
Location:		GPS Easting:	2909367.929
Drain Area:	Southwest	GPS Accuracy:	Sub-Meter
Cover Shape:	Circular	Evidence of Surcharge:	No
Cover Size:	22.5	Potential for Runoff:	None
Comments:

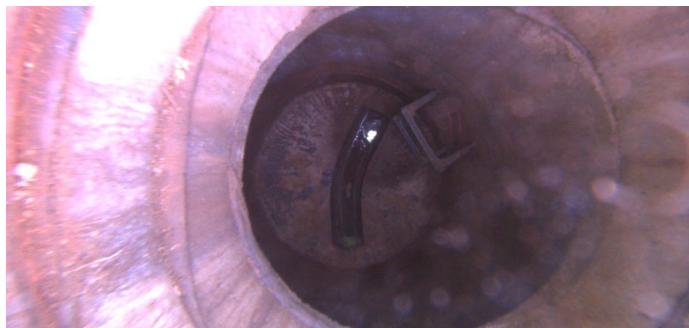
Code: **MGP**
Description: **General Photo**

Distance (ft): **.0**
Structural Grade: **0**
O&M Grade: **0**
Clock Start/From:
Clock To:
1st Value:
2nd Value:
Value Percent:
Step: **NO**
Remarks:

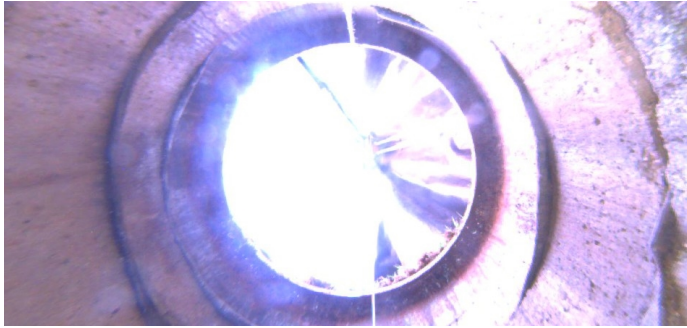
Code: **MGP**
Description: **General Photo**

Distance (ft): **2.6**
Structural Grade: **0**
O&M Grade: **0**
Clock Start/From:
Clock To:
1st Value:
2nd Value:
Value Percent:
Step: **NO**
Remarks:

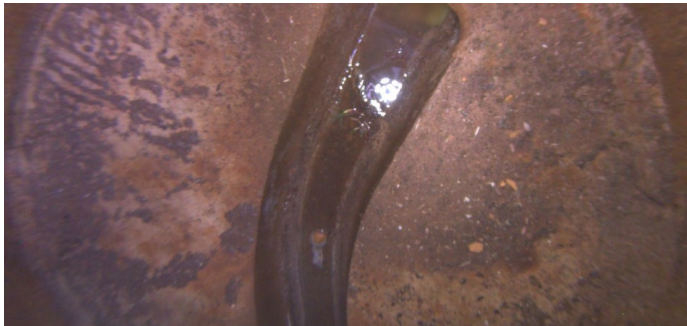
Code: **MGO**
Description: **General Observation**

Distance (ft): **4.8**
Structural Grade: **0**
O&M Grade: **0**
Clock Start/From:
Clock To:
1st Value:
2nd Value:
Value Percent:
Step: **NO**
Remarks: **Ins. Comp.**
