Manhole Inspection Report

Date:	04/13/2018	Weather:		Coding:	RZMACP
MH#:	M-809-016	Owner:	NA	Len. Surveyed:	5.4
P.O.#:		Surveyor:	John Kuglmaier	Rim to Invert:	6.0
Customer:		Cert. #:	U-1215-07002349	Wall Material:	Concrete (reinforced)

Street:	Tanager St. 535' East of Grosbeak Ct.	Project:	Hobart, IN
City:	Hobart, IN	GPS Northing:	0.0
Location:		GPS Easting:	0.0
Drain Area:	Southwest	GPS Accuracy:	Nearest Meter
Cover Shape:	Circular	Evidence of Surcharge:	No
Cover Size:	22.5	Potential for Runoff:	None
Comments:

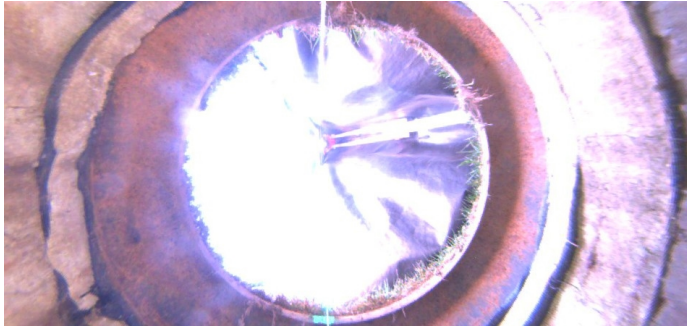
Code: **MGP**
Description: **General Photo**

Distance (ft): **2.2**
Structural Grade: **0**
O&M Grade: **0**
Clock Start/From:
Clock To:
1st Value:
2nd Value:
Value Percent:
Step: **NO**
Remarks:

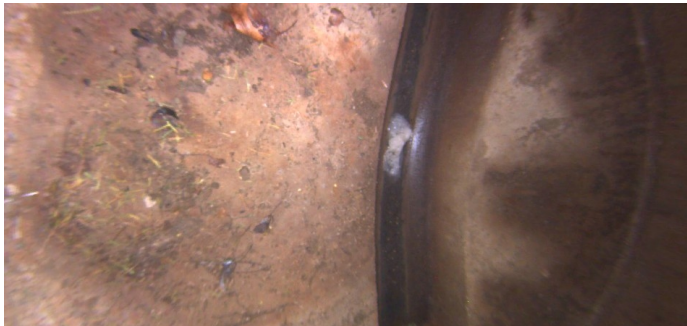
Code: **MGO**
Description: **General Observation**

Distance (ft): **4.1**
Structural Grade: **0**
O&M Grade: **0**
Clock Start/From:
Clock To:
1st Value:
2nd Value:
Value Percent:
Step: **NO**
Remarks: **Ins. Comp.**
