Manhole Inspection Report

Date:	04/13/2018	Weather:		Coding:	RZMACP
MH#:	M-809-017	Owner:	NA	Len. Surveyed:	4.6
P.O.#:		Surveyor:	John Kuglmaier	Rim to Invert:	5.1
Customer:		Cert. #:	U-1215-07002349	Wall Material:	Concrete (reinforced)

Street:	Tanager St. 477' East of Grosbeak Ct.	Project:	Hobart, IN
City:	Hobart, IN	GPS Northing:	2909353.19
Location:		GPS Easting:	2909353.19
Drain Area:	Southwest	GPS Accuracy:	Sub-Meter
Cover Shape:	Circular	Evidence of Surcharge:	No
Cover Size:	22.5	Potential for Runoff:	None
Comments:

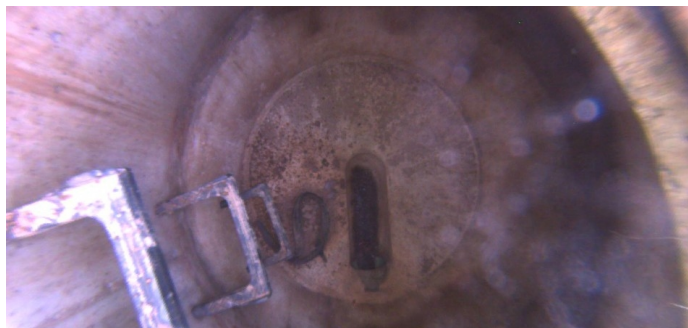
Code: **MGP**
Description: **General Photo**

Distance (ft): **.0**
Structural Grade: **0**
O&M Grade: **0**
Clock Start/From:
Clock To:
1st Value:
2nd Value:
Value Percent:
Step: **NO**
Remarks:

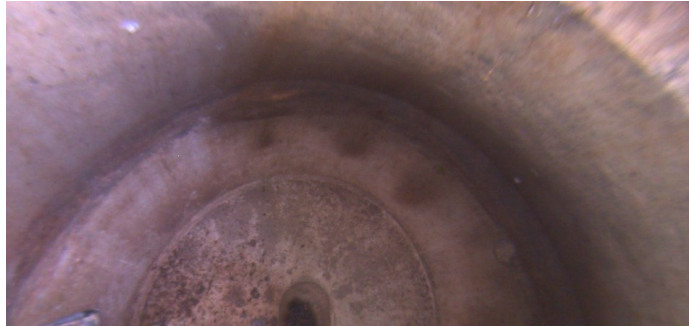
Code: **IS**
Description: **Infil Stain**

Distance (ft): **.5**
Structural Grade: **0**
O&M Grade: **0**
Clock Start/From: **11**
Clock To: **6**
1st Value:
2nd Value:
Value Percent:
Step: **NO**
Remarks:

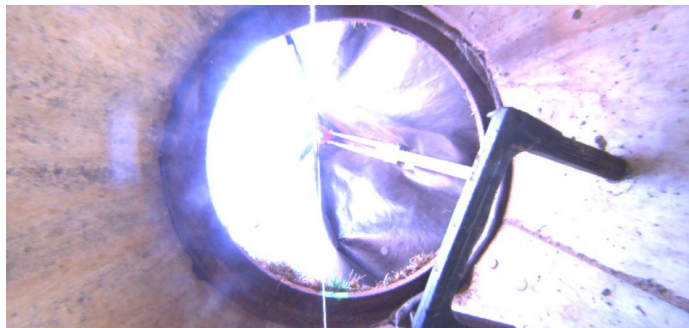
Code: **MGP**
Description: **General Photo**

Distance (ft): **2.2**
Structural Grade: **0**
O&M Grade: **0**
Clock Start/From:
Clock To:
1st Value:
2nd Value:
Value Percent:
Step: **NO**
Remarks:

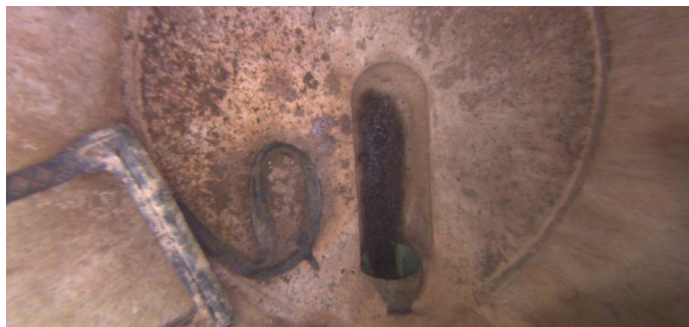
Code: **OBZ**
Description: **Obstacle Other**

Distance (ft): **2.5**
Structural Grade: **0**
O&M Grade: **2**
Clock Start/From: **7**
Clock To: **8**
1st Value:
2nd Value:
Value Percent: **5.000**
Step: **NO**
Remarks: **Seal**

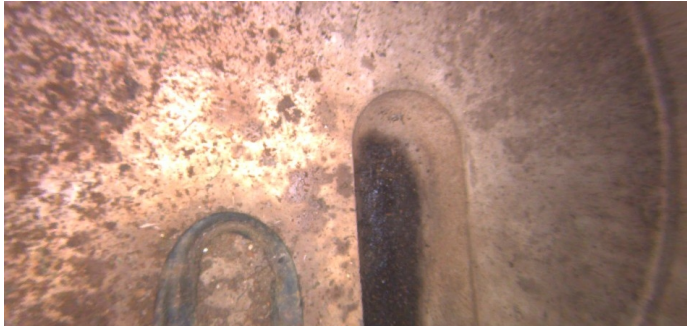
Code:	MGO
Description:	General Observation
Distance (ft):	3.6
Structural Grade:	0
O&M Grade:	0
Clock Start/From:	
Clock To:	
1st Value:	
2nd Value:	
Value Percent:	
Step:	NO
Remarks:	Ins. Comp.
