Manhole Inspection Report

| MH#: | M-809-018 | Owner: | NA | Len. Surveyed: | 11.3 |

| Street: | Intersection of Bracken Parkway. an | Project: | Hobart, IN |

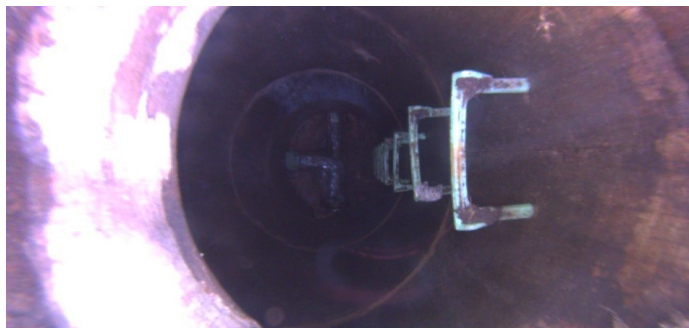
Code: **MGP**
Description: **General Photo**

Distance (ft): **.0**
Structural Grade: **0**
O&M Grade: **0**
Clock Start/From:
Clock To:
1st Value:
2nd Value:
Value Percent:
Step: **NO**
Remarks:

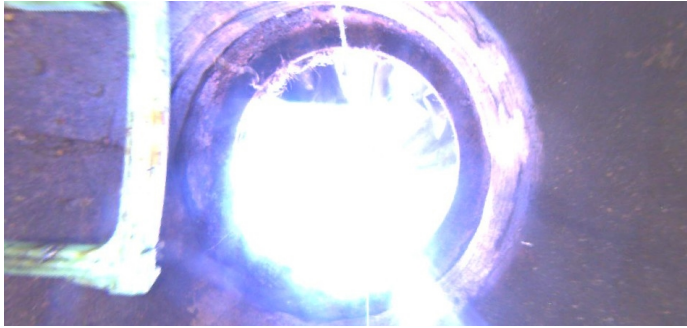
Code: **MGP**
Description: **General Photo**

Distance (ft): **2.9**
Structural Grade: **0**
O&M Grade: **0**
Clock Start/From:
Clock To:
1st Value:
2nd Value:
Value Percent:
Step: **NO**
Remarks:

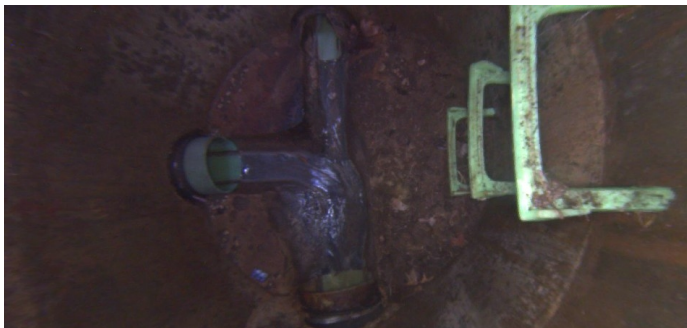
Code: **DAZ**
Description: **Deposits Attached Other**

| | Position | Code | Observation | Video (sec) | Grade |
|--|---|---|---|---|---|
| | 8.1 | DAZ | Deposits Attached Other | 54 | M 2 |

Distance (ft): **8.1**
Structural Grade: **0**
O&M Grade: **2**
Clock Start/From: **12**
Clock To: **12**
1st Value:
2nd Value:
Value Percent: **5.000**
Step: **NO**
Remarks: **Mixed materials**

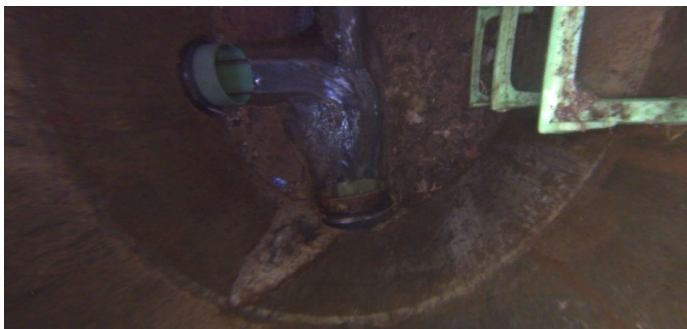
Code: **IS**
Description: **Infil Stain**

| | Position | Code | Observation | Video (sec) | Grade |
|--|---|---|---|---|---|
| | 8.1 | IS | Infil Stain | 65 | NA |

Distance (ft): **8.1**
Structural Grade: **0**
O&M Grade: **0**
Clock Start/From: **7**
Clock To:
1st Value:
2nd Value:
Value Percent:
Step: **NO**
Remarks:

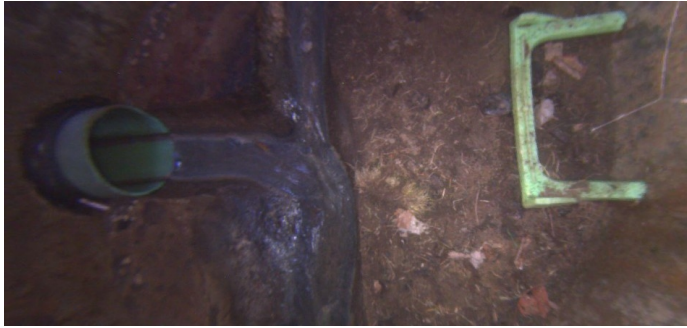
| Code: | MGO |

| Description: | General Observation |
| Remarks: | Ins. Comp. |
