Manhole Inspection Report

Date:	04/12/2018	Weather:		Coding:	RZMACP
MH#:	M-809-019	Owner:	NA	Len. Surveyed:	10.5
P.O.#:		Surveyor:	John Kuglmaier	Rim to Invert:	10.6
Customer:		Cert. #:	U-1215-07002349	Wall Material:	Concrete (reinforced)

Street:	Intersection of Eider Ave. and Brack	Project:	Hobart, IN
City:	Hobart, IN	GPS Northing:	2909139.81
Location:		GPS Easting:	2909139.81
Drain Area:	Southwest	GPS Accuracy:	Sub-Meter
Cover Shape:	Circular	Evidence of Surcharge:	No
Cover Size:	22.5	Potential for Runoff:	None
Comments:

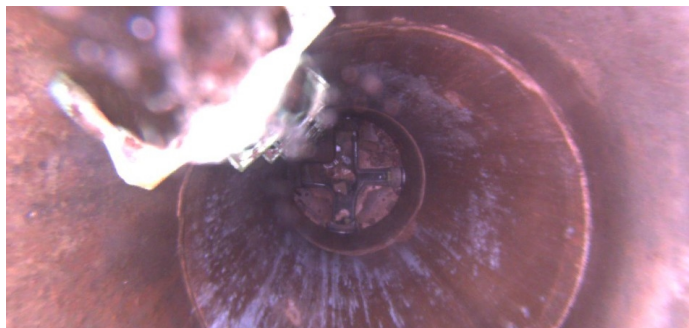
Code: **MGP**
Description: **General Photo**

Distance (ft): **.0**
Structural Grade: **0**
O&M Grade: **0**
Clock Start/From:
Clock To:
1st Value:
2nd Value:
Value Percent:
Step: **NO**
Remarks:

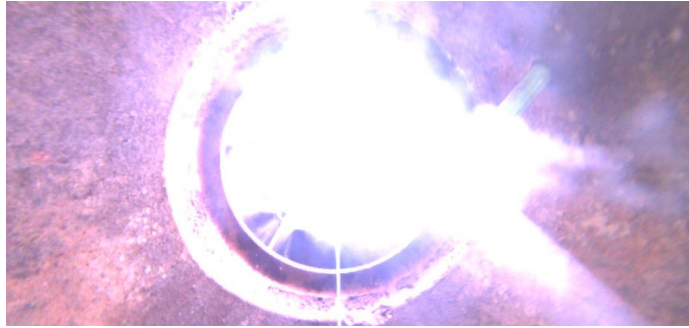
Code:	MGP
Description:	General Photo
Distance (ft):	2.7
Structural Grade:	0
O&M Grade:	0
Clock Start/From:	
Clock To:	
1st Value:	
2nd Value:	
Value Percent:	
Step:	NO
Remarks:

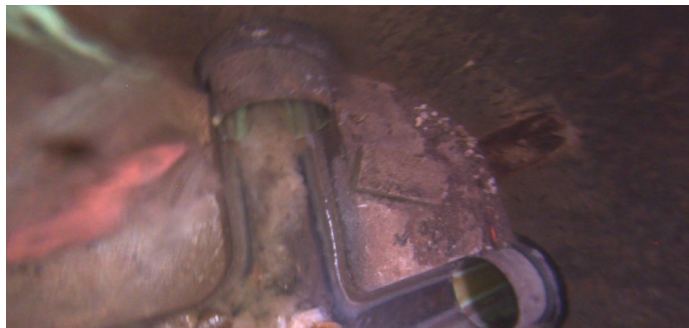
Code:	IS
Description:	Infil Stain
Distance (ft):	8.5
Structural Grade:	0
O&M Grade:	0
Clock Start/From:	2
Clock To:	
1st Value:	
2nd Value:	
Value Percent:	
Step:	NO
Remarks:

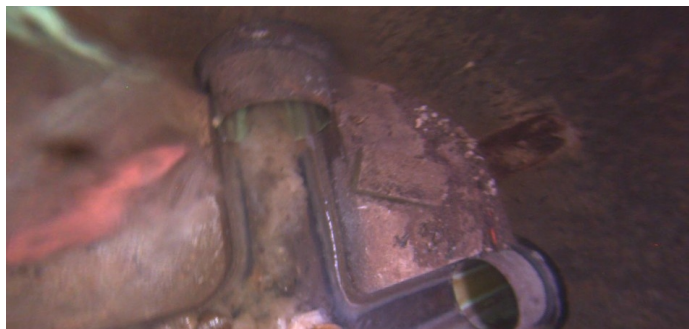
Code:	OBB
Description:	Obstacle Brick
Distance (ft):	8.5
Structural Grade:	0
O&M Grade:	2
Clock Start/From:	1
Clock To:	2
1st Value:	
2nd Value:	
Value Percent:	5.000
Step:	NO
Remarks:

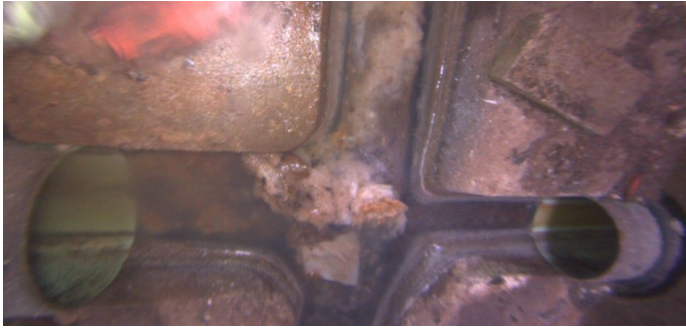
Code:	MGO
Description:	General Observation
Distance (ft):	9.0
Structural Grade:	0
O&M Grade:	0
Clock Start/From:	
Clock To:	
1st Value:	
2nd Value:	
Value Percent:	
Step:	NO
Remarks:	Ins. Comp.
