Manhole Inspection Report

Date:	04/12/2018	Weather:		Coding:	RZMACP
MH#:	M-809-020	Owner:	NA	Len. Surveyed:	9.2
P.O.#:		Surveyor:	John Kuglmaier	Rim to Invert:	9.8
Customer:		Cert. #:	U-1215-07002349	Wall Material:	Concrete (reinforced)

Street:	Bracken Parkway. 106' East of Eider	Project:	Hobart, IN
City:	Hobart, IN	GPS Northing:	2909194.442
Location:		GPS Easting:	2909194.442
Drain Area:	Southwest	GPS Accuracy:	Sub-Meter
Cover Shape:	Circular	Evidence of Surcharge:	No
Cover Size:	22.5	Potential for Runoff:	None
Comments:

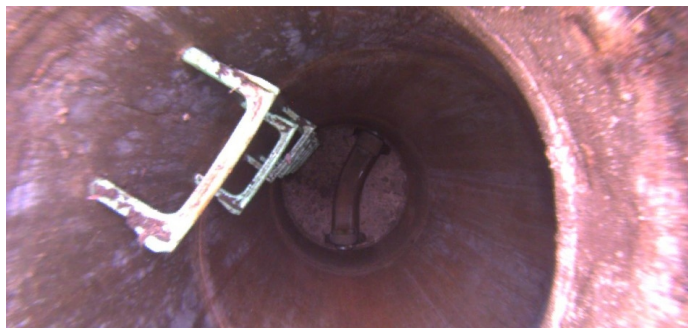
Code: **MGP**
Description: **General Photo**

Distance (ft): **.0**
Structural Grade: **0**
O&M Grade: **0**
Clock Start/From:
Clock To:
1st Value:
2nd Value:
Value Percent:
Step: **NO**
Remarks:

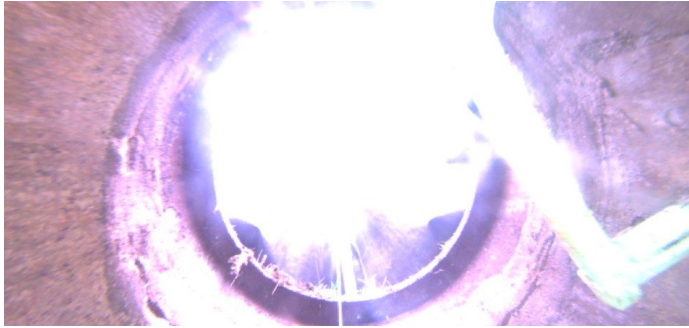
Code:	MGP
Description:	General Photo
Distance (ft):	2.6
Structural Grade:	0
O&M Grade:	0
Clock Start/From:	
Clock To:	
1st Value:	
2nd Value:	
Value Percent:	
Step:	NO
Remarks:

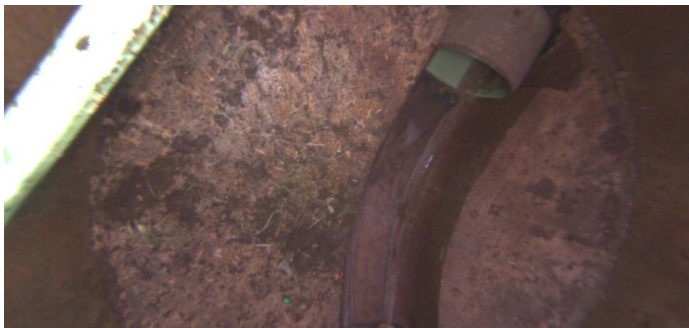
Code:	MGO
Description:	General Observation
Distance (ft):	7.5
Structural Grade:	0
O&M Grade:	0
Clock Start/From:	
Clock To:	
1st Value:	
2nd Value:	
Value Percent:	
Step:	NO
Remarks:	Ins. Comp.
