Manhole Inspection Report

Date:	11/01/2022	Weather:		Coding:	RZMACP
MH#:	M-809-022	Owner:	NA	Len. Surveyed:	7.1
P.O.#:		Surveyor:	Jen Costello	Rim to Invert:	8.2
Customer:		Cert. #:	U-907-5518	Wall Material:	Concrete (non-reinforced)

Street:	Intersection of Bracken Parkway. an	Project:	502259S9MACP26Jan2023
City:	Hobart, IN	GPS Northing:	2909632.158
Location:		GPS Easting:	2909632.158
Drain Area:	Southwest	GPS Accuracy:	Sub-Meter
Cover Shape:	Circular	Evidence of Surcharge:	No
Cover Size:	24.0	Potential for Runoff:	None
Comments:

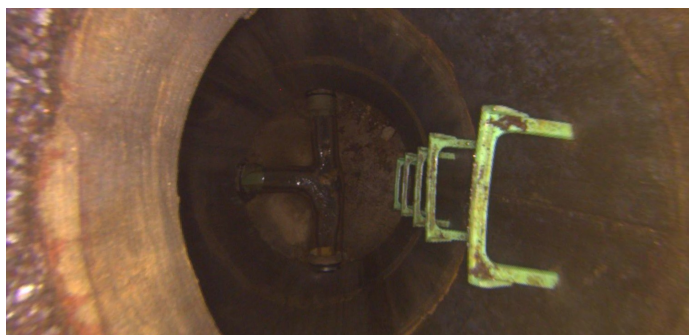
Code: **SRI**
Description: **Surface Roughness Increased**

Distance (ft): **.0**
Structural Grade: **1**
O&M Grade: **0**
Clock Start/From: **12**
Clock To: **12**
1st Value:
2nd Value:
Value Percent:
Step: **NO**
Remarks:

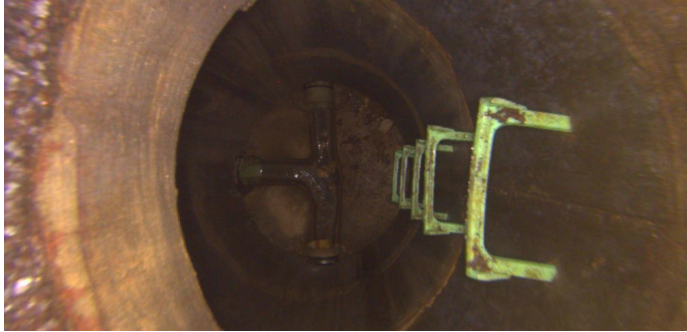
Code: **MGO**
Description: **General Observation**

Distance (ft): **.0**
Structural Grade: **0**
O&M Grade: **0**
Clock Start/From:
Clock To:
1st Value:
2nd Value:
Value Percent:
Step: **NO**
Remarks: **access mh**

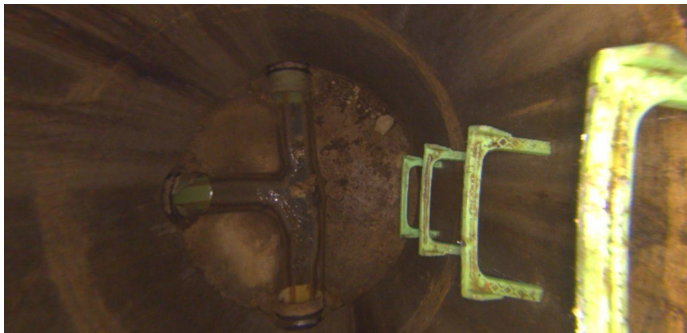
Code: **IW**
Description: **Infil Weeper**

Distance (ft): **2.1**
Structural Grade: **0**
O&M Grade: **2**
Clock Start/From: **12**
Clock To: **12**
1st Value:
2nd Value:
Value Percent:
Step: **NO**
Remarks:

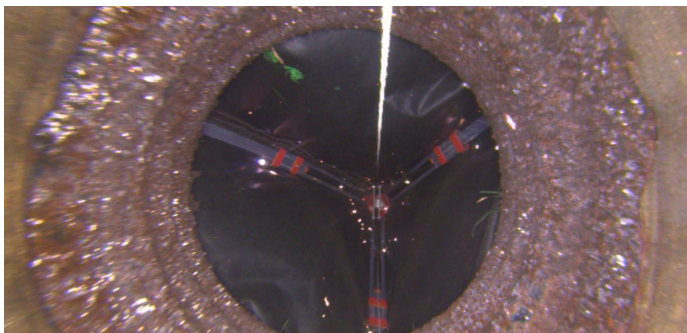
Code: **MGO**
Description: **General Observation**

Distance (ft): **2.1**
Structural Grade: **0**
O&M Grade: **0**
Clock Start/From:
Clock To:
1st Value:
2nd Value:
Value Percent:
Step: **NO**
Remarks: **underside of frame**

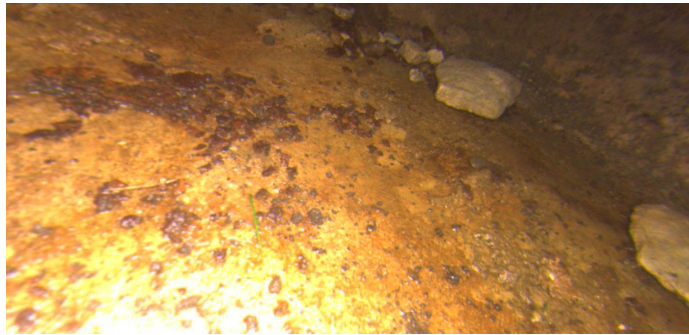
Code: **MGO**
Description: **General Observation**

Distance (ft): **7.1**
Structural Grade: **0**
O&M Grade: **0**
Clock Start/From:
Clock To:
1st Value:
2nd Value:
Value Percent:
Step: **NO**
Remarks: **end of survey**

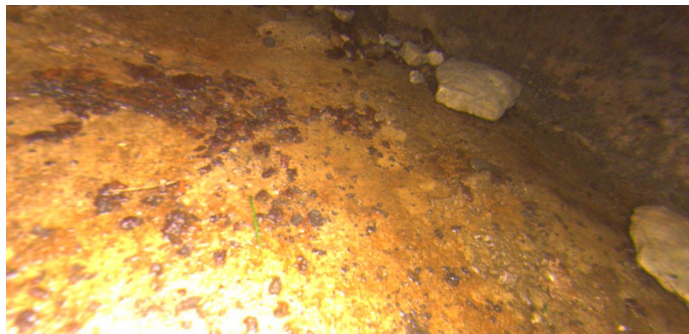
Code: **SRI**
Description: **Surface Roughness Increased**

Distance (ft): **7.1**
Structural Grade: **1**
O&M Grade: **0**
Clock Start/From: **12**
Clock To: **12**
1st Value:
2nd Value:
Value Percent:
Step: **NO**
Remarks:

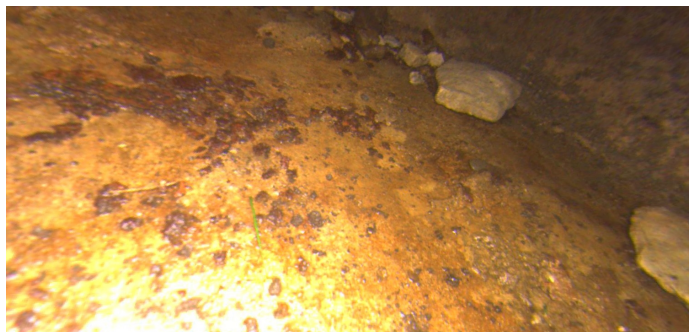
Code: **OBR**
Description: **Obstacle Rocks**

Distance (ft): **7.1**
Structural Grade: **0**
O&M Grade: **2**
Clock Start/From: **12**
Clock To: **3**
1st Value:
2nd Value:
Value Percent: **5.000**
Step: **NO**
Remarks:

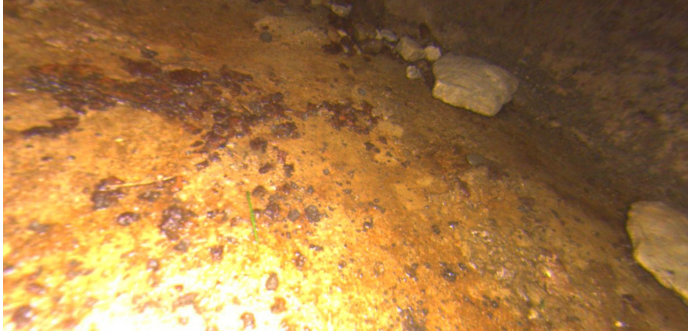
Code:	DSF
Description:	Deposits Settled Fine
Distance (ft):	7.1
Structural Grade:	0
O&M Grade:	2
Clock Start/From:	12
Clock To:	12
1st Value:	
2nd Value:	
Value Percent:	5.000
Step:	NO
Remarks:
