Manhole Inspection Report

Date:	04/11/2018	Weather:		Coding:	RZMACP
MH#:	M-809-024	Owner:	NA	Len. Surveyed:	3.7
P.O.#:		Surveyor:	John Kuglmaier	Rim to Invert:	3.9
Customer:		Cert. #:	U-1215-07002349	Wall Material:	Concrete (reinforced)

Street:	Murrelet St. to the East Cul De Sac.	Project:	Hobart, IN
City:	Hobart, IN	GPS Northing:	2909839.757
Location:		GPS Easting:	2909839.757
Drain Area:	Southwest	GPS Accuracy:	Sub-Meter
Cover Shape:	Circular	Evidence of Surcharge:	No
Cover Size:	22.5	Potential for Runoff:	None
Comments:

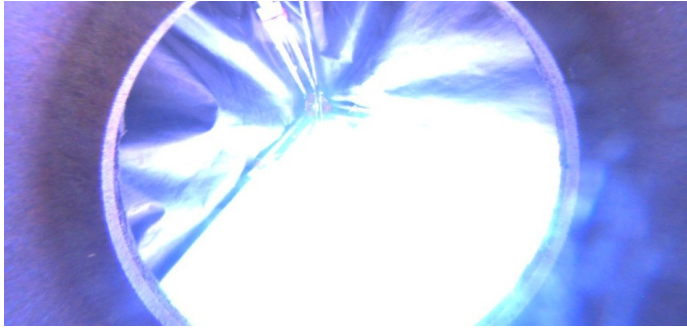
Code: **MGP**
Description: **General Photo**

Distance (ft): **1.5**
Structural Grade: **0**
O&M Grade: **0**
Clock Start/From:
Clock To:
1st Value:
2nd Value:
Value Percent:
Step: **NO**
Remarks:

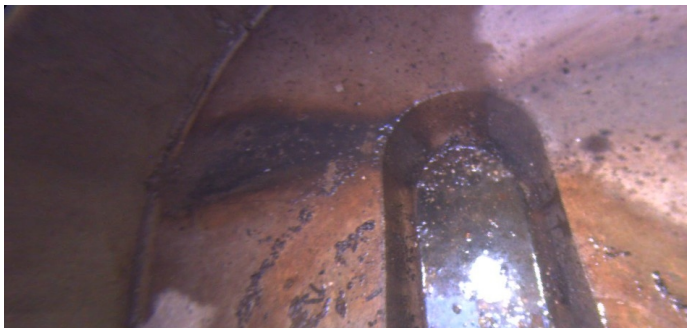
Code: **IS**
Description: **Infil Stain**

Distance (ft): **2.3**
Structural Grade: **0**
O&M Grade: **0**
Clock Start/From: **10**
Clock To:
1st Value:
2nd Value:
Value Percent:
Step: **NO**
Remarks:

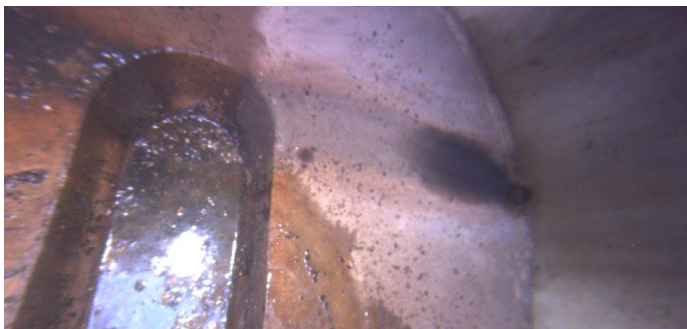
Code: **IS**
Description: **Infil Stain**

Distance (ft): **2.3**
Structural Grade: **0**
O&M Grade: **0**
Clock Start/From: **2**
Clock To:
1st Value:
2nd Value:
Value Percent:
Step: **NO**
Remarks:

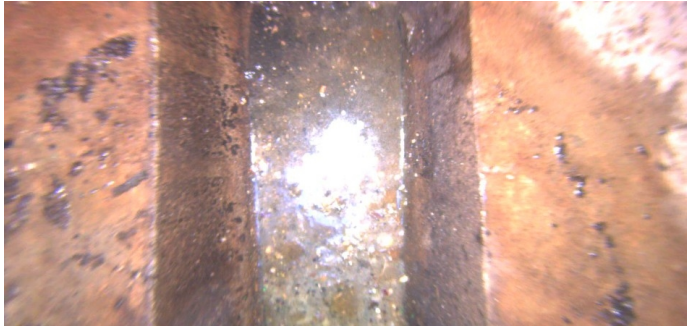
Code:	MGO
Description:	General Observation
Distance (ft):	3.1
Structural Grade:	0
O&M Grade:	0
Clock Start/From:	
Clock To:	
1st Value:	
2nd Value:	
Value Percent:	
Step:	NO
Remarks:	Ins. Comp.
