Manhole Inspection Report

M-809-030

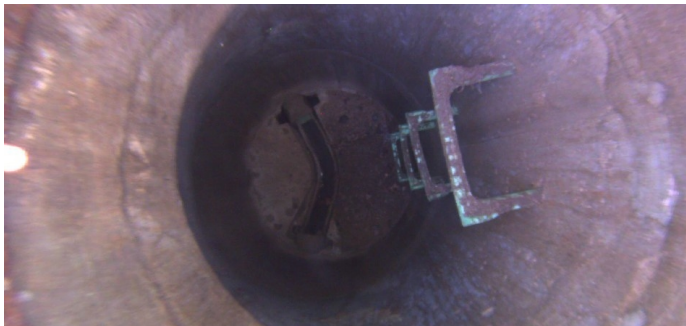
Code:	MGP
Description:	General Photo

Distance (ft):	.0
Structural Grade:	0
O&M Grade:	0
Clock Start/From:	
Clock To:	
1st Value:	
2nd Value:	
Value Percent:	
Step:	NO
Remarks:

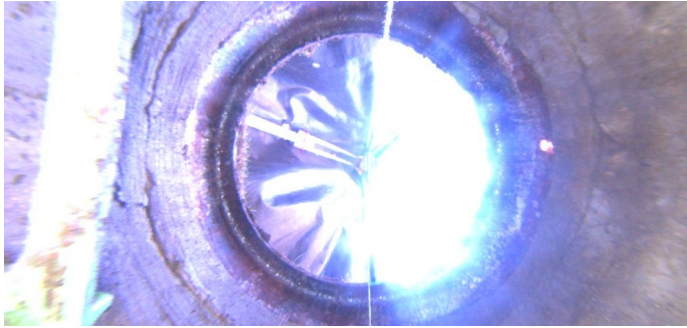
Code: **MGP**
Description: **General Photo**

Distance (ft): **2.5**
Structural Grade: **0**
O&M Grade: **0**
Clock Start/From:
Clock To:
1st Value:
2nd Value:
Value Percent:
Step: **NO**
Remarks:

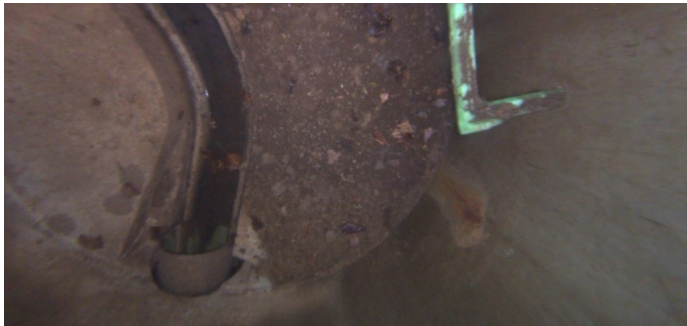
Code: **IS**
Description: **Infil Stain**

Distance (ft): **4.6**
Structural Grade: **0**
O&M Grade: **0**
Clock Start/From: **4**
Clock To:
1st Value:
2nd Value:
Value Percent:
Step: **NO**
Remarks:

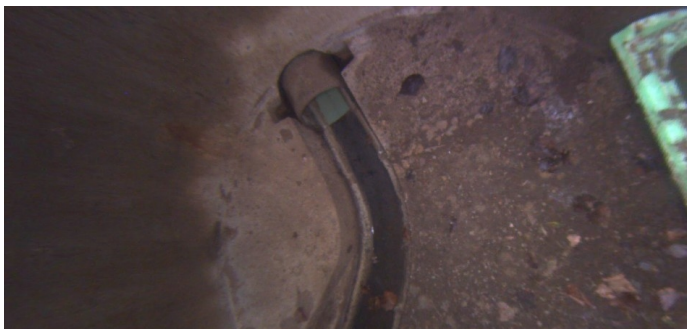
Code: **IS**
Description: **Infil Stain**

Distance (ft): **4.6**
Structural Grade: **0**
O&M Grade: **0**
Clock Start/From: **10**
Clock To:
1st Value:
2nd Value:
Value Percent:
Step: **NO**
Remarks:

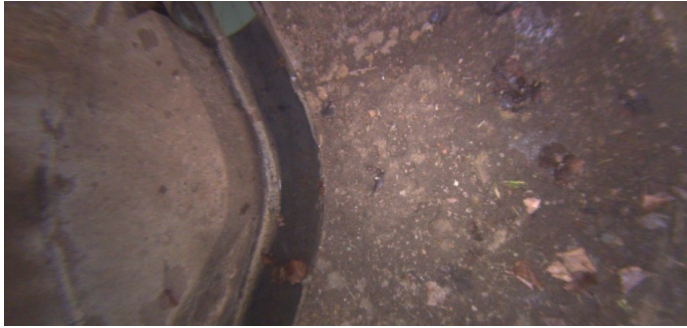
Code:	MGO
Description:	General Observation
Distance (ft):	5.6
Structural Grade:	0
O&M Grade:	0
Clock Start/From:	
Clock To:	
1st Value:	
2nd Value:	
Value Percent:	
Step:	NO
Remarks:	Ins. Comp.
