Manhole Inspection Report

Date:	04/11/2018	Weather:		Coding:	RZMACP
MH#:	M-809-031	Owner:	NA	Len. Surveyed:	6.7
P.O.#:		Surveyor:	John Kuglmaier	Rim to Invert:	7.3
Customer:		Cert. #:	U-1215-07002349	Wall Material:	Concrete (reinforced)

Street:	Eider Ave. 471' Northwest of Bracke	Project:	Hobart, IN
City:	Hobart, IN	GPS Northing:	2908747.03
Location:		GPS Easting:	2908747.03
Drain Area:	Southwest	GPS Accuracy:	Sub-Meter
Cover Shape:	Circular	Evidence of Surcharge:	No
Cover Size:	22.5	Potential for Runoff:	None
Comments:

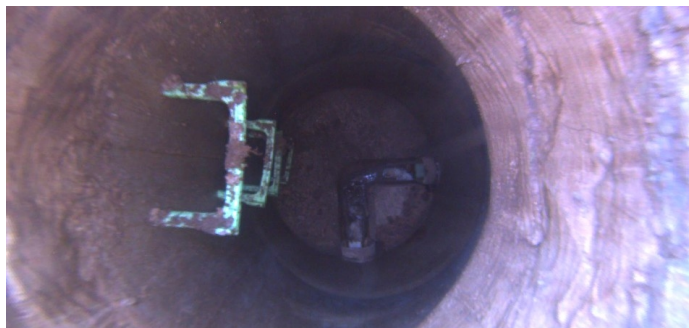
Code: **MGP**
Description: **General Photo**

Distance (ft): **.0**
Structural Grade: **0**
O&M Grade: **0**
Clock Start/From:
Clock To:
1st Value:
2nd Value:
Value Percent:
Step: **NO**
Remarks:

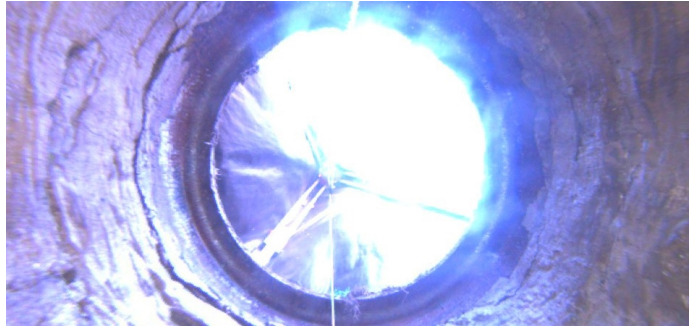
Code: **MGP**
Description: **General Photo**

Distance (ft): **2.3**
Structural Grade: **0**
O&M Grade: **0**
Clock Start/From:
Clock To:
1st Value:
2nd Value:
Value Percent:
Step: **NO**
Remarks:

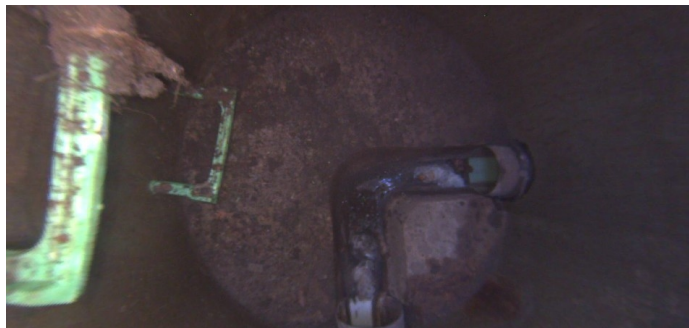
Code: **DSF**
Description: **Deposits Settled Fine**

Distance (ft): **3.7**
Structural Grade: **0**
O&M Grade: **2**
Clock Start/From: **12**
Clock To: **12**
1st Value:
2nd Value:
Value Percent: **5.000**
Step: **NO**
Remarks:

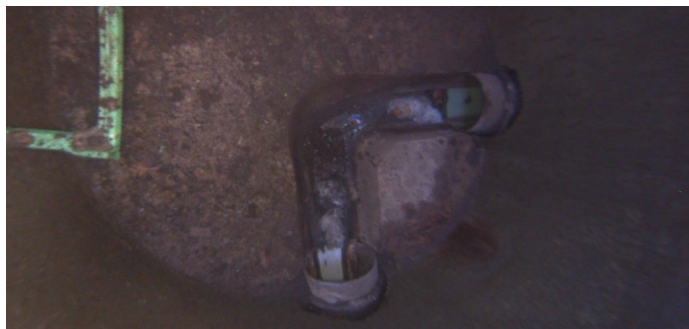
Code: **IS**
Description: **Infil Stain**

Distance (ft): **4.5**
Structural Grade: **0**
O&M Grade: **0**
Clock Start/From: **5**
Clock To:
1st Value:
2nd Value:
Value Percent:
Step: **NO**
Remarks:

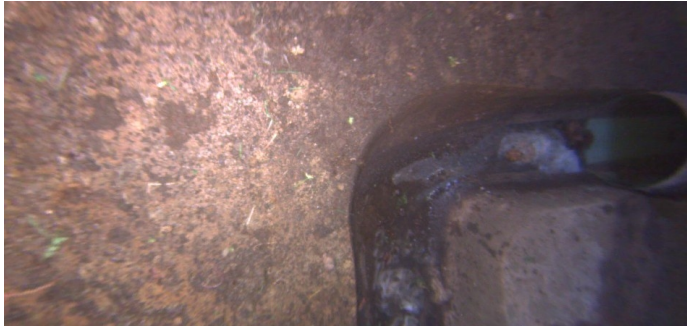
Code:	MGO
Description:	General Observation
Distance (ft):	5.8
Structural Grade:	0
O&M Grade:	0
Clock Start/From:	
Clock To:	
1st Value:	
2nd Value:	
Value Percent:	
Step:	NO
Remarks:	Ins. Comp.
