Manhole Inspection Report

Date:	04/11/2018	Weather:		Coding:	RZMACP
MH#:	M-809-033	Owner:	NA	Len. Surveyed:	12.4
P.O.#:		Surveyor:	John Kuglmaier	Rim to Invert:	13.1
Customer:		Cert. #:	U-1215-07002349	Wall Material:	Concrete (reinforced)

Street:	Intersection of Tanager St. and Kestr	Project:	Hobart, IN
City:	Hobart, IN	GPS Northing:	2908621.846
Location:		GPS Easting:	2908621.846
Drain Area:	Southwest	GPS Accuracy:	Sub-Meter
Cover Shape:	Circular	Evidence of Surcharge:	No
Cover Size:	22.5	Potential for Runoff:	None
Comments:

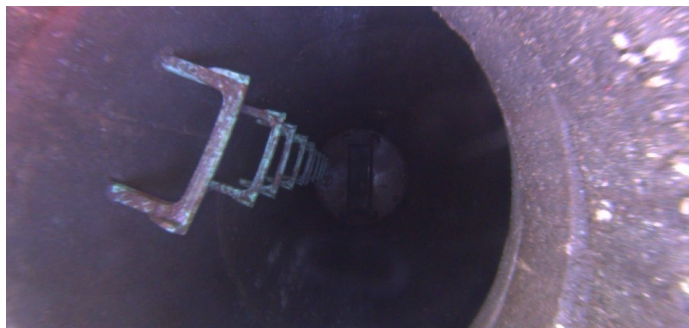
Code: **MGP**
Description: **General Photo**

Distance (ft): **.0**
Structural Grade: **0**
O&M Grade: **0**
Clock Start/From:
Clock To:
1st Value:
2nd Value:
Value Percent:
Step: **NO**
Remarks:

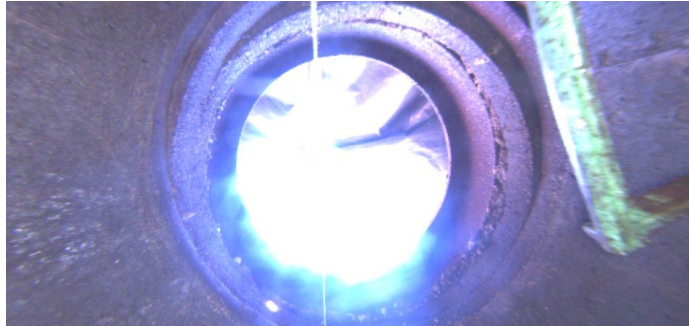
Code: **MGP**
Description: **General Photo**

Distance (ft): **2.9**
Structural Grade: **0**
O&M Grade: **0**
Clock Start/From:
Clock To:
1st Value:
2nd Value:
Value Percent:
Step: **NO**
Remarks:

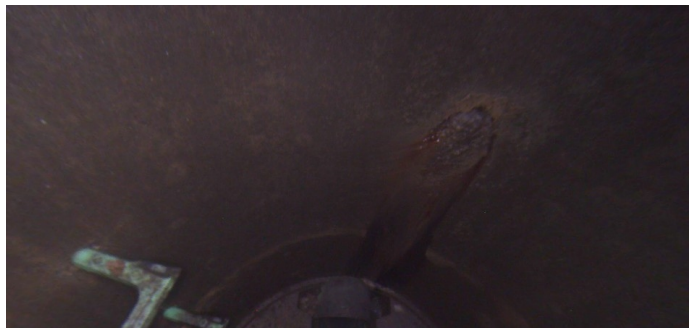
Code: **IS**
Description: **Infil Stain**

Distance (ft): **7.4**
Structural Grade: **0**
O&M Grade: **0**
Clock Start/From: **1**
Clock To:
1st Value:
2nd Value:
Value Percent:
Step: **NO**
Remarks:

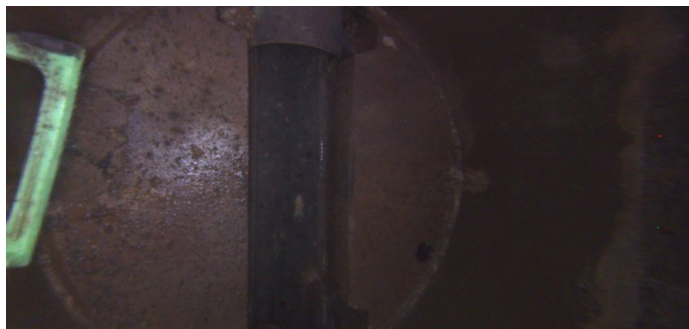
Code: **IS**
Description: **Infil Stain**

Distance (ft): **9.7**
Structural Grade: **0**
O&M Grade: **0**
Clock Start/From: **3**
Clock To:
1st Value:
2nd Value:
Value Percent:
Step: **NO**
Remarks:

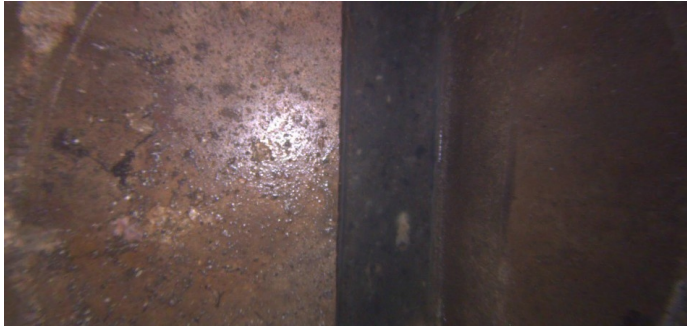
Code:	MGO
Description:	General Observation
Distance (ft):	11.1
Structural Grade:	0
O&M Grade:	0
Clock Start/From:	
Clock To:	
1st Value:	
2nd Value:	
Value Percent:	
Step:	NO
Remarks:	Ins. Comp.
