# Manhole Inspection Report

Date:	04/11/2018	Weather:		Coding:	RZMACP
MH#:	M-809-034	Owner:	NA	Len. Surveyed:	11.9
P.O.#:		Surveyor:	John Kuglmaier	Rim to Invert:	12.5
Customer:		Cert. #:	U-1215-07002349	Wall Material:	Concrete (reinforced)

Street:	Tanager St. 233' North of Kestrel St.	Project:	Hobart, IN
City:	Hobart, IN	GPS Northing:	0.0
Location:		GPS Easting:	0.0
Drain Area:	Southwest	GPS Accuracy:	Nearest Meter
Cover Shape:	Circular	Evidence of Surcharge:	No
Cover Size:	22.5	Potential for Runoff:	None
Comments:

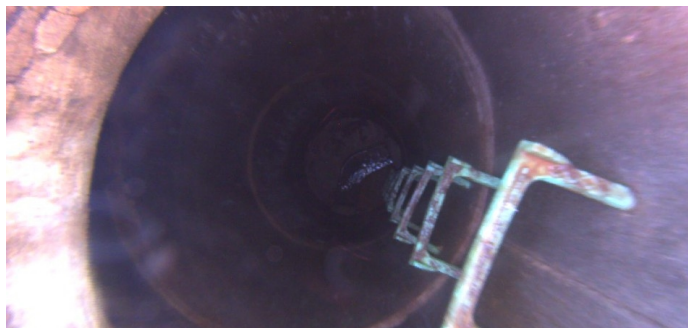
Code: **MGP**  
Description: **General Photo**

Distance (ft): **.0**  
Structural Grade: **0**  
O&M Grade: **0**  
Clock Start/From:  
Clock To:  
1st Value:  
2nd Value:  
Value Percent:  
Step: **NO**  
Remarks:

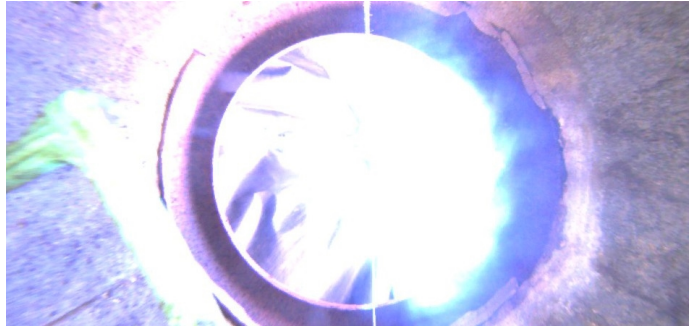
Code: **MGP**  
Description: **General Photo**

Distance (ft): **2.3**  
Structural Grade: **0**  
O&M Grade: **0**  
Clock Start/From:  
Clock To:  
1st Value:  
2nd Value:  
Value Percent:  
Step: **NO**  
Remarks:

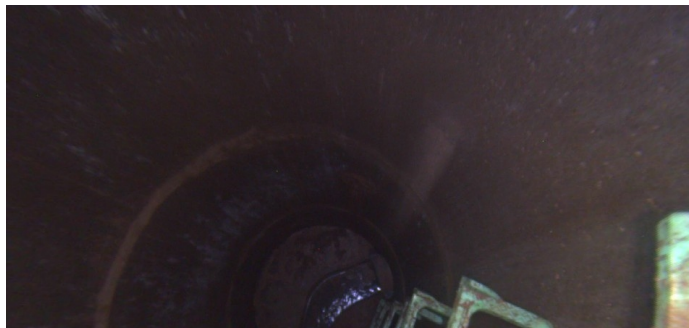
Code: **IS**  
Description: **Infil Stain**

Distance (ft): **3.0**  
Structural Grade: **0**  
O&M Grade: **0**  
Clock Start/From: **2**  
Clock To:  
1st Value:  
2nd Value:  
Value Percent:  
Step: **NO**  
Remarks:

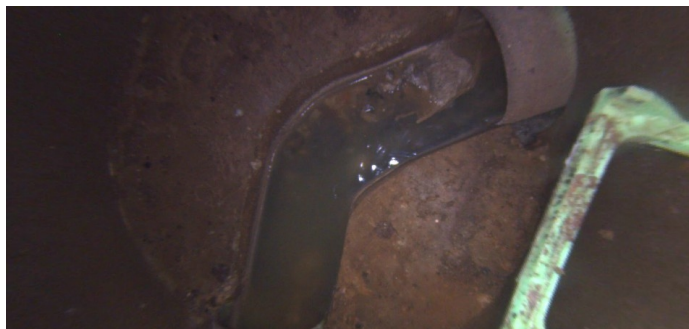
Code: **MGO**  
Description: **General Observation**

Distance (ft): **9.8**  
Structural Grade: **0**  
O&M Grade: **0**  
Clock Start/From:  
Clock To:  
1st Value:  
2nd Value:  
Value Percent:  
Step: **NO**  
Remarks: **Ins. Comp.**
