Manhole Inspection Report

Date:	09/21/2022	Weather:		Coding:	RZMACP
MH#:	M-809-035	Owner:	NA	Len. Surveyed:	11.3
P.O.#:		Surveyor:	Jen Costello	Rim to Invert:	12.5
Customer:		Cert. #:	U-907-5518	Wall Material:	Concrete (cast in place)

Street:	Merganser St. and Tanager St.	Project:	Hobart, IN
City:	Hobart, IN	GPS Northing:	2279311.545
Location:	Local Rural Streets	GPS Easting:	2908264.626
Drain Area:	Southwest	GPS Accuracy:	Sub-Meter
Cover Shape:	Circular	Evidence of Surcharge:	No
Cover Size:	24.0	Potential for Runoff:	None
Comments:

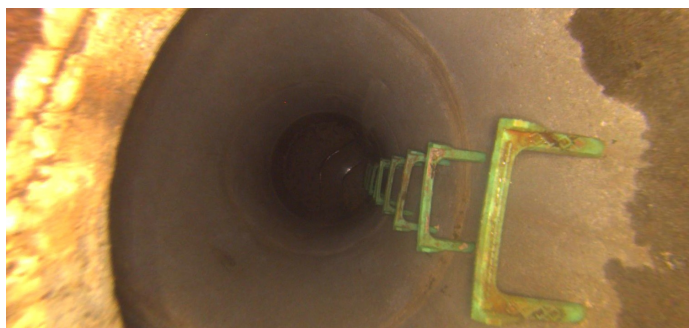
Code: **MGO**
Description: **General Observation**

Distance (ft): **.0**
Structural Grade: **0**
O&M Grade: **0**
Clock Start/From:
Clock To:
1st Value:
2nd Value:
Value Percent:
Step: **NO**
Remarks: **access mh**

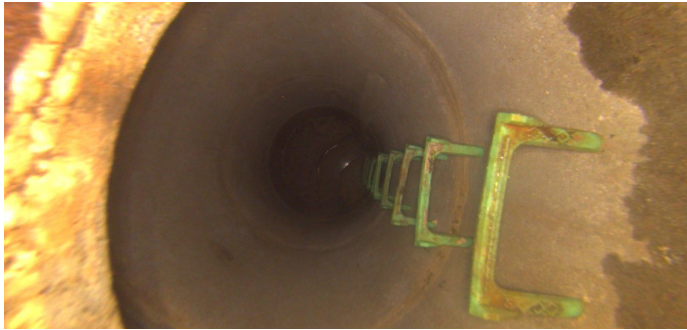
Code: **SRI**
Description: **Surface Roughness Increased**

Distance (ft): **.0**
Structural Grade: **1**
O&M Grade: **0**
Clock Start/From: **12**
Clock To: **12**
1st Value:
2nd Value:
Value Percent:
Step: **NO**
Remarks:

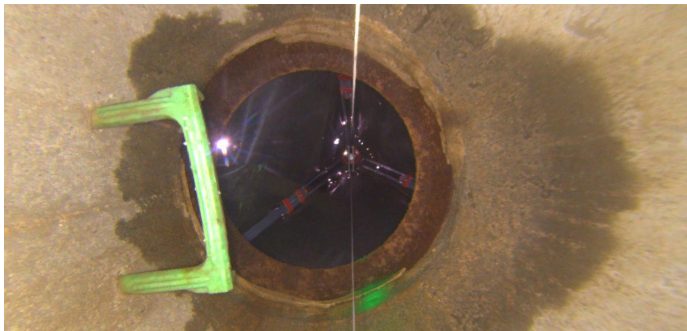
Code: **MGO**
Description: **General Observation**

Distance (ft): **2.8**
Structural Grade: **0**
O&M Grade: **0**
Clock Start/From:
Clock To:
1st Value:
2nd Value:
Value Percent:
Step: **NO**
Remarks: **underside of frame**

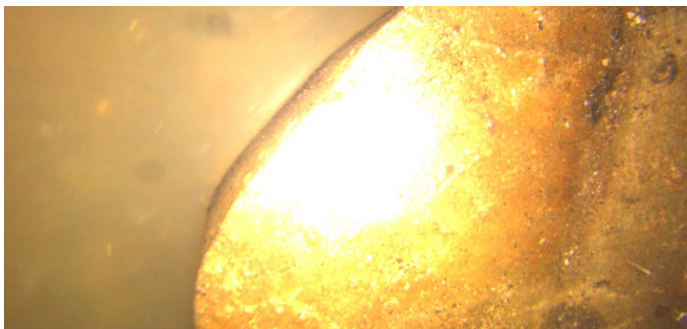
Code: **DSF**
Description: **Deposits Settled Fine**

Distance (ft): **11.3**
Structural Grade: **0**
O&M Grade: **2**
Clock Start/From: **12**
Clock To: **12**
1st Value:
2nd Value:
Value Percent: **5.000**
Step: **NO**
Remarks:

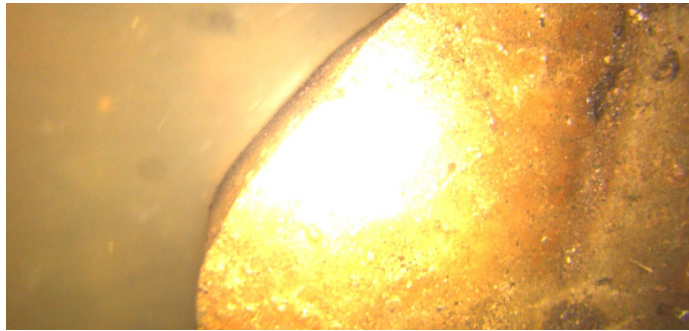
Code: **MGO**
Description: **General Observation**

Distance (ft): **11.3**
Structural Grade: **0**
O&M Grade: **0**
Clock Start/From:
Clock To:
1st Value:
2nd Value:
Value Percent:
Step: **NO**
Remarks: **end of survey**

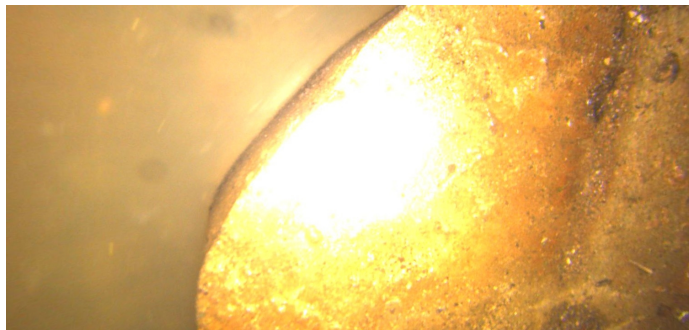
Code: **SRI**
Description: **Surface Roughness Increased**

Distance (ft): **11.3**
Structural Grade: **1**
O&M Grade: **0**
Clock Start/From: **12**
Clock To: **12**
1st Value:
2nd Value:
Value Percent:
Step: **NO**
Remarks:
