# Manhole Inspection Report

Date:	<b>04/11/2018</b>	Weather:		Coding:	<b>RZMACP</b>
MH#:	<b>M-809-037</b>	Owner:	<b>NA</b>	Len. Surveyed:	<b>12.0</b>
P.O.#:		Surveyor:	<b>John Kuglmaier</b>	Rim to Invert:	<b>12.9</b>
Customer:		Cert. #:	<b>U-1215-07002349</b>	Wall Material:	<b>Concrete (reinforced)</b>

Street:	<b>Merganser St. 537' East of Kestrel St.</b>	Project:	<b>Hobart, IN</b>
City:	<b>Hobart, IN</b>	GPS Northing:	<b>2907850.333</b>
Location:		GPS Easting:	<b>2907850.333</b>
Drain Area:	<b>Southwest</b>	GPS Accuracy:	<b>Sub-Meter</b>
Cover Shape:	<b>Circular</b>	Evidence of Surcharge:	<b>No</b>
Cover Size:	<b>22.5</b>	Potential for Runoff:	<b>None</b>
Comments:

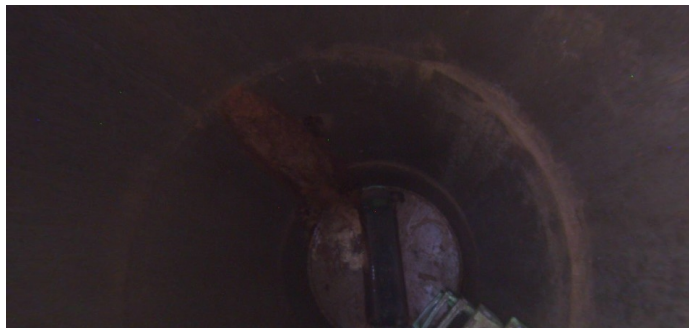
Code: **IS**  
Description: **Infil Stain**

Distance (ft): **4.3**  
Structural Grade: **0**  
O&M Grade: **0**  
Clock Start/From: **11**  
Clock To:  
1st Value:  
2nd Value:  
Value Percent:  
Step: **NO**  
Remarks:

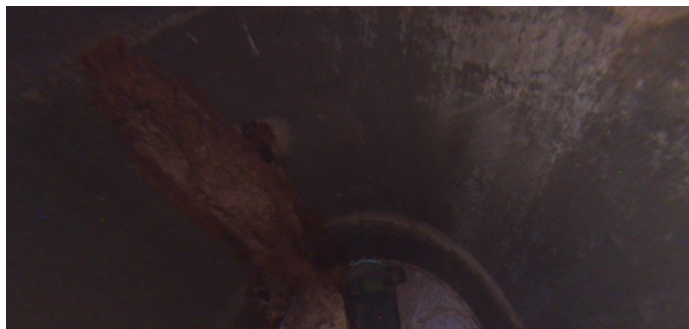
Code: **DAE**  
Description: **Deposits Attached Encrustation**

Distance (ft): **6.2**  
Structural Grade: **0**  
O&M Grade: **2**  
Clock Start/From: **11**  
Clock To:  
1st Value:  
2nd Value:  
Value Percent: **5.000**  
Step: **NO**  
Remarks:

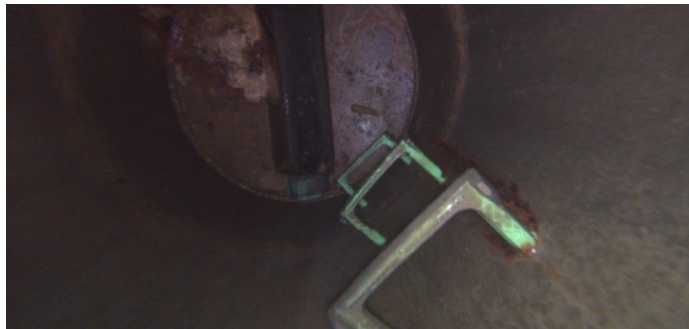
Code: **IS**  
Description: **Infil Stain**

Distance (ft): **7.3**  
Structural Grade: **0**  
O&M Grade: **0**  
Clock Start/From: **4**  
Clock To:  
1st Value:  
2nd Value:  
Value Percent:  
Step: **YES**  
Remarks:

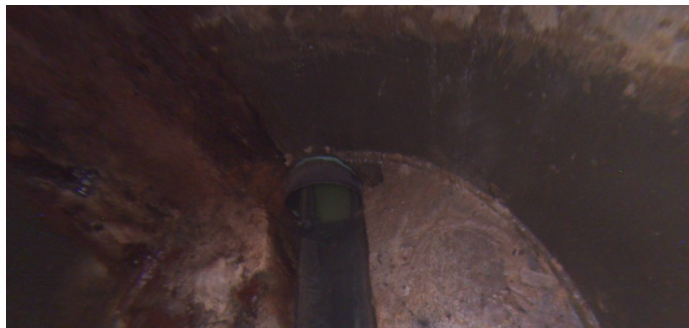
Code: **DAE**  
Description: **Deposits Attached Encrustation**

Distance (ft): **9.9**  
Structural Grade: **0**  
O&M Grade: **2**  
Clock Start/From: **11**  
Clock To:  
1st Value:  
2nd Value:  
Value Percent: **5.000**  
Step: **NO**  
Remarks:

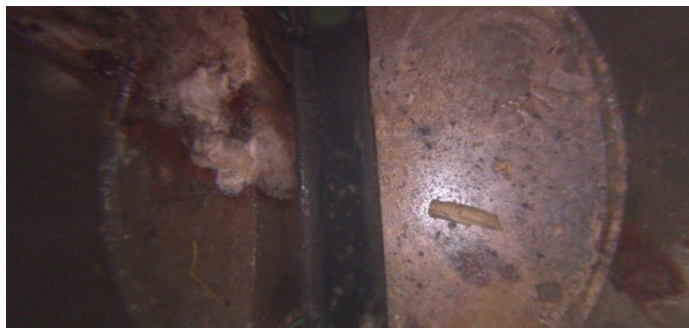
Code: **MGO**  
Description: **General Observation**

Distance (ft): **10.2**  
Structural Grade: **0**  
O&M Grade: **0**  
Clock Start/From:  
Clock To:  
1st Value:  
2nd Value:  
Value Percent:  
Step: **NO**  
Remarks: **Ins. Comp.**
