Manhole Inspection Report

Date:	04/11/2018	Weather:		Coding:	RZMACP
MH#:	M-809-040	Owner:	NA	Len. Surveyed:	7.6
P.O.#:		Surveyor:	John Kuglmaier	Rim to Invert:	8.1
Customer:		Cert. #:	U-1215-07002349	Wall Material:	Concrete (reinforced)

Street:	Kestrel St. 203' South of Merganser	Project:	Hobart, IN
City:	Hobart, IN	GPS Northing:	2907348.384
Location:		GPS Easting:	2907348.384
Drain Area:	Southwest	GPS Accuracy:	Sub-Meter
Cover Shape:	Circular	Evidence of Surcharge:	No
Cover Size:	22.5	Potential for Runoff:	None
Comments:

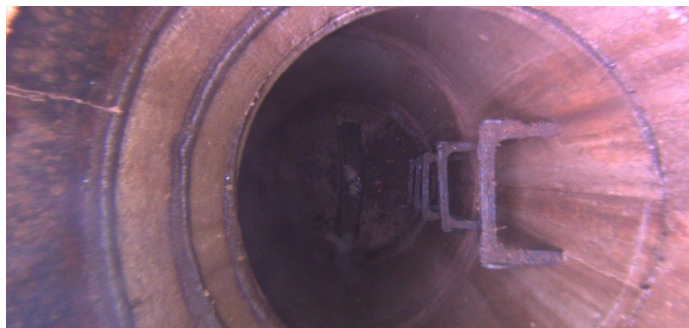
Code: **MGP**
 Description: **General Photo**

Distance (ft): **.0**
 Structural Grade: **0**
 O&M Grade: **0**
 Clock Start/From:
 Clock To:
 1st Value:
 2nd Value:
 Value Percent:
 Step: **NO**
 Remarks:

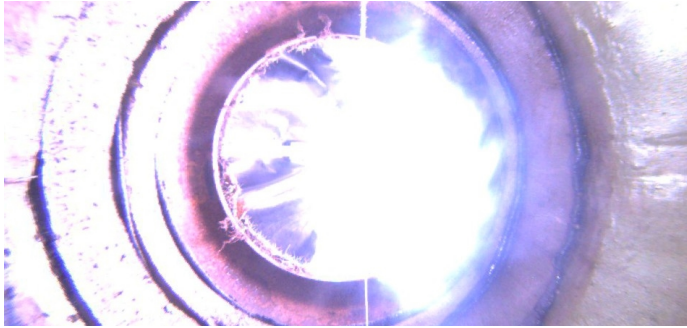
Code: **MGP**
Description: **General Photo**

Distance (ft): **2.7**
Structural Grade: **0**
O&M Grade: **0**
Clock Start/From:
Clock To:
1st Value:
2nd Value:
Value Percent:
Step: **NO**
Remarks:

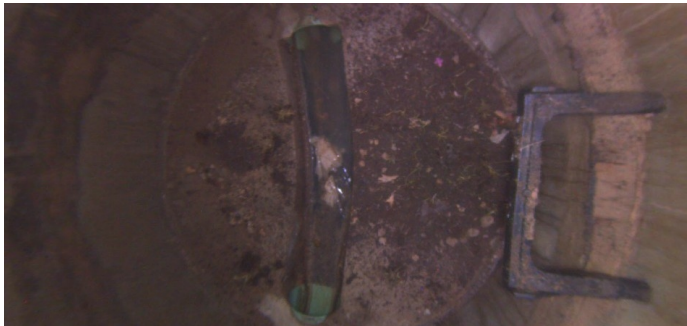
Code: **DAZ**
Description: **Deposits Attached Other**

Distance (ft): **4.9**
Structural Grade: **0**
O&M Grade: **2**
Clock Start/From: **12**
Clock To: **12**
1st Value:
2nd Value:
Value Percent: **5.000**
Step: **NO**
Remarks: **Mixed materials**

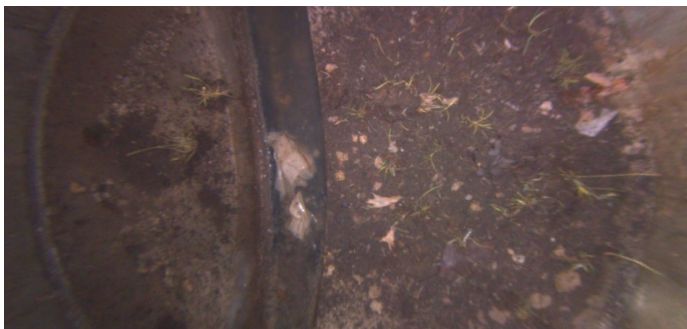
Code: **MGO**
Description: **General Observation**

Distance (ft): **6.2**
Structural Grade: **0**
O&M Grade: **0**
Clock Start/From:
Clock To:
1st Value:
2nd Value:
Value Percent:
Step: **NO**
Remarks: **Ins. Comp.**
