# Manhole Inspection Report

Date:	04/11/2018	Weather:		Coding:	RZMACP
MH#:	M-809-041	Owner:	NA	Len. Surveyed:	8.0
P.O.#:		Surveyor:	John Kuglmaier	Rim to Invert:	8.5
Customer:		Cert. #:	U-1215-07002349	Wall Material:	Concrete (reinforced)

Street:	Kestrel St. 281' Southeast of Mergan	Project:	Hobart, IN
City:	Hobart, IN	GPS Northing:	2907405.304
Location:		GPS Easting:	2907405.304
Drain Area:	Southwest	GPS Accuracy:	Sub-Meter
Cover Shape:	Circular	Evidence of Surcharge:	No
Cover Size:	22.5	Potential for Runoff:	None
Comments:

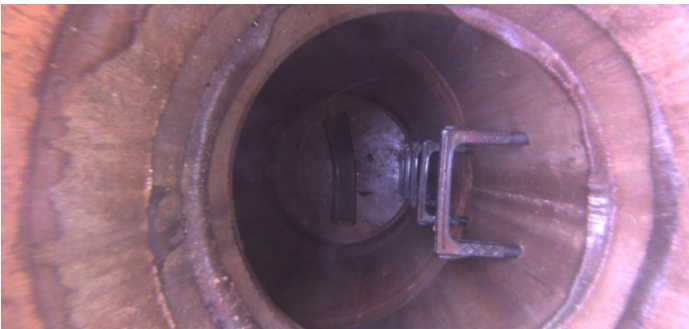
Code: **MGP**  
 Description: **General Photo**

Distance (ft): **.0**  
 Structural Grade: **0**  
 O&M Grade: **0**  
 Clock Start/From:  
 Clock To:  
 1st Value:  
 2nd Value:  
 Value Percent:  
 Step: **NO**  
 Remarks:

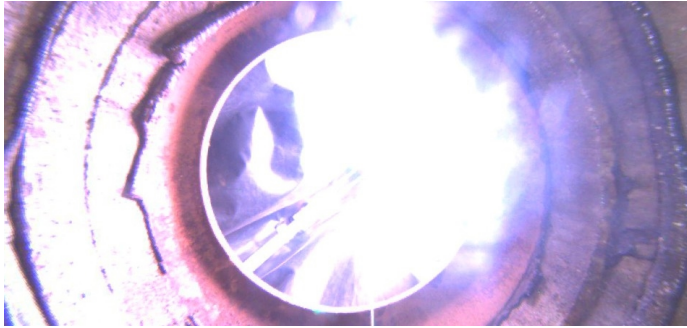
Code: **MGP**  
Description: **General Photo**

Distance (ft): **2.2**  
Structural Grade: **0**  
O&M Grade: **0**  
Clock Start/From:  
Clock To:  
1st Value:  
2nd Value:  
Value Percent:  
Step: **NO**  
Remarks:

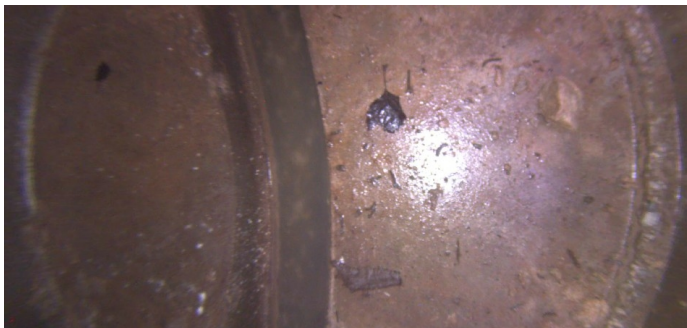
Code: **MGO**  
Description: **General Observation**

Distance (ft): **6.5**  
Structural Grade: **0**  
O&M Grade: **0**  
Clock Start/From:  
Clock To:  
1st Value:  
2nd Value:  
Value Percent:  
Step: **NO**  
Remarks: **Ins. Comp.**
