Manhole Inspection Report

Date:	04/11/2018	Weather:		Coding:	RZMACP
MH#:	M-809-042	Owner:	NA	Len. Surveyed:	7.9
P.O.#:		Surveyor:	John Kuglmaier	Rim to Invert:	8.2
Customer:		Cert. #:	U-1215-07002349	Wall Material:	Concrete (reinforced)

Street:	Kestrel St. 350' Southeast of Mergan	Project:	Hobart, IN
City:	Hobart, IN	GPS Northing:	2907482.926
Location:		GPS Easting:	2907482.926
Drain Area:	Southwest	GPS Accuracy:	Sub-Meter
Cover Shape:	Circular	Evidence of Surcharge:	No
Cover Size:	22.5	Potential for Runoff:	None
Comments:

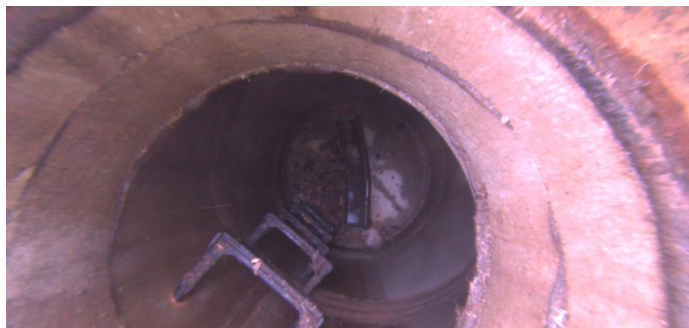
Code: **MGP**
Description: **General Photo**

Distance (ft): **.0**
Structural Grade: **0**
O&M Grade: **0**
Clock Start/From:
Clock To:
1st Value:
2nd Value:
Value Percent:
Step: **NO**
Remarks:

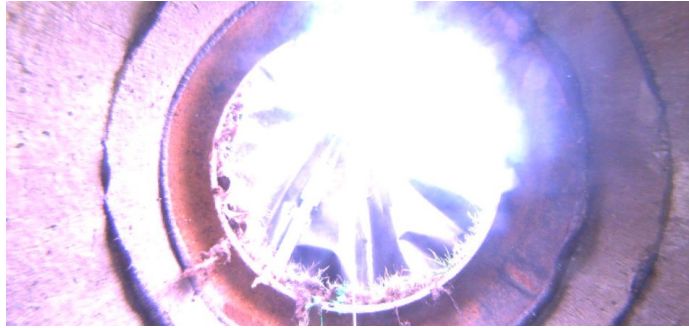
Code: **MGP**
Description: **General Photo**

Distance (ft): **2.4**
Structural Grade: **0**
O&M Grade: **0**
Clock Start/From:
Clock To:
1st Value:
2nd Value:
Value Percent:
Step: **NO**
Remarks:

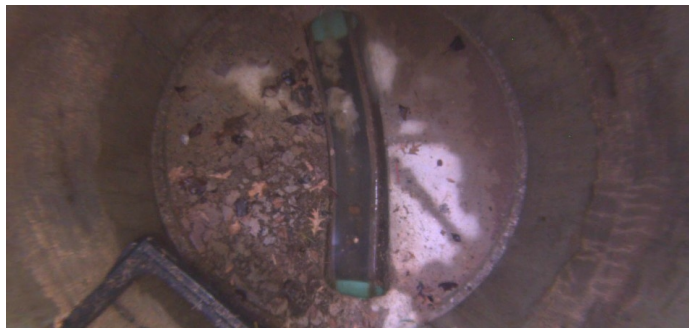
Code: **DAZ**
Description: **Deposits Attached Other**

Distance (ft): **5.0**
Structural Grade: **0**
O&M Grade: **2**
Clock Start/From: **6**
Clock To: **10**
1st Value:
2nd Value:
Value Percent: **5.000**
Step: **NO**
Remarks: **Mixed materials**

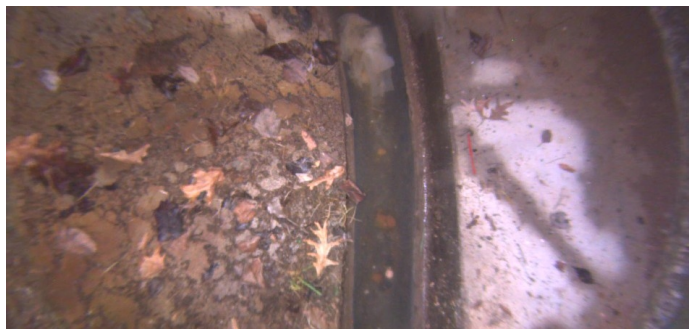
Code: **MGO**
Description: **General Observation**

Distance (ft): **6.5**
Structural Grade: **0**
O&M Grade: **0**
Clock Start/From:
Clock To:
1st Value:
2nd Value:
Value Percent:
Step: **NO**
Remarks: **Ins. Comp.**
