Manhole Inspection Report

Date:	04/11/2018	Weather:		Coding:	RZMACP
MH#:	M-809-044	Owner:	NA	Len. Surveyed:	7.1
P.O.#:		Surveyor:	John Kuglmaier	Rim to Invert:	7.8
Customer:		Cert. #:	U-1215-07002349	Wall Material:	Concrete (reinforced)

Street:	Kestrel St. 587' Southeast of Mergan	Project:	Hobart, IN
City:	Hobart, IN	GPS Northing:	2907804.551
Location:		GPS Easting:	2907804.551
Drain Area:	Southwest	GPS Accuracy:	Sub-Meter
Cover Shape:	Circular	Evidence of Surcharge:	No
Cover Size:	22.5	Potential for Runoff:	None
Comments:

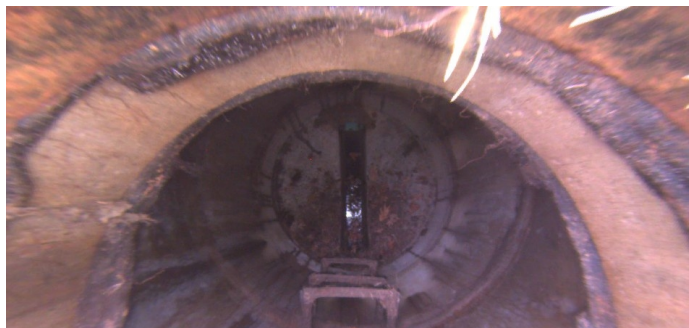
Code: **MGP**
Description: **General Photo**

Distance (ft): **.0**
Structural Grade: **0**
O&M Grade: **0**
Clock Start/From:
Clock To:
1st Value:
2nd Value:
Value Percent:
Step: **NO**
Remarks:

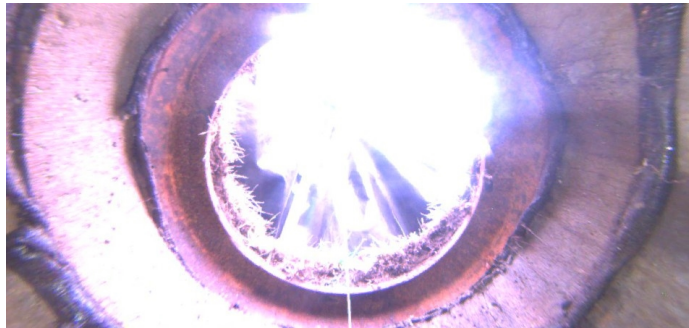
Code: **MGP**
Description: **General Photo**

Distance (ft): **2.3**
Structural Grade: **0**
O&M Grade: **0**
Clock Start/From:
Clock To:
1st Value:
2nd Value:
Value Percent:
Step: **NO**
Remarks:

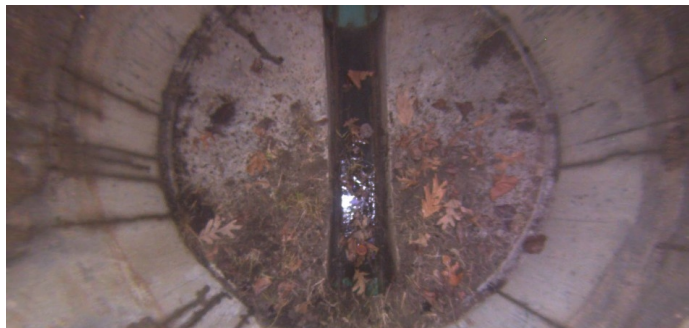
Code: **DAZ**
Description: **Deposits Attached Other**

Distance (ft): **4.3**
Structural Grade: **0**
O&M Grade: **2**
Clock Start/From: **12**
Clock To: **12**
1st Value:
2nd Value:
Value Percent: **5.000**
Step: **NO**
Remarks: **Mixed materials**

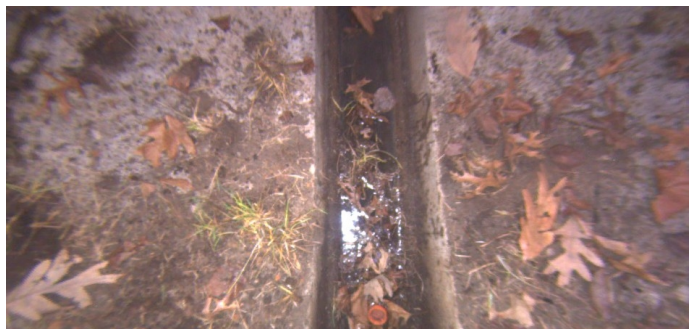
Code: **MGO**
Description: **General Observation**

Distance (ft): **5.9**
Structural Grade: **0**
O&M Grade: **0**
Clock Start/From:
Clock To:
1st Value:
2nd Value:
Value Percent:
Step: **NO**
Remarks: **Ins. Comp.**
