Manhole Inspection Report

Date:	04/12/2018	Weather:		Coding:	RZMACP
MH#:	M-809-045	Owner:	NA	Len. Surveyed:	5.1
P.O.#:		Surveyor:	John Kuglmaier	Rim to Invert:	5.6
Customer:		Cert. #:	U-1215-07002349	Wall Material:	Concrete (reinforced)

Street:	Kestrel St. 471' West of Tanager St.	Project:	Hobart, IN
City:	Hobart, IN	GPS Northing:	2908150.584
Location:		GPS Easting:	2908150.584
Drain Area:	Southwest	GPS Accuracy:	Sub-Meter
Cover Shape:	Circular	Evidence of Surcharge:	No
Cover Size:	22.5	Potential for Runoff:	None
Comments:

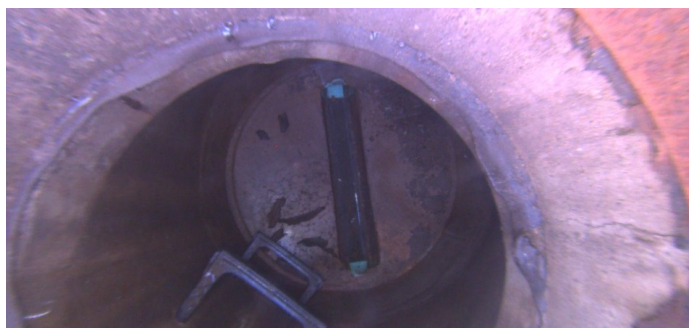
Code: **MGP**
Description: **General Photo**

Distance (ft): **.0**
Structural Grade: **0**
O&M Grade: **0**
Clock Start/From:
Clock To:
1st Value:
2nd Value:
Value Percent:
Step: **NO**
Remarks:

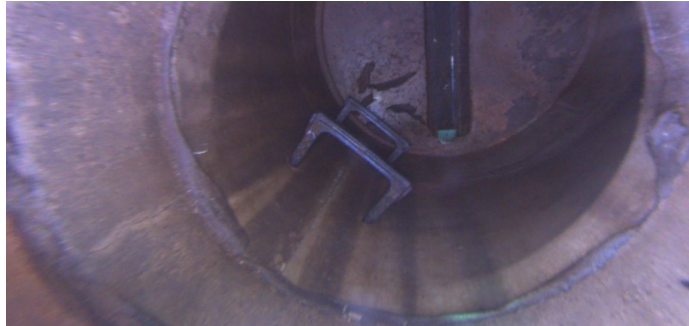
Code: **IS**
Description: **Infil Stain**

Distance (ft): **.0**
Structural Grade: **0**
O&M Grade: **0**
Clock Start/From: **6**
Clock To: **8**
1st Value:
2nd Value:
Value Percent:
Step: **NO**
Remarks:

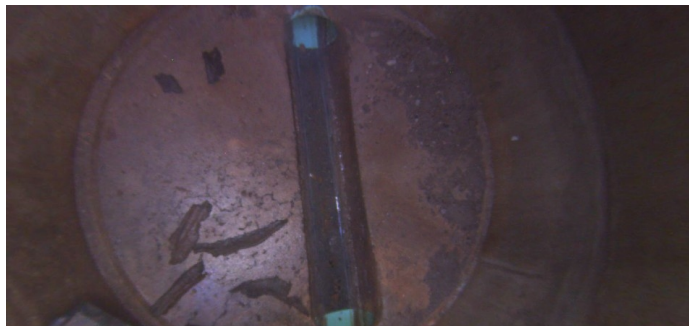
Code: **DSF**
Description: **Deposits Settled Fine**

Distance (ft): **2.4**
Structural Grade: **0**
O&M Grade: **2**
Clock Start/From: **1**
Clock To: **5**
1st Value:
2nd Value:
Value Percent: **5.000**
Step: **NO**
Remarks:

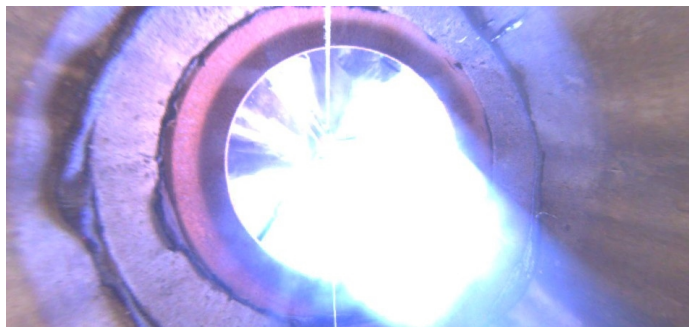
Code: **MGP**
Description: **General Photo**

Distance (ft): **2.6**
Structural Grade: **0**
O&M Grade: **0**
Clock Start/From:
Clock To:
1st Value:
2nd Value:
Value Percent:
Step: **NO**
Remarks:

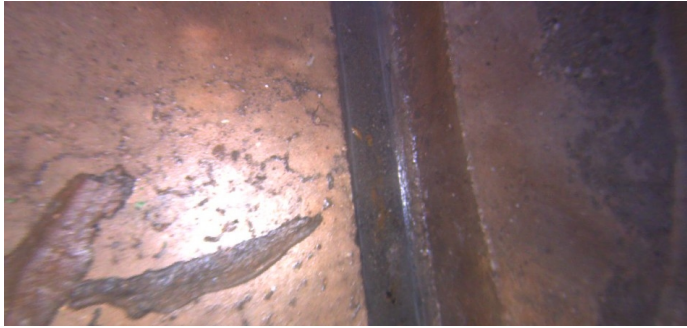
Code:	MGO
Description:	General Observation
Distance (ft):	4.0
Structural Grade:	0
O&M Grade:	0
Clock Start/From:	
Clock To:	
1st Value:	
2nd Value:	
Value Percent:	
Step:	NO
Remarks:	Ins. Comp.
