Manhole Inspection Report

Date:	04/11/2018	Weather:		Coding:	RZMACP
MH#:	M-809-047	Owner:	NA	Len. Surveyed:	5.9
P.O.#:		Surveyor:	John Kuglmaier	Rim to Invert:	6.6
Customer:		Cert. #:	U-1215-07002349	Wall Material:	Concrete (reinforced)

Street:	Tanager St. 104' North of Merganser	Project:	Hobart, IN
City:	Hobart, IN	GPS Northing:	2908171.018
Location:		GPS Easting:	2908171.018
Drain Area:	Southwest	GPS Accuracy:	Sub-Meter
Cover Shape:	Circular	Evidence of Surcharge:	No
Cover Size:	22.5	Potential for Runoff:	None
Comments:

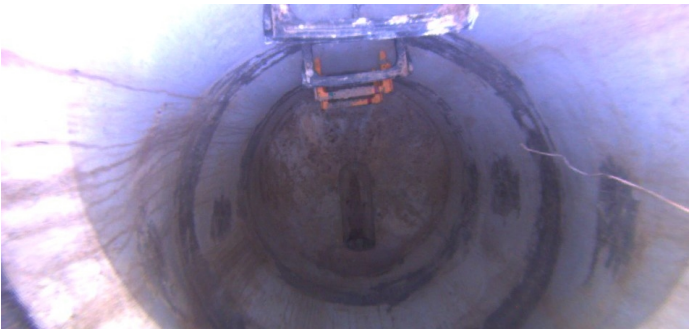
Code: **MGP**
Description: **General Photo**

Distance (ft): **.0**
Structural Grade: **0**
O&M Grade: **0**
Clock Start/From:
Clock To:
1st Value:
2nd Value:
Value Percent:
Step: **NO**
Remarks:

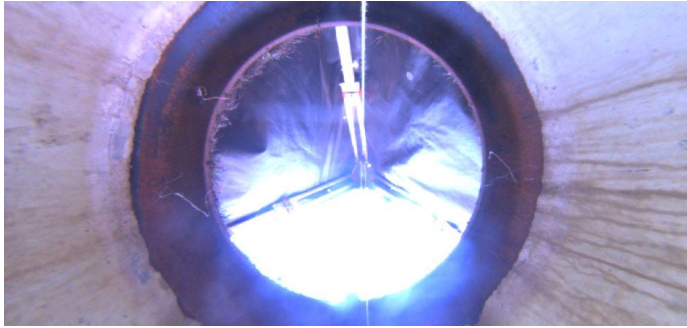
Code: **MGP**
Description: **General Photo**

Distance (ft): **2.4**
Structural Grade: **0**
O&M Grade: **0**
Clock Start/From:
Clock To:
1st Value:
2nd Value:
Value Percent:
Step: **NO**
Remarks:

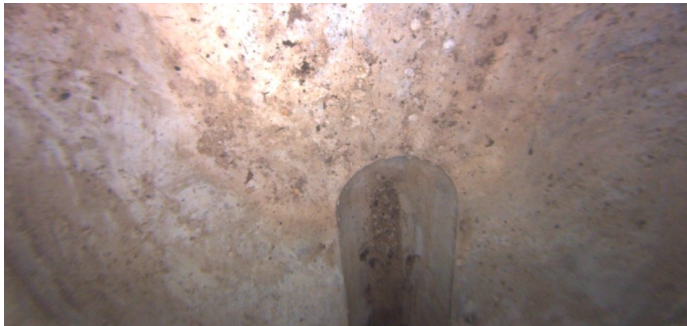
Code: **MGO**
Description: **General Observation**

Distance (ft): **5.0**
Structural Grade: **0**
O&M Grade: **0**
Clock Start/From:
Clock To:
1st Value:
2nd Value:
Value Percent:
Step: **NO**
Remarks: **Ins. Comp.**
