Manhole Inspection Report

Date:	04/11/2018	Weather:		Coding:	RZMACP
MH#:	M-809-048	Owner:	NA	Len. Surveyed:	7.1
P.O.#:		Surveyor:	John Kuglmaier	Rim to Invert:	7.5
Customer:		Cert. #:	U-1215-07002349	Wall Material:	Concrete (reinforced)

Street:	Tanager St. 336' North of Merganser	Project:	Hobart, IN
City:	Hobart, IN	GPS Northing:	2907981.894
Location:		GPS Easting:	2907981.894
Drain Area:	Southwest	GPS Accuracy:	Sub-Meter
Cover Shape:	Circular	Evidence of Surcharge:	No
Cover Size:	22.5	Potential for Runoff:	None
Comments:

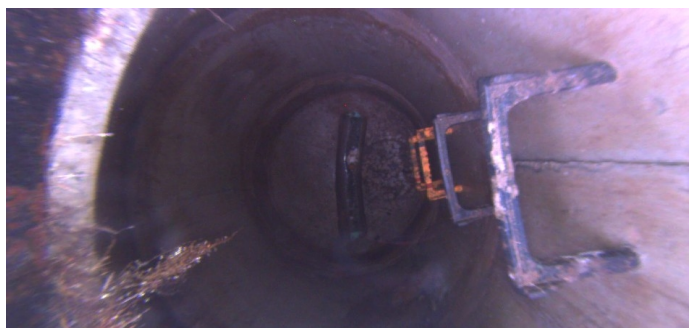
Code: **MGP**
Description: **General Photo**

Distance (ft): **.0**
Structural Grade: **0**
O&M Grade: **0**
Clock Start/From:
Clock To:
1st Value:
2nd Value:
Value Percent:
Step: **NO**
Remarks:

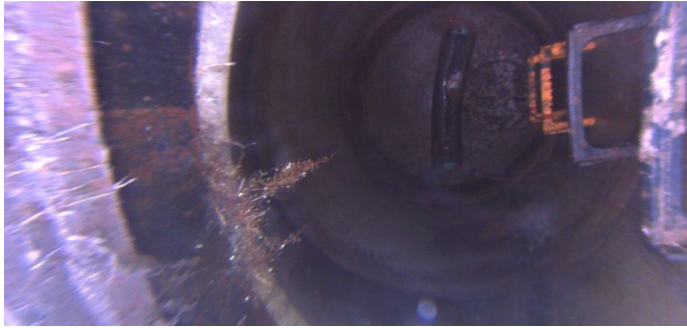
Code: **RFJ**
Description: **Roots Fine Joint**

Distance (ft): **.0**
Structural Grade: **0**
O&M Grade: **1**
Clock Start/From: **8**
Clock To:
1st Value:
2nd Value:
Value Percent:
Step: **NO**
Remarks:

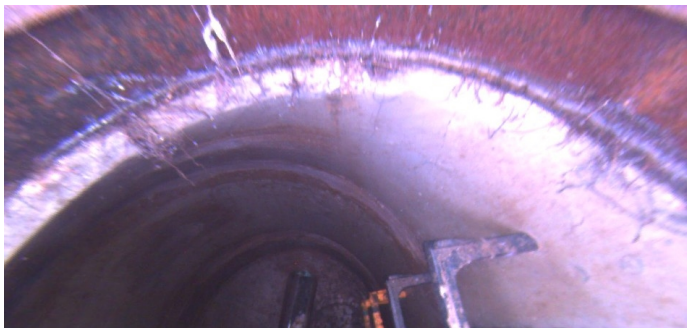
Code: **RFJ**
Description: **Roots Fine Joint**

Distance (ft): **.0**
Structural Grade: **0**
O&M Grade: **1**
Clock Start/From: **11**
Clock To: **4**
1st Value:
2nd Value:
Value Percent:
Step: **NO**
Remarks:

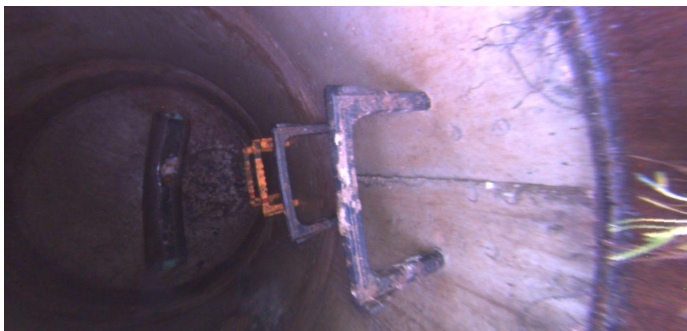
Code: **FL**
Description: **Fracture Longitudinal**

Distance (ft): **.2**
Structural Grade: **3**
O&M Grade: **0**
Clock Start/From: **3**
Clock To:
1st Value:
2nd Value:
Value Percent:
Step: **NO**
Remarks:

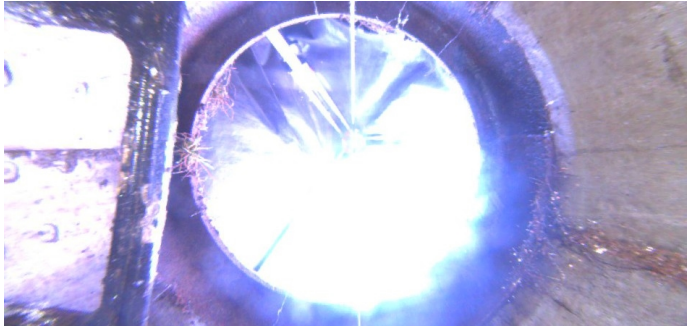
Code: **MGP**
Description: **General Photo**

Distance (ft): **2.2**
Structural Grade: **0**
O&M Grade: **0**
Clock Start/From:
Clock To:
1st Value:
2nd Value:
Value Percent:
Step: **NO**
Remarks:

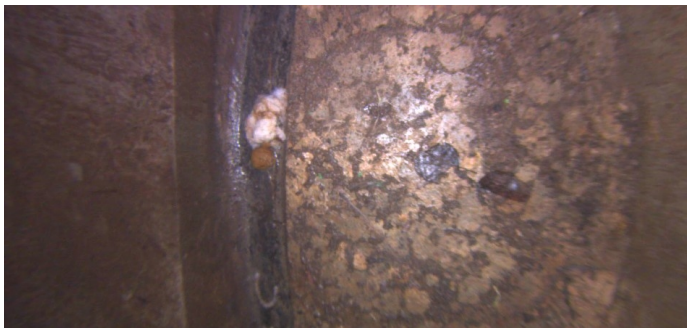
Code: **MGO**
Description: **General Observation**

Distance (ft): **5.8**
Structural Grade: **0**
O&M Grade: **0**
Clock Start/From:
Clock To:
1st Value:
2nd Value:
Value Percent:
Step: **NO**
Remarks: **Ins. Comp.**
