# Manhole Inspection Report

Date:	<b>04/11/2018</b>	Weather:		Coding:	<b>RZMACP</b>
MH#:	<b>M-809-049</b>	Owner:	<b>NA</b>	Len. Surveyed:	<b>7.6</b>
P.O.#:		Surveyor:	<b>John Kuglmaier</b>	Rim to Invert:	<b>8.0</b>
Customer:		Cert. #:	<b>U-1215-07002349</b>	Wall Material:	<b>Concrete (reinforced)</b>

Street:	<b>Tanager St. 922' East of Bracken Par</b>	Project:	<b>Hobart, IN</b>
City:	<b>Hobart, IN</b>	GPS Northing:	<b>2907914.529</b>
Location:		GPS Easting:	<b>2907914.529</b>
Drain Area:	<b>Southwest</b>	GPS Accuracy:	<b>Sub-Meter</b>
Cover Shape:	<b>Circular</b>	Evidence of Surcharge:	<b>No</b>
Cover Size:	<b>22.5</b>	Potential for Runoff:	<b>None</b>
Comments:

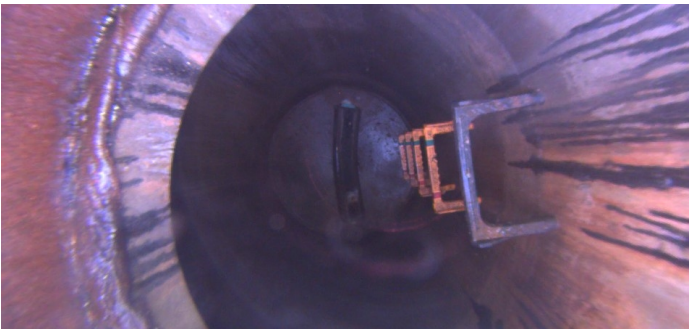
Code: **MGP**  
 Description: **General Photo**

Distance (ft): **.0**  
 Structural Grade: **0**  
 O&M Grade: **0**  
 Clock Start/From:  
 Clock To:  
 1st Value:  
 2nd Value:  
 Value Percent:  
 Step: **NO**  
 Remarks:

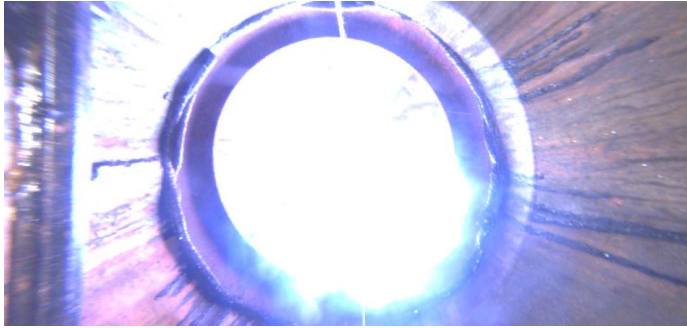
Code: **MGP**  
Description: **General Photo**

Distance (ft): **2.6**  
Structural Grade: **0**  
O&M Grade: **0**  
Clock Start/From:  
Clock To:  
1st Value:  
2nd Value:  
Value Percent:  
Step: **NO**  
Remarks:

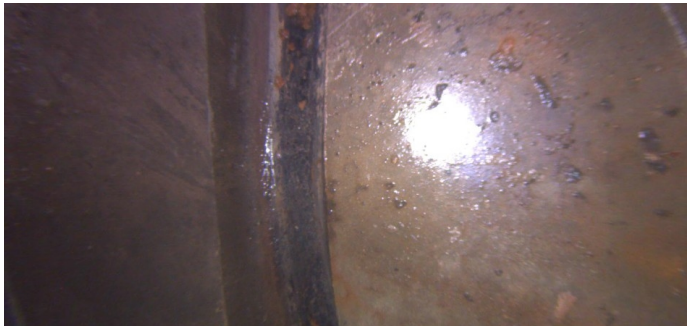
Code: **MGO**  
Description: **General Observation**

Distance (ft): **6.4**  
Structural Grade: **0**  
O&M Grade: **0**  
Clock Start/From:  
Clock To:  
1st Value:  
2nd Value:  
Value Percent:  
Step: **NO**  
Remarks: **Ins. Comp.**
