Manhole Inspection Report

Date:	04/11/2018	Weather:		Coding:	RZMACP
MH#:	M-809-050	Owner:	NA	Len. Surveyed:	8.6
P.O.#:		Surveyor:	John Kuglmaier	Rim to Invert:	9.4
Customer:		Cert. #:	U-1215-07002349	Wall Material:	Concrete (reinforced)

Street:	Tanager St. 651' East of Bracken Par	Project:	Hobart, IN
City:	Hobart, IN	GPS Northing:	2907645.166
Location:		GPS Easting:	2907645.166
Drain Area:	Southwest	GPS Accuracy:	Sub-Meter
Cover Shape:	Circular	Evidence of Surcharge:	No
Cover Size:	22.5	Potential for Runoff:	None
Comments:

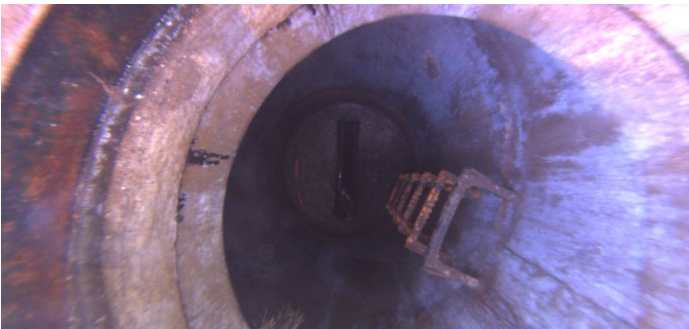
Code: **MGP**
 Description: **General Photo**

Distance (ft): **.0**
 Structural Grade: **0**
 O&M Grade: **0**
 Clock Start/From:
 Clock To:
 1st Value:
 2nd Value:
 Value Percent:
 Step: **NO**
 Remarks:

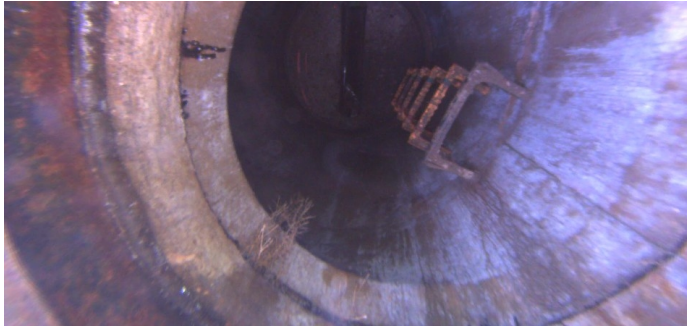
Code: **RFJ**
Description: **Roots Fine Joint**

Distance (ft): **.0**
Structural Grade: **0**
O&M Grade: **1**
Clock Start/From: **7**
Clock To:
1st Value:
2nd Value:
Value Percent:
Step: **NO**
Remarks:

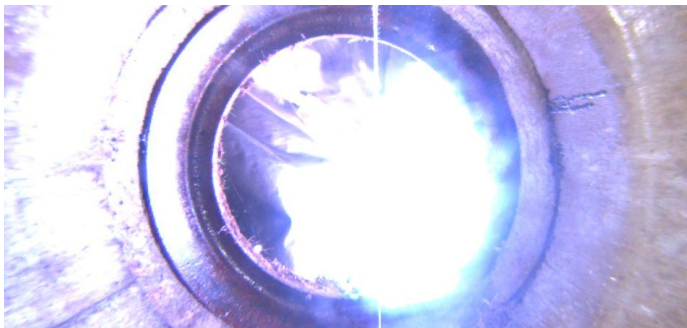
Code: **MGP**
Description: **General Photo**

Distance (ft): **2.4**
Structural Grade: **0**
O&M Grade: **0**
Clock Start/From:
Clock To:
1st Value:
2nd Value:
Value Percent:
Step: **NO**
Remarks:

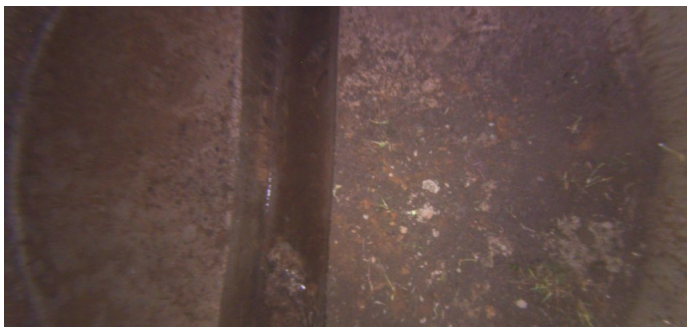
Code: **MGO**
Description: **General Observation**

Distance (ft): **7.5**
Structural Grade: **0**
O&M Grade: **0**
Clock Start/From:
Clock To:
1st Value:
2nd Value:
Value Percent:
Step: **NO**
Remarks: **Ins. Comp.**
