Manhole Inspection Report

Date:	04/12/2018	Weather:		Coding:	RZMACP
MH#:	M-809-055	Owner:	NA	Len. Surveyed:	5.1
P.O.#:		Surveyor:	John Kuglmaier	Rim to Invert:	5.7
Customer:		Cert. #:	U-1215-07002349	Wall Material:	Concrete (reinforced)

Street:	208' South of Bracken Parkway. Wes	Project:	Hobart, IN
City:	Hobart, IN	GPS Northing:	2909802.211
Location:		GPS Easting:	2909802.211
Drain Area:	Southwest	GPS Accuracy:	Sub-Meter
Cover Shape:	Circular	Evidence of Surcharge:	No
Cover Size:	22.5	Potential for Runoff:	None
Comments:

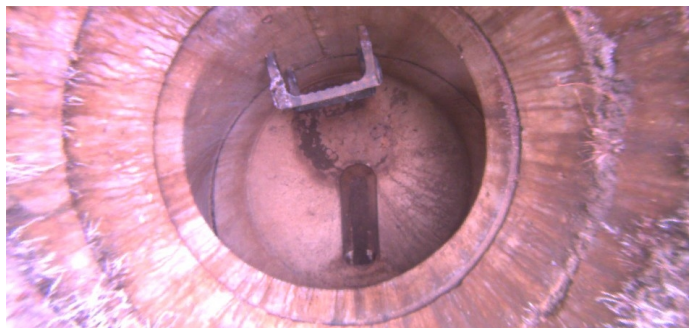
Code: **MGP**
Description: **General Photo**

Distance (ft): **.0**
Structural Grade: **0**
O&M Grade: **0**
Clock Start/From:
Clock To:
1st Value:
2nd Value:
Value Percent:
Step: **NO**
Remarks:

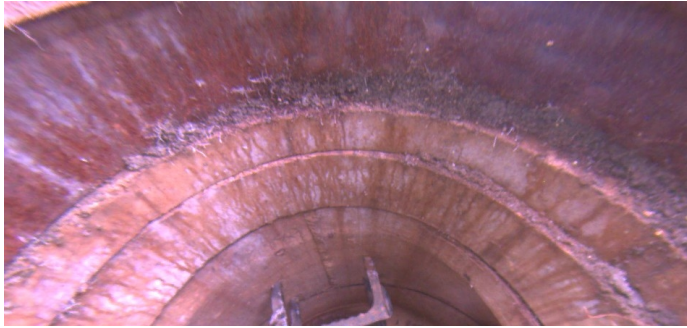
Code: **RFJ**
Description: **Roots Fine Joint**

Distance (ft): **.0**
Structural Grade: **0**
O&M Grade: **1**
Clock Start/From: **12**
Clock To: **12**
1st Value:
2nd Value:
Value Percent:
Step: **NO**
Remarks:

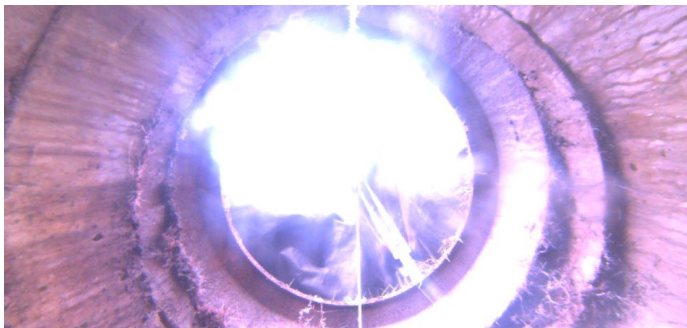
Code: **MGP**
Description: **General Photo**

Distance (ft): **2.5**
Structural Grade: **0**
O&M Grade: **0**
Clock Start/From:
Clock To:
1st Value:
2nd Value:
Value Percent:
Step: **NO**
Remarks:

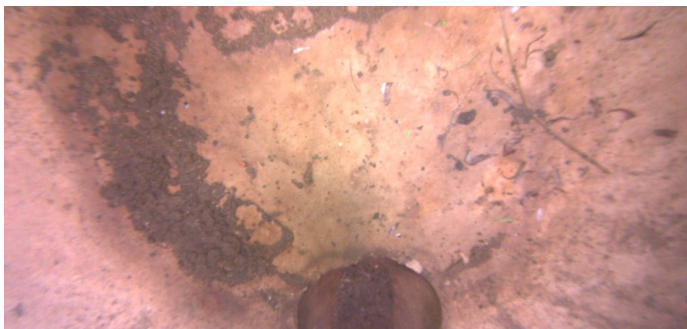
Code: **MGO**
Description: **General Observation**

Distance (ft): **4.3**
Structural Grade: **0**
O&M Grade: **0**
Clock Start/From:
Clock To:
1st Value:
2nd Value:
Value Percent:
Step: **NO**
Remarks: **Ins. Comp.**
