Manhole Inspection Report

Date:	04/12/2018	Weather:		Coding:	RZMACP
MH#:	M-809-056	Owner:	NA	Len. Surveyed:	5.5
P.O.#:		Surveyor:	John Kuglmaier	Rim to Invert:	6.1
Customer:		Cert. #:	U-1215-07002349	Wall Material:	Concrete (reinforced)

Street:	345' South of Bracken Parkway. Wes	Project:	Hobart, IN
City:	Hobart, IN	GPS Northing:	2909797.819
Location:		GPS Easting:	2909797.819
Drain Area:	Southwest	GPS Accuracy:	Sub-Meter
Cover Shape:	Circular	Evidence of Surcharge:	Yes
Cover Size:	22.5	Potential for Runoff:	None
Comments:

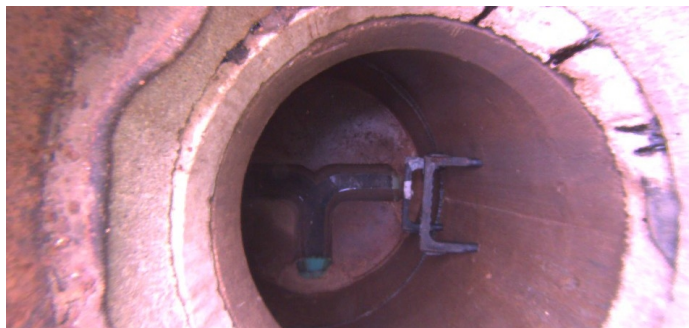
Code: **MGP**
 Description: **General Photo**

Distance (ft): **.0**
 Structural Grade: **0**
 O&M Grade: **0**
 Clock Start/From:
 Clock To:
 1st Value:
 2nd Value:
 Value Percent:
 Step: **NO**
 Remarks:

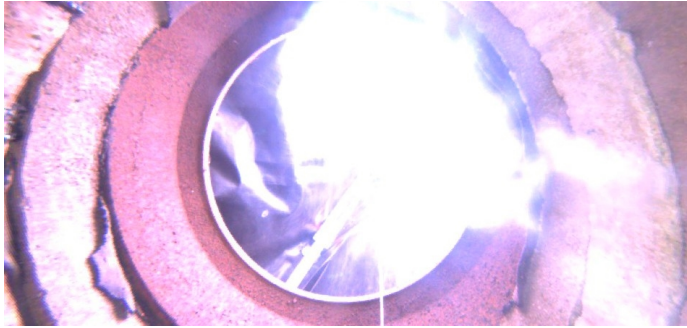
Code: **MGP**
Description: **General Photo**

Distance (ft): **2.3**
Structural Grade: **0**
O&M Grade: **0**
Clock Start/From:
Clock To:
1st Value:
2nd Value:
Value Percent:
Step: **NO**
Remarks:

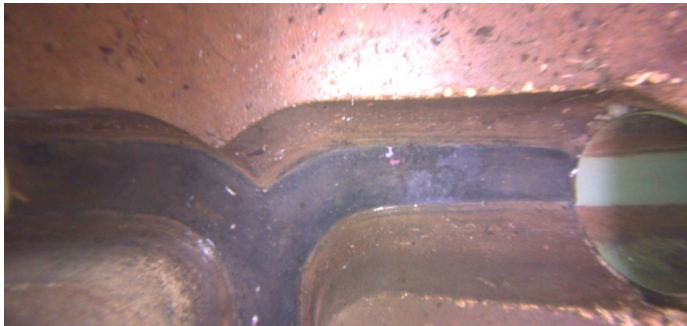
Code: **MGO**
Description: **General Observation**

Distance (ft): **4.7**
Structural Grade: **0**
O&M Grade: **0**
Clock Start/From:
Clock To:
1st Value:
2nd Value:
Value Percent:
Step: **NO**
Remarks: **Ins. Comp.**
