Manhole Inspection Report

Date:	04/12/2018	Weather:		Coding:	RZMACP
MH#:	M-809-057	Owner:	NA	Len. Surveyed:	4.1
P.O.#:		Surveyor:	John Kuglmaier	Rim to Invert:	5.9
Customer:		Cert. #:	U-1215-07002349	Wall Material:	Concrete (reinforced)

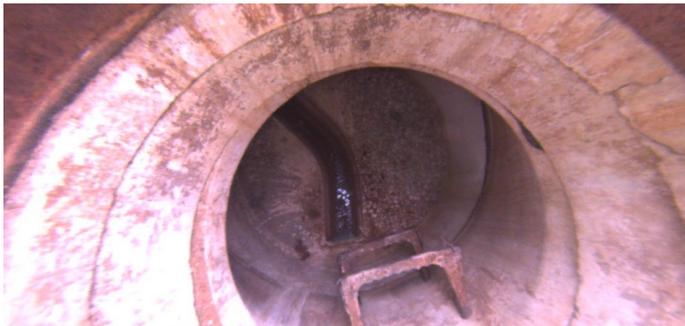
Code: **MGP**
Description: **General Photo**

Distance (ft): **.0**
Structural Grade: **0**
O&M Grade: **0**
Clock Start/From:
Clock To:
1st Value:
2nd Value:
Value Percent:
Step: **NO**
Remarks:

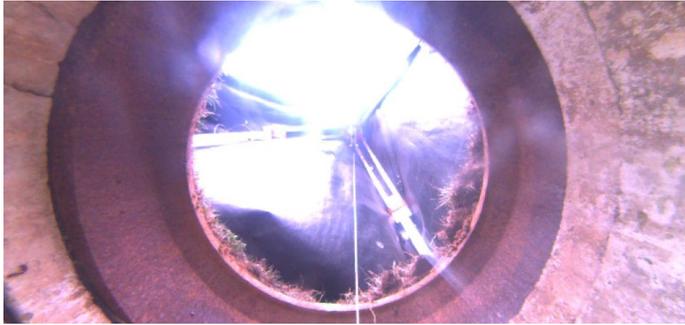
Code: **MGP**
Description: **General Photo**

Distance (ft): **2.0**
Structural Grade: **0**
O&M Grade: **0**
Clock Start/From:
Clock To:
1st Value:
2nd Value:
Value Percent:
Step: **NO**
Remarks:

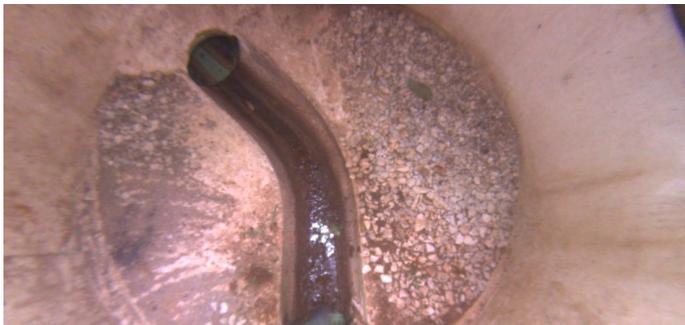
Code: **DSGV**
Description: **Deposits Settled Gravel**

Distance (ft): **2.7**
Structural Grade: **0**
O&M Grade: **2**
Clock Start/From: **1**
Clock To: **5**
1st Value:
2nd Value:
Value Percent: **10.000**
Step: **NO**
Remarks:

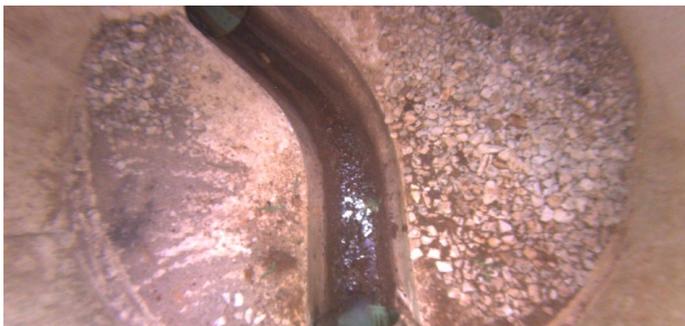
Code: **MGO**
Description: **General Observation**

Distance (ft): **3.6**
Structural Grade: **0**
O&M Grade: **0**
Clock Start/From:
Clock To:
1st Value:
2nd Value:
Value Percent:
Step: **NO**
Remarks: **Ins. Comp.**
