Manhole Inspection Report

Date:	04/12/2018	Weather:		Coding:	RZMACP
MH#:	M-809-058	Owner:	NA	Len. Surveyed:	5.5
P.O.#:		Surveyor:	John Kuglmaier	Rim to Invert:	6.1
Customer:		Cert. #:	U-1215-07002349	Wall Material:	Concrete (reinforced)

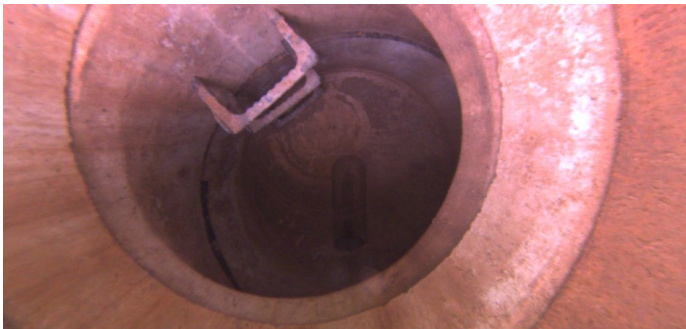
Code:	MGP
Description:	General Photo

Distance (ft):	.0
Structural Grade:	0
O&M Grade:	0
Clock Start/From:	
Clock To:	
1st Value:	
2nd Value:	
Value Percent:	
Step:	NO
Remarks:

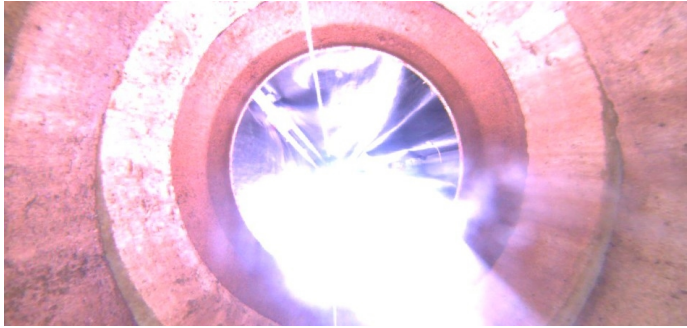
Code: **MGP**
Description: **General Photo**

Distance (ft): **2.6**
Structural Grade: **0**
O&M Grade: **0**
Clock Start/From:
Clock To:
1st Value:
2nd Value:
Value Percent:
Step: **NO**
Remarks:

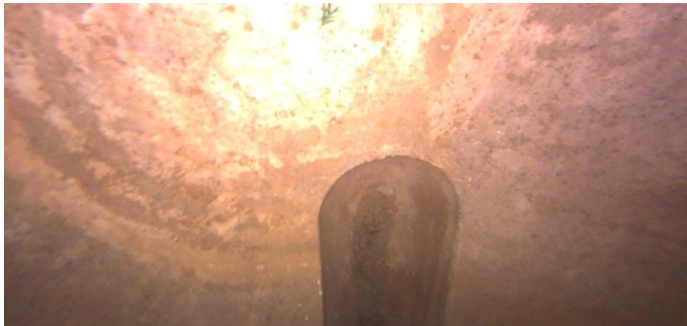
Code: **MGO**
Description: **General Observation**

Distance (ft): **4.6**
Structural Grade: **0**
O&M Grade: **0**
Clock Start/From:
Clock To:
1st Value:
2nd Value:
Value Percent:
Step: **NO**
Remarks: **Ins. Comp.**
