# Manhole Inspection Report

Date:	<b>04/12/2018</b>	Weather:		Coding:	<b>RZMACP</b>
MH#:	<b>M-809-059</b>	Owner:	<b>NA</b>	Len. Surveyed:	<b>5.6</b>
P.O.#:		Surveyor:	<b>John Kuglmaier</b>	Rim to Invert:	<b>6.3</b>
Customer:		Cert. #:	<b>U-1215-07002349</b>	Wall Material:	<b>Concrete (reinforced)</b>

Street:	<b>South of Bracken Parkway. 339' Wes</b>	Project:	<b>Hobart, IN</b>
City:	<b>Hobart, IN</b>	GPS Northing:	<b>2909669.952</b>
Location:		GPS Easting:	<b>2909669.952</b>
Drain Area:	<b>Southwest</b>	GPS Accuracy:	<b>Sub-Meter</b>
Cover Shape:	<b>Circular</b>	Evidence of Surcharge:	<b>No</b>
Cover Size:	<b>22.5</b>	Potential for Runoff:	<b>None</b>
Comments:

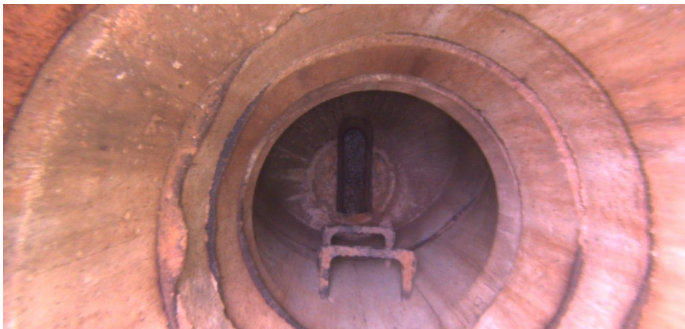
Code:	<b>MGP</b>
Description:	<b>General Photo</b>

Distance (ft):	.0
Structural Grade:	0
O&M Grade:	0
Clock Start/From:	
Clock To:	
1st Value:	
2nd Value:	
Value Percent:	
Step:	NO
Remarks:

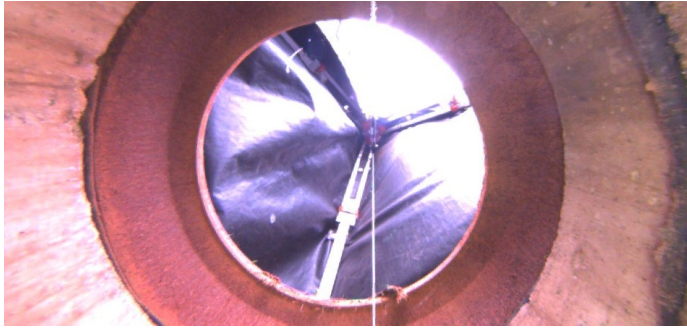
Code: **MGP**  
Description: **General Photo**

Distance (ft): **2.1**  
Structural Grade: **0**  
O&M Grade: **0**  
Clock Start/From:  
Clock To:  
1st Value:  
2nd Value:  
Value Percent:  
Step: **NO**  
Remarks:

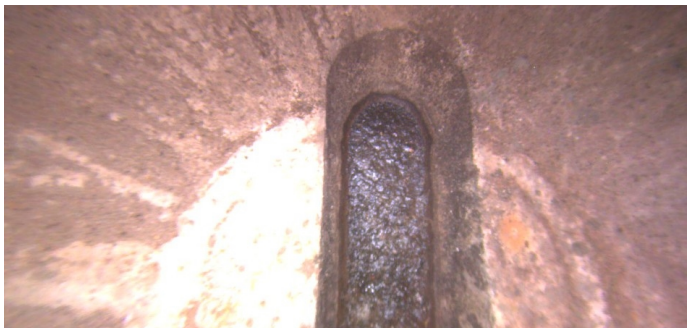
Code: **MGO**  
Description: **General Observation**

Distance (ft): **4.7**  
Structural Grade: **0**  
O&M Grade: **0**  
Clock Start/From:  
Clock To:  
1st Value:  
2nd Value:  
Value Percent:  
Step: **NO**  
Remarks: **Ins. Comp.**
