Manhole Inspection Report

Date:	04/12/2018	Weather:		Coding:	RZMACP
MH#:	M-809-061	Owner:	NA	Len. Surveyed:	6.8
P.O.#:		Surveyor:	John Kuglmaier	Rim to Invert:	7.3
Customer:		Cert. #:	U-1215-07002349	Wall Material:	Concrete (reinforced)

Street:	353' South of Bracken Parkway. Wes	Project:	Hobart, IN
City:	Hobart, IN	GPS Northing:	2909486.232
Location:		GPS Easting:	2909486.232
Drain Area:	Southwest	GPS Accuracy:	Sub-Meter
Cover Shape:	Circular	Evidence of Surcharge:	No
Cover Size:	22.5	Potential for Runoff:	None
Comments:

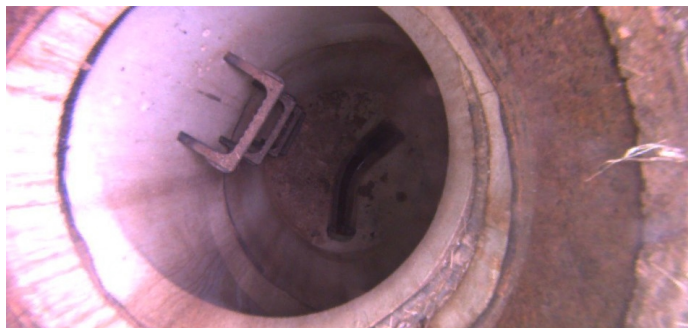
Code: **MGP**
Description: **General Photo**

Distance (ft): **.0**
Structural Grade: **0**
O&M Grade: **0**
Clock Start/From:
Clock To:
1st Value:
2nd Value:
Value Percent:
Step: **NO**
Remarks:

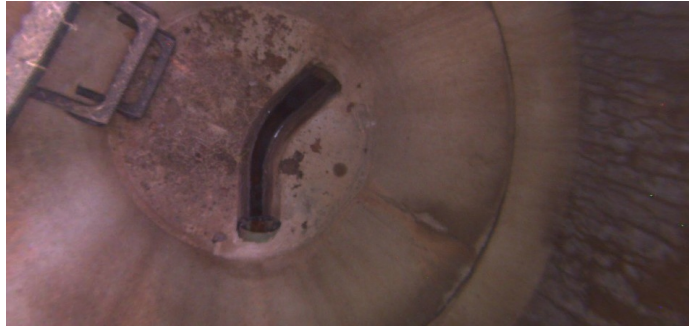
Code: **IS**
Description: **Infil Stain**

Distance (ft): **2.1**
Structural Grade: **0**
O&M Grade: **0**
Clock Start/From: **4**
Clock To:
1st Value:
2nd Value:
Value Percent:
Step: **NO**
Remarks:

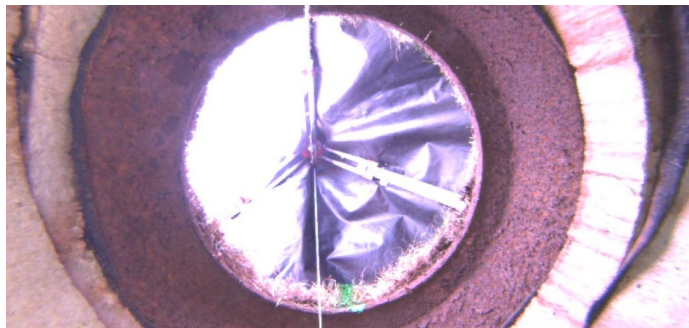
Code: **MGP**
Description: **General Photo**

Distance (ft): **2.4**
Structural Grade: **0**
O&M Grade: **0**
Clock Start/From:
Clock To:
1st Value:
2nd Value:
Value Percent:
Step: **NO**
Remarks:

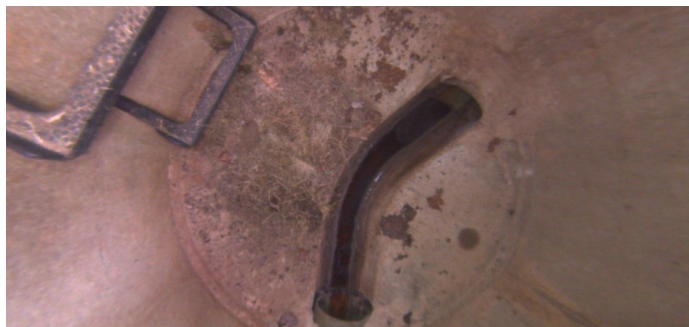
Code: **DAZ**
Description: **Deposits Attached Other**

Distance (ft): **4.0**
Structural Grade: **0**
O&M Grade: **2**
Clock Start/From: **6**
Clock To: **2**
1st Value:
2nd Value:
Value Percent: **5.000**
Step: **NO**
Remarks: **Mixed materials**

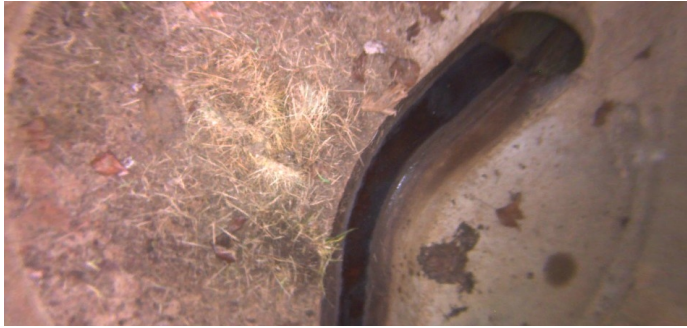
Code:	MGO
Description:	General Observation
Distance (ft):	5.6
Structural Grade:	0
O&M Grade:	0
Clock Start/From:	
Clock To:	
1st Value:	
2nd Value:	
Value Percent:	
Step:	NO
Remarks:	Ins. Comp.
