Manhole Inspection Report

Date:	04/12/2018	Weather:		Coding:	RZMACP
MH#:	M-809-062	Owner:	NA	Len. Surveyed:	6.9
P.O.#:		Surveyor:	John Kuglmaier	Rim to Invert:	7.4
Customer:		Cert. #:	U-1215-07002349	Wall Material:	Concrete (reinforced)

Street:	400' South of Bracken Parkway. Wes	Project:	Hobart, IN
City:	Hobart, IN	GPS Northing:	2909445.321
Location:		GPS Easting:	2909445.321
Drain Area:	Southwest	GPS Accuracy:	Sub-Meter
Cover Shape:	Circular	Evidence of Surcharge:	No
Cover Size:	22.5	Potential for Runoff:	None
Comments:

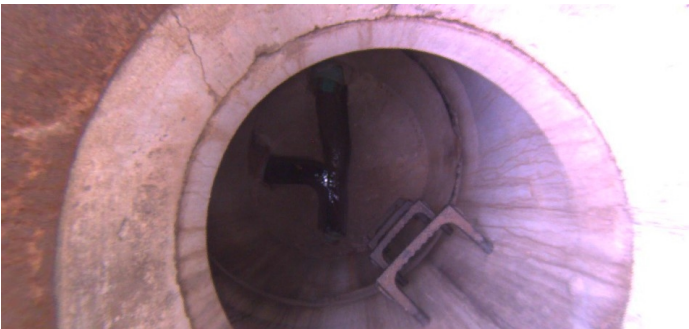
Code: **MGP**
 Description: **General Photo**

Distance (ft): **.0**
 Structural Grade: **0**
 O&M Grade: **0**
 Clock Start/From:
 Clock To:
 1st Value:
 2nd Value:
 Value Percent:
 Step: **NO**
 Remarks:

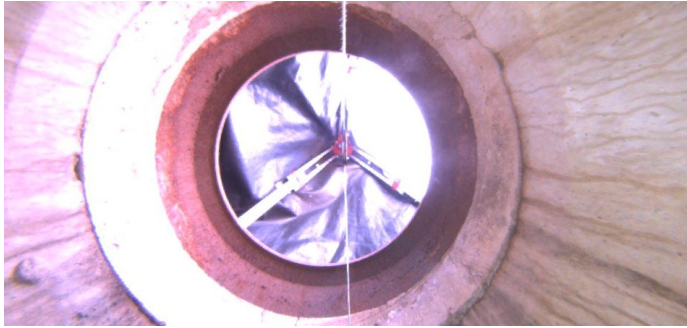
Code: **MGP**
Description: **General Photo**

Distance (ft): **2.9**
Structural Grade: **0**
O&M Grade: **0**
Clock Start/From:
Clock To:
1st Value:
2nd Value:
Value Percent:
Step: **NO**
Remarks:

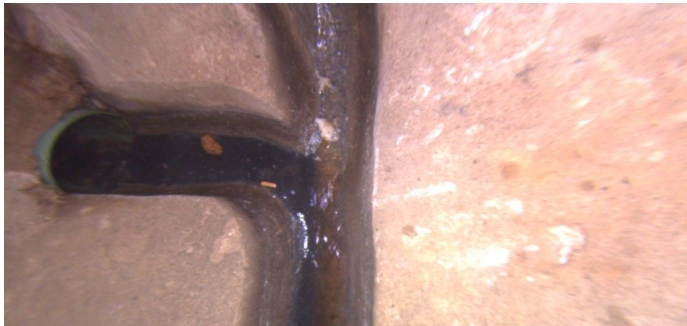
Code: **MGO**
Description: **General Observation**

Distance (ft): **5.5**
Structural Grade: **0**
O&M Grade: **0**
Clock Start/From:
Clock To:
1st Value:
2nd Value:
Value Percent:
Step: **NO**
Remarks: **Ins. Comp.**
