Manhole Inspection Report

Date:	03/24/2018	Weather:		Coding:	RZMACP
MH#:	M-902-003.5	Owner:	NA	Len. Surveyed:	5.6
P.O.#:		Surveyor:	John Kuglmaier	Rim to Invert:	7.2
Customer:		Cert. #:	U-1215-07002349	Wall Material:	Concrete (reinforced)

Street:	North of Hwy 6. 359' East of St Josep	Project:	Hobart, IN
City:	Hobart, IN	GPS Northing:	0.0
Location:		GPS Easting:	0.0
Drain Area:	Northeast	GPS Accuracy:	Nearest Meter
Cover Shape:	Circular	Evidence of Surcharge:	No
Cover Size:	23.0	Potential for Runoff:	None
Comments:

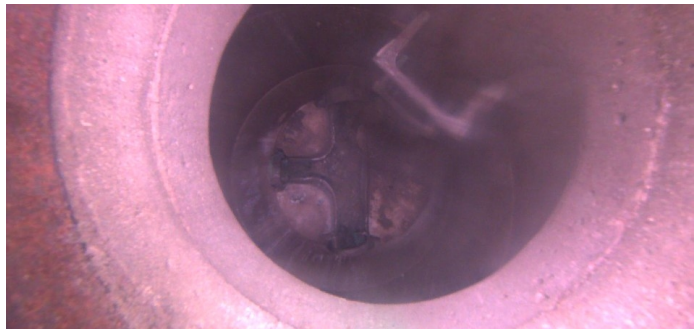
Code: **MGP**
Description: **General Photo**

Distance (ft): **.0**
Structural Grade: **0**
O&M Grade: **0**
Clock Start/From:
Clock To:
1st Value:
2nd Value:
Value Percent:
Step: **NO**
Remarks:

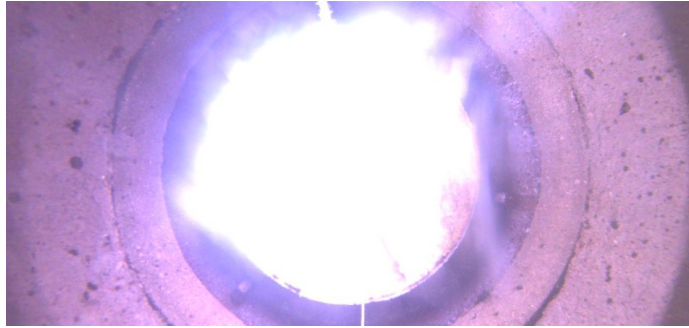
Code: **MGP**
Description: **General Photo**

Distance (ft): **2.4**
Structural Grade: **0**
O&M Grade: **0**
Clock Start/From:
Clock To:
1st Value:
2nd Value:
Value Percent:
Step: **NO**
Remarks:

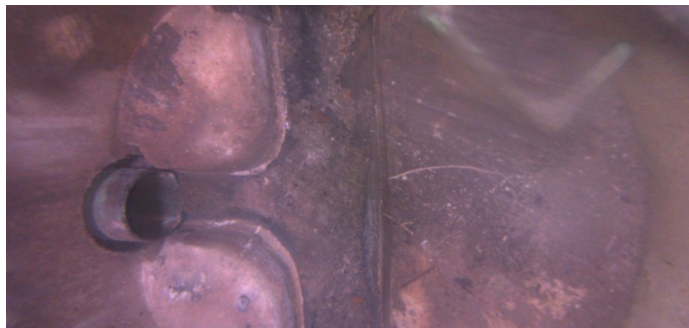
Code: **MGO**
Description: **General Observation**

Distance (ft): **4.8**
Structural Grade: **0**
O&M Grade: **0**
Clock Start/From:
Clock To:
1st Value:
2nd Value:
Value Percent:
Step: **NO**
Remarks: **Ins. Comp.**
