Manhole Inspection Report

Date:	03/24/2018	Weather:		Coding:	RZMACP
MH#:	M-902-007	Owner:	NA	Len. Surveyed:	5.8
P.O.#:		Surveyor:	John Kuglmaier	Rim to Invert:	7.0
Customer:		Cert. #:	U-1215-07002349	Wall Material:	Concrete (reinforced)

Street:	Spencer Pl. and 34th Ln.	Project:	Hobart, IN
City:	Hobart, IN	GPS Northing:	0.0
Location:		GPS Easting:	0.0
Drain Area:	Northeast	GPS Accuracy:	Nearest Meter
Cover Shape:	Circular	Evidence of Surcharge:	No
Cover Size:	23.0	Potential for Runoff:	None
Comments:

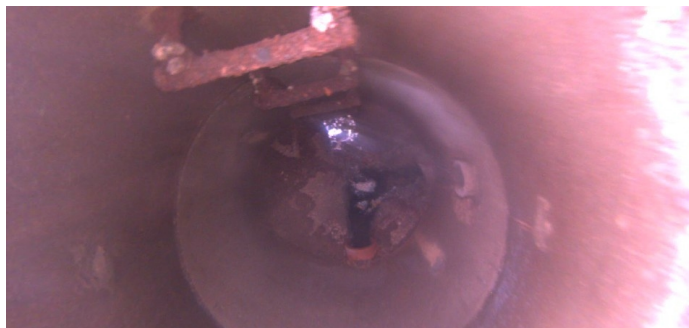
Code: **MGP**
Description: **General Photo**

Distance (ft): **.0**
Structural Grade: **0**
O&M Grade: **0**
Clock Start/From:
Clock To:
1st Value:
2nd Value:
Value Percent:
Step: **NO**
Remarks:

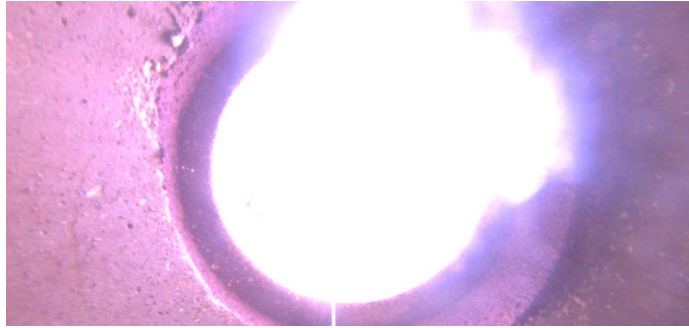
Code: **MGP**
Description: **General Photo**

Distance (ft): **1.8**
Structural Grade: **0**
O&M Grade: **0**
Clock Start/From:
Clock To:
1st Value:
2nd Value:
Value Percent:
Step: **NO**
Remarks:

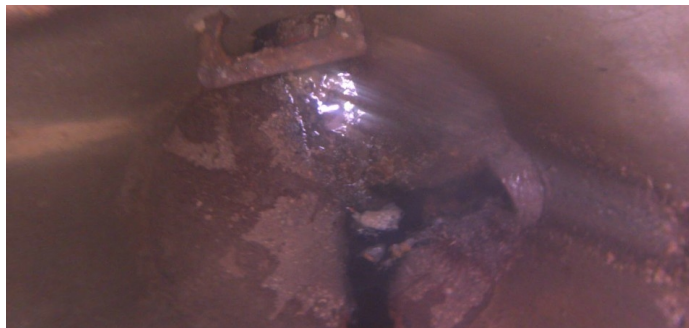
Code: **DAZ**
Description: **Deposits Attached Other**

Distance (ft): **3.7**
Structural Grade: **0**
O&M Grade: **2**
Clock Start/From: **12**
Clock To: **12**
1st Value:
2nd Value:
Value Percent: **5.000**
Step: **NO**
Remarks: **Mixed materials**

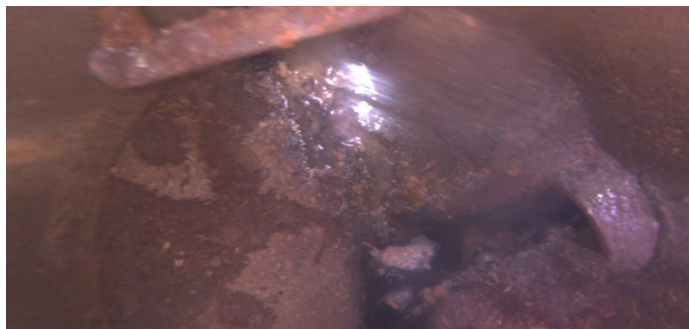
Code: **MGO**
Description: **General Observation**

Distance (ft): **4.6**
Structural Grade: **0**
O&M Grade: **0**
Clock Start/From:
Clock To:
1st Value:
2nd Value:
Value Percent:
Step: **NO**
Remarks: **Ins. Comp.**

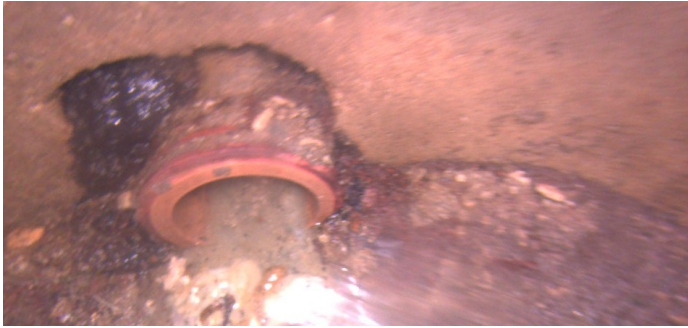
Code:	HSV
Description:	Hole Soil Visible
Distance (ft):	5.5
Structural Grade:	5
O&M Grade:	0
Clock Start/From:	12
Clock To:	
1st Value:	
2nd Value:	
Value Percent:	
Step:	NO
Remarks:
