Manhole Inspection Report

| MH#: | M-902-009 | Owner: | NA | Len. Surveyed: | 8.3 |

| Street: | South of 34th Ln. 374' East of St. Jos | Project: | Hobart, IN |

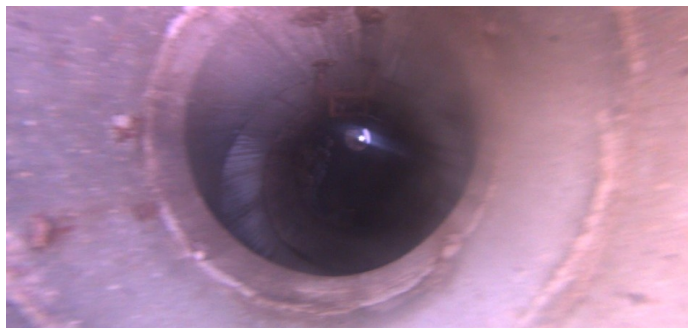
Code: **MGP**
Description: **General Photo**

Distance (ft): **.0**
Structural Grade: **0**
O&M Grade: **0**
Clock Start/From:
Clock To:
1st Value:
2nd Value:
Value Percent:
Step: **NO**
Remarks:

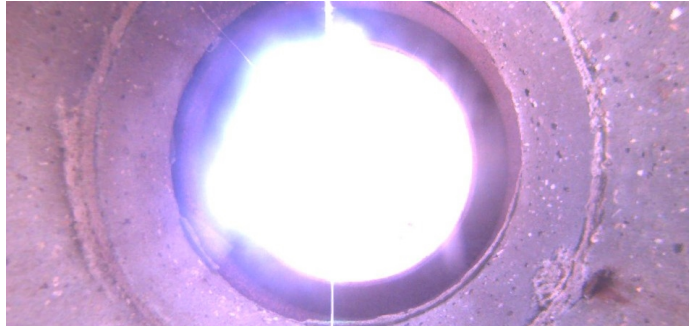
Code: **MGP**
Description: **General Photo**

Distance (ft): **1.8**
Structural Grade: **0**
O&M Grade: **0**
Clock Start/From:
Clock To:
1st Value:
2nd Value:
Value Percent:
Step: **NO**
Remarks:

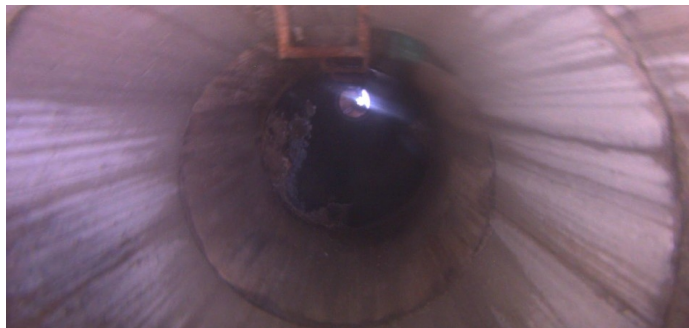
Code: **IS**
Description: **Infil Stain**

Distance (ft): **2.8**
Structural Grade: **0**
O&M Grade: **0**
Clock Start/From: **12**
Clock To: **12**
1st Value:
2nd Value:
Value Percent:
Step: **NO**
Remarks:

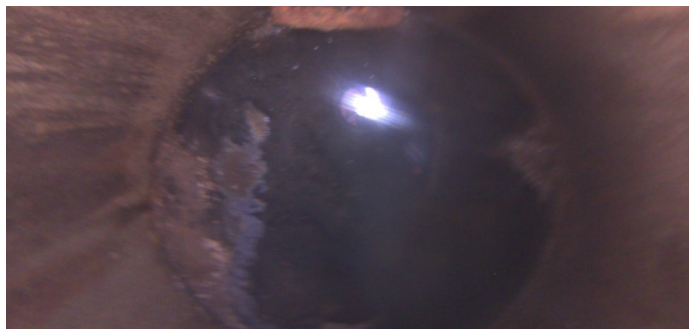
Code: **MGO**
Description: **General Observation**

Distance (ft): **6.6**
Structural Grade: **0**
O&M Grade: **0**
Clock Start/From:
Clock To:
1st Value:
2nd Value:
Value Percent:
Step: **NO**
Remarks: **Surcharge**

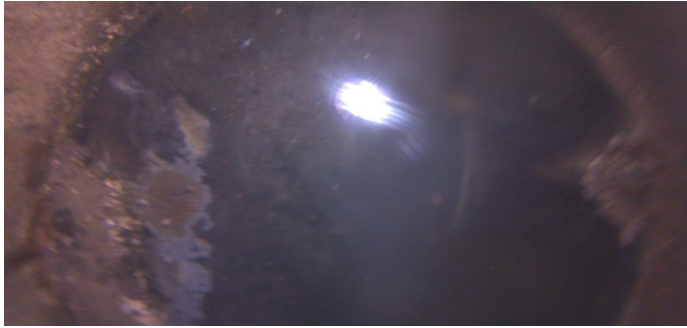
| Code: | MGO |
| Description: | General Observation |
| Distance (ft): | 7.5 |
| Remarks: | Ins. Comp. |
