Manhole Inspection Report

Date:	03/26/2018	Weather:		Coding:	RZMACP
MH#:	M-902-011	Owner:	NA	Len. Surveyed:	5.9
P.O.#:		Surveyor:	John Kuglmaier	Rim to Invert:	7.0
Customer:		Cert. #:	U-1215-07002349	Wall Material:	Concrete (reinforced)

Street:	402' East of Shelby St. South of 34th	Project:	Hobart, IN
City:	Hobart, IN	GPS Northing:	0.0
Location:		GPS Easting:	0.0
Drain Area:	Northeast	GPS Accuracy:	Nearest Meter
Cover Shape:	Circular	Evidence of Surcharge:	No
Cover Size:	23.0	Potential for Runoff:	None
Comments:

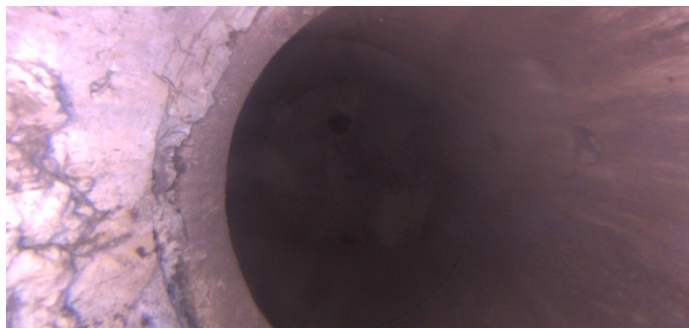
Code: **MGP**
Description: **General Photo**

Distance (ft): **.0**
Structural Grade: **0**
O&M Grade: **0**
Clock Start/From:
Clock To:
1st Value:
2nd Value:
Value Percent:
Step: **NO**
Remarks:

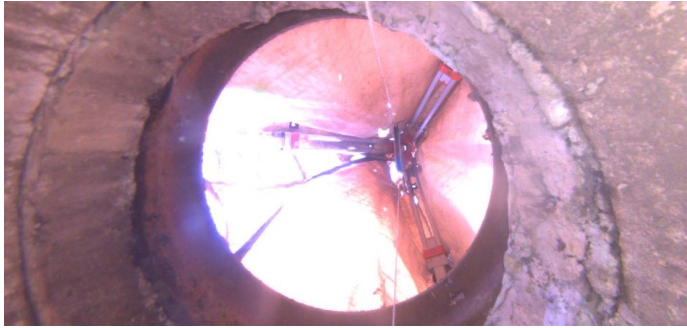
Code: **MGP**
Description: **General Photo**

Distance (ft): **1.7**
Structural Grade: **0**
O&M Grade: **0**
Clock Start/From:
Clock To:
1st Value:
2nd Value:
Value Percent:
Step: **NO**
Remarks:

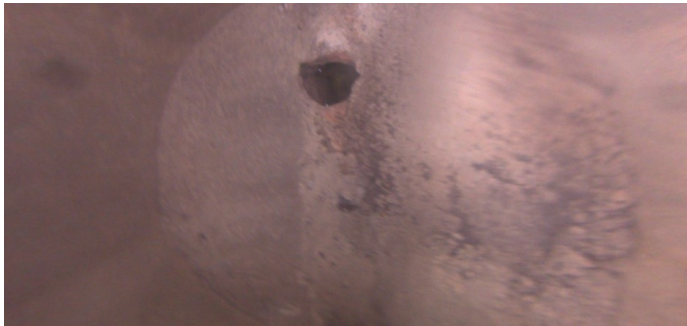
Code: **MGO**
Description: **General Observation**

Distance (ft): **4.0**
Structural Grade: **0**
O&M Grade: **0**
Clock Start/From:
Clock To:
1st Value:
2nd Value:
Value Percent:
Step: **NO**
Remarks: **Ins. Comp.**
