Manhole Inspection Report

Date:	03/25/2018	Weather:		Coding:	RZMACP
MH#:	M-902-014	Owner:	NA	Len. Surveyed:	8.1
P.O.#:		Surveyor:	John Kuglmaier	Rim to Invert:	9.3
Customer:		Cert. #:	U-1215-07002349	Wall Material:	Concrete (reinforced)

Street:	194' East of Shelby St. South of 34th	Project:	Hobart, IN
City:	Hobart, IN	GPS Northing:	0.0
Location:		GPS Easting:	0.0
Drain Area:	Northeast	GPS Accuracy:	Nearest Meter
Cover Shape:	Circular	Evidence of Surcharge:	Yes
Cover Size:	23.0	Potential for Runoff:	None
Comments:

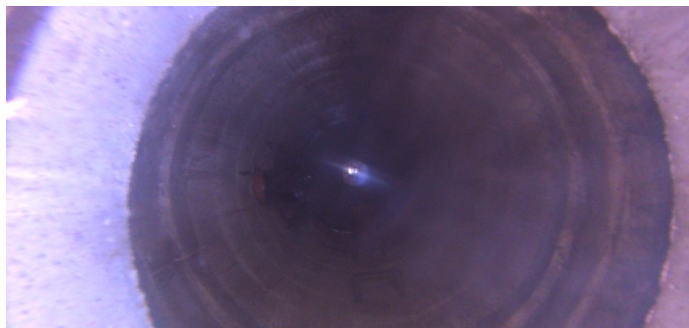
Code: **MGP**
Description: **General Photo**

Distance (ft): **.0**
Structural Grade: **0**
O&M Grade: **0**
Clock Start/From:
Clock To:
1st Value:
2nd Value:
Value Percent:
Step: **NO**
Remarks:

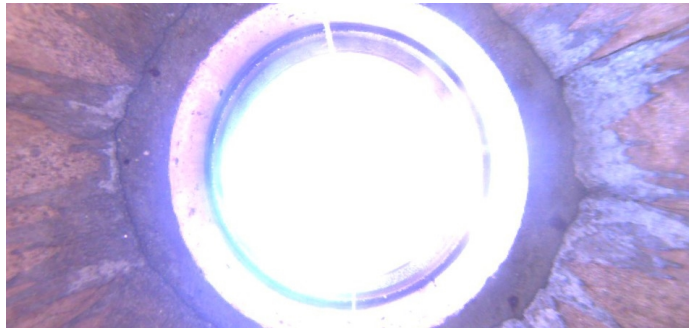
Code: **MGP**
Description: **General Photo**

Distance (ft): **2.5**
Structural Grade: **0**
O&M Grade: **0**
Clock Start/From:
Clock To:
1st Value:
2nd Value:
Value Percent:
Step: **NO**
Remarks:

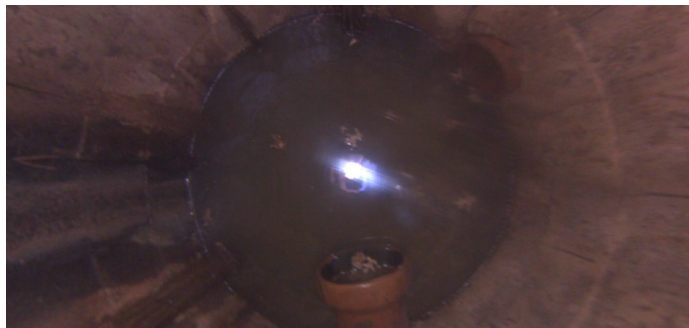
Code: **MGO**
Description: **General Observation**

Distance (ft): **5.6**
Structural Grade: **0**
O&M Grade: **0**
Clock Start/From:
Clock To:
1st Value:
2nd Value:
Value Percent:
Step: **NO**
Remarks: **Surcharge**

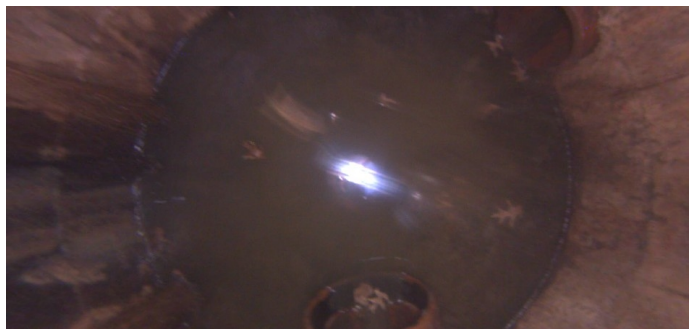
Code: **MGO**
Description: **General Observation**

Distance (ft): **6.5**
Structural Grade: **0**
O&M Grade: **0**
Clock Start/From:
Clock To:
1st Value:
2nd Value:
Value Percent:
Step: **NO**
Remarks: **Ins. Comp.**
