Manhole Inspection Report

Date:	03/25/2018	Weather:		Coding:	RZMACP
MH#:	M-902-015	Owner:	NA	Len. Surveyed:	10.3
P.O.#:		Surveyor:	John Kuglmaier	Rim to Invert:	11.6
Customer:		Cert. #:	U-1215-07002349	Wall Material:	Concrete (reinforced)

Street:	194' East of Shelby St. South of 34th	Project:	Hobart, IN
City:	Hobart, IN	GPS Northing:	0.0
Location:		GPS Easting:	0.0
Drain Area:	Northeast	GPS Accuracy:	Nearest Meter
Cover Shape:	Circular	Evidence of Surcharge:	Yes
Cover Size:	23.0	Potential for Runoff:	None
Comments:

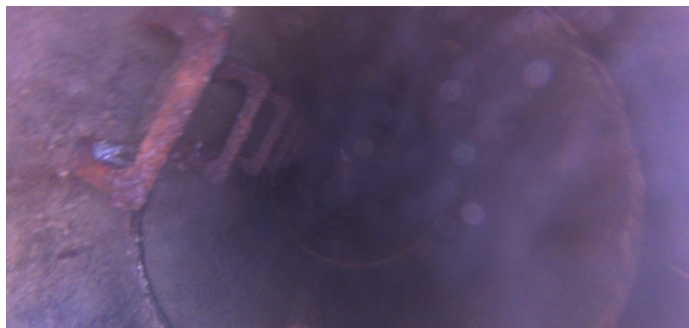
Code: **MGP**
Description: **General Photo**

Distance (ft): **.0**
Structural Grade: **0**
O&M Grade: **0**
Clock Start/From:
Clock To:
1st Value:
2nd Value:
Value Percent:
Step: **NO**
Remarks:

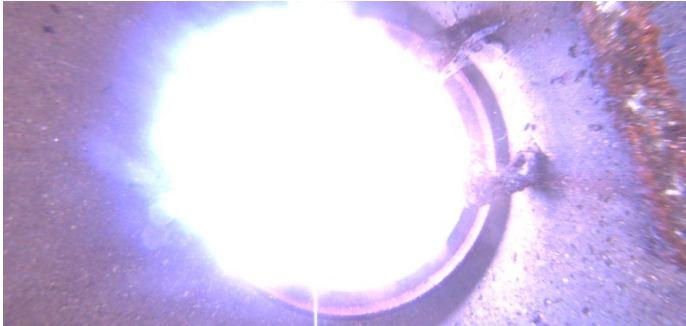
Code: **MGP**
Description: **General Photo**

Distance (ft): **2.2**
Structural Grade: **0**
O&M Grade: **0**
Clock Start/From:
Clock To:
1st Value:
2nd Value:
Value Percent:
Step: **NO**
Remarks:

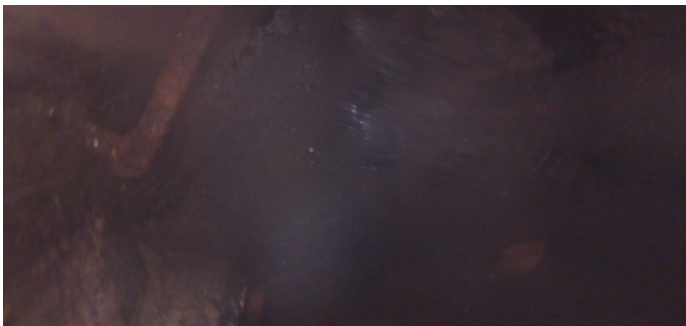
Code: **DAZ**
Description: **Deposits Attached Other**

Distance (ft): **8.1**
Structural Grade: **0**
O&M Grade: **2**
Clock Start/From: **12**
Clock To: **12**
1st Value:
2nd Value:
Value Percent: **10.000**
Step: **NO**
Remarks: **Mixed materials**

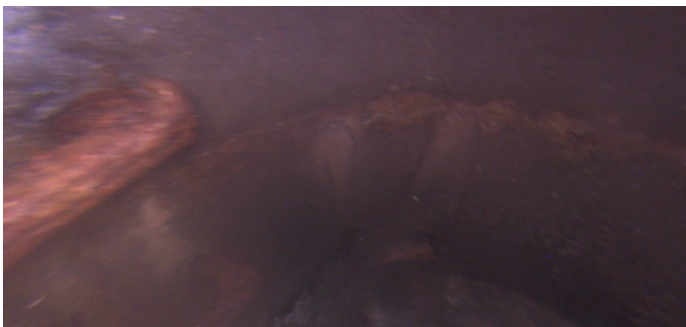
Code: **IS**
Description: **Infil Stain**

Distance (ft): **8.2**
Structural Grade: **0**
O&M Grade: **0**
Clock Start/From: **11**
Clock To: **1**
1st Value:
2nd Value:
Value Percent:
Step: **NO**
Remarks:

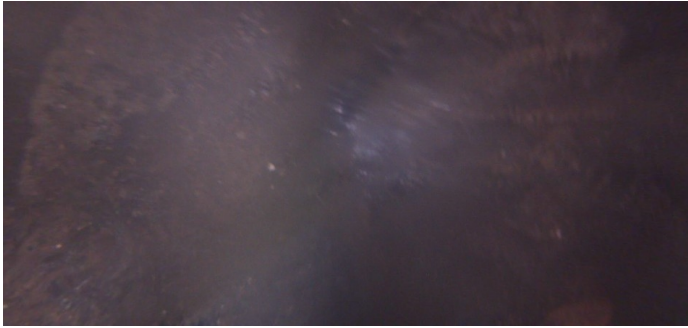
Code:	MGO
Description:	General Observation
Distance (ft):	9.0
Structural Grade:	0
O&M Grade:	0
Clock Start/From:	
Clock To:	
1st Value:	
2nd Value:	
Value Percent:	
Step:	NO
Remarks:	Ins. Comp.
