Manhole Inspection Report

Date:	09/19/2022	Weather:		Coding:	RZMACP
MH#:	M-902-019B	Owner:	NA	Len. Surveyed:	7.7
P.O.#:		Surveyor:	Jen Costello	Rim to Invert:	8.7
Customer:		Cert. #:	U-907-5518	Wall Material:	Concrete (cast in place)

Street:	North of 34th Ct. and 187' East of Sh	Project:	Hobart, IN
City:	Hobart, IN	GPS Northing:	2297741.339
Location:	Yard	GPS Easting:	2911047.042
Drain Area:	Northeast	GPS Accuracy:	Sub-Meter
Cover Shape:	Circular	Evidence of Surcharge:	No
Cover Size:	24.0	Potential for Runoff:	None
Comments:

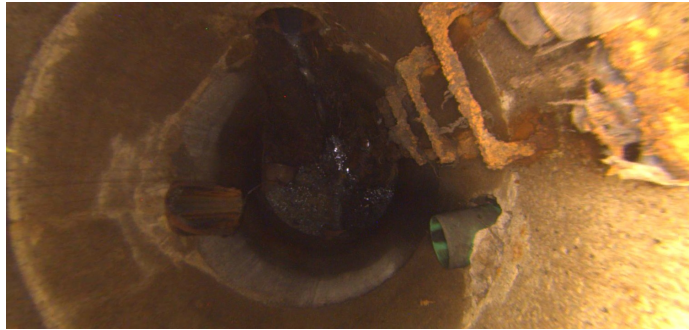
Code: **SAV**
Description: **Surface Aggregate Visible**

Distance (ft): **.0**
Structural Grade: **3**
O&M Grade: **0**
Clock Start/From: **12**
Clock To: **12**
1st Value:
2nd Value:
Value Percent:
Step: **NO**
Remarks:

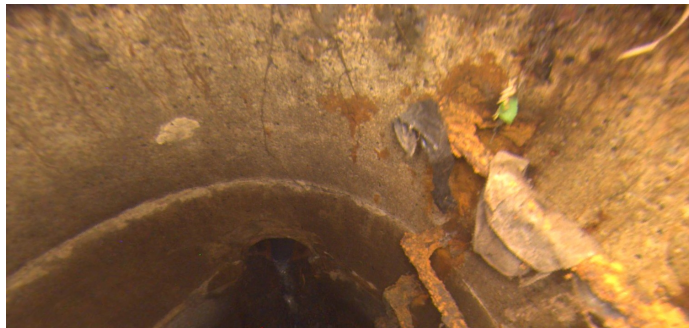
Code: **RFJ**
Description: **Roots Fine Joint**

Distance (ft): **.0**
Structural Grade: **0**
O&M Grade: **1**
Clock Start/From: **12**
Clock To: **12**
1st Value:
2nd Value:
Value Percent:
Step: **NO**
Remarks:

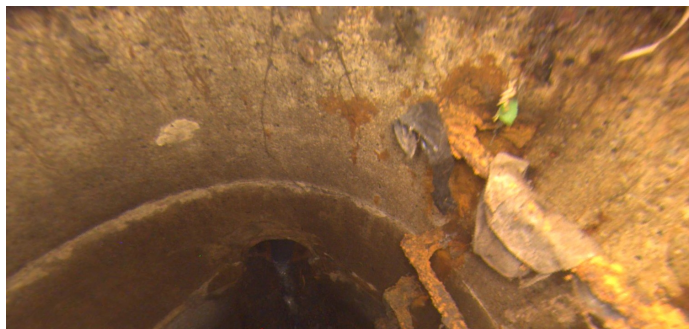
Code: **DAR**
Description: **Deposits Attached Ragging**

Distance (ft): **.0**
Structural Grade: **0**
O&M Grade: **2**
Clock Start/From: **2**
Clock To: **3**
1st Value:
2nd Value:
Value Percent: **5.000**
Step: **YES**
Remarks:

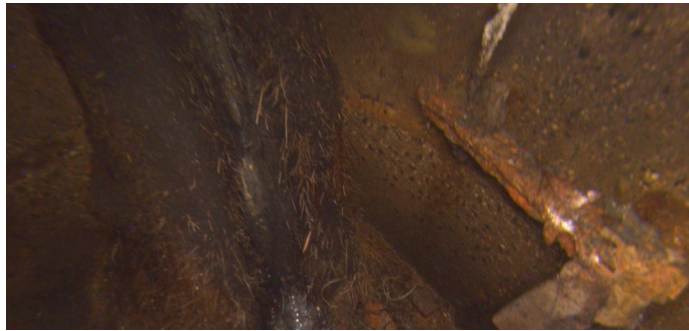
Code: **RMC**
Description: **Roots Medium Connection**

Distance (ft): **4.9**
Structural Grade: **0**
O&M Grade: **3**
Clock Start/From: **11**
Clock To: **12**
1st Value:
2nd Value:
Value Percent: **10.000**
Step: **NO**
Remarks:

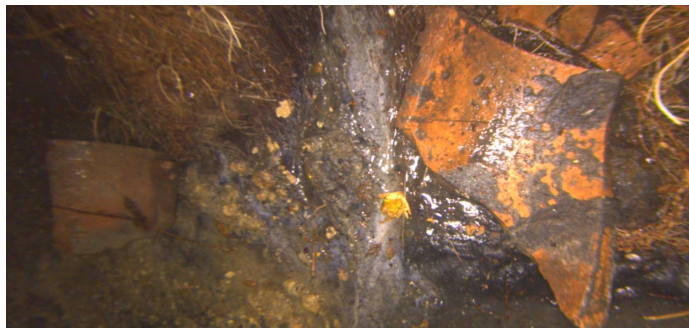
Code: **OBM**
Description: **Obstacle Pipe Material**

Distance (ft): **6.8**
Structural Grade: **0**
O&M Grade: **2**
Clock Start/From: **9**
Clock To:
1st Value:
2nd Value:
Value Percent: **5.000**
Step: **NO**
Remarks:

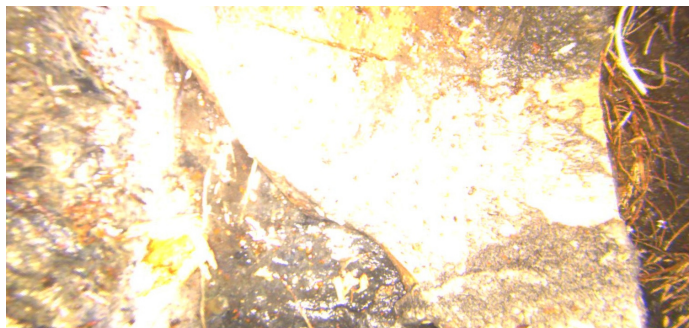
Code: **OBM**
Description: **Obstacle Pipe Material**

Distance (ft): **7.7**
Structural Grade: **0**
O&M Grade: **2**
Clock Start/From: **2**
Clock To: **3**
1st Value:
2nd Value:
Value Percent: **10.000**
Step: **NO**
Remarks:

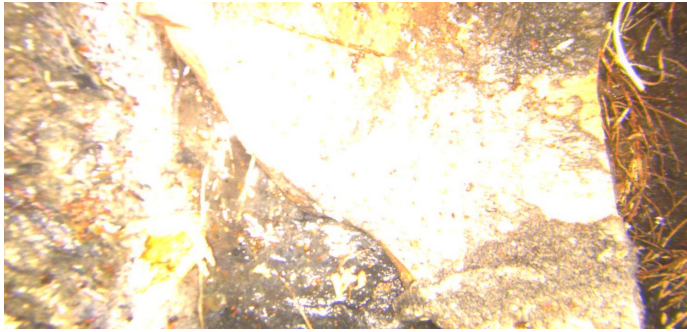
Code: **SAV**
Description: **Surface Aggregate Visible**

Distance (ft): **7.7**
Structural Grade: **3**
O&M Grade: **0**
Clock Start/From: **12**
Clock To: **12**
1st Value:
2nd Value:
Value Percent:
Step: **NO**
Remarks:

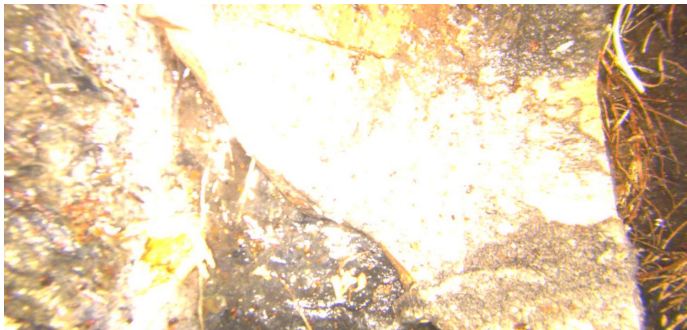
Code: **DAR**
Description: **Deposits Attached Ragging**

Distance (ft): **7.7**
Structural Grade: **0**
O&M Grade: **2**
Clock Start/From: **2**
Clock To: **3**
1st Value:
2nd Value:
Value Percent: **5.000**
Step: **NO**
Remarks:
