Manhole Inspection Report

Date:	03/25/2018	Weather:		Coding:	RZMACP
MH#:	M-902-020	Owner:	NA	Len. Surveyed:	8.3
P.O.#:		Surveyor:	John Kuglmaier	Rim to Invert:	9.9
Customer:		Cert. #:	U-1215-07002349	Wall Material:	Concrete (reinforced)

Street:	256' East of Hwy 51. South of 34th L	Project:	Hobart, IN
City:	Hobart, IN	GPS Northing:	0.0
Location:		GPS Easting:	0.0
Drain Area:	Northeast	GPS Accuracy:	Nearest Meter
Cover Shape:	Circular	Evidence of Surcharge:	Yes
Cover Size:	23.0	Potential for Runoff:	None
Comments:

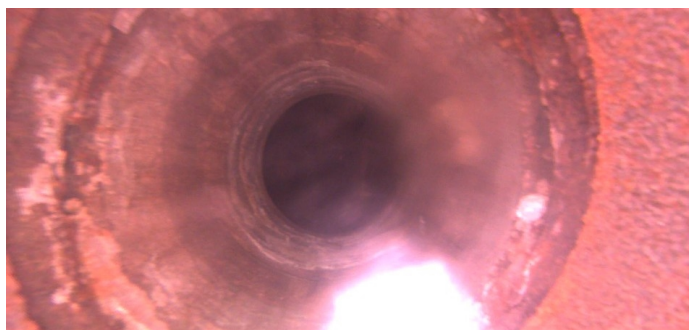
Code: **MGP**
 Description: **General Photo**

Distance (ft): **.0**
 Structural Grade: **0**
 O&M Grade: **0**
 Clock Start/From:
 Clock To:
 1st Value:
 2nd Value:
 Value Percent:
 Step: **NO**
 Remarks:

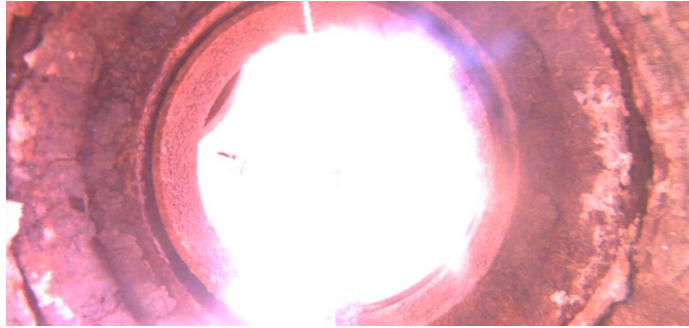
Code:	MGP
Description:	General Photo
Distance (ft):	2.1
Structural Grade:	0
O&M Grade:	0
Clock Start/From:	
Clock To:	
1st Value:	
2nd Value:	
Value Percent:	
Step:	NO
Remarks:

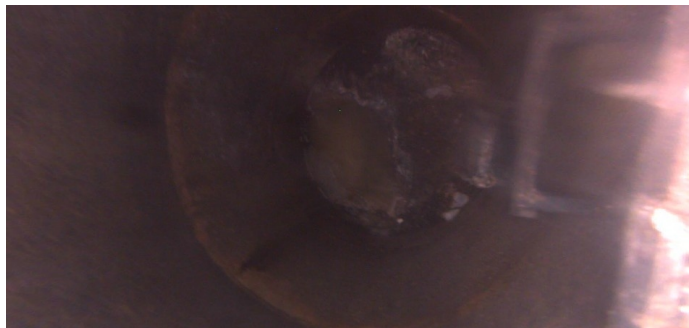
Code:	IS
Description:	Infil Stain
Distance (ft):	3.8
Structural Grade:	0
O&M Grade:	0
Clock Start/From:	8
Clock To:	
1st Value:	
2nd Value:	
Value Percent:	
Step:	NO
Remarks:

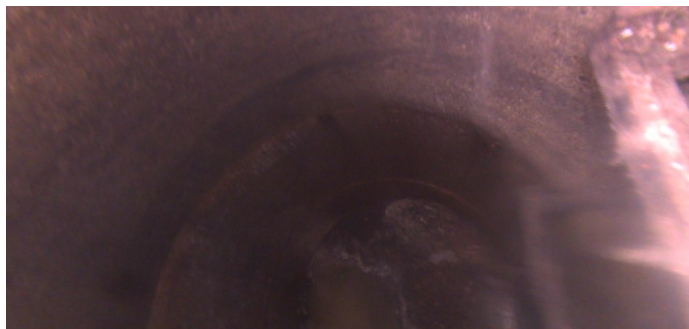
Code:	IS
Description:	Infil Stain
Distance (ft):	3.8
Structural Grade:	0
O&M Grade:	0
Clock Start/From:	11
Clock To:	
1st Value:	
2nd Value:	
Value Percent:	
Step:	NO
Remarks:

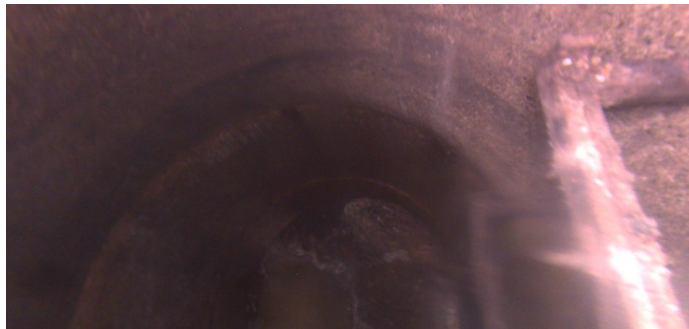
Code: **IS**
Description: **Infil Stain**

Distance (ft): **3.8**
Structural Grade: **0**
O&M Grade: **0**
Clock Start/From: **2**
Clock To:
1st Value:
2nd Value:
Value Percent:
Step: **NO**
Remarks:

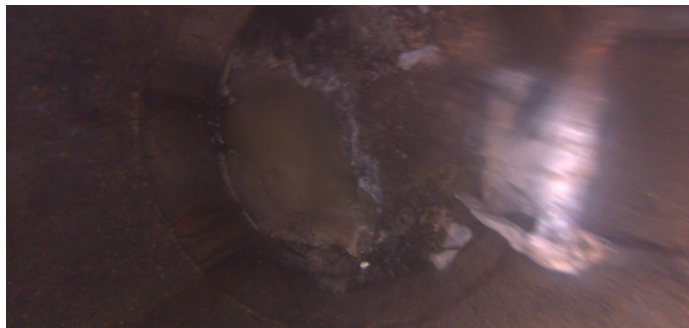
Code: **IS**
Description: **Infil Stain**

Distance (ft): **5.8**
Structural Grade: **0**
O&M Grade: **0**
Clock Start/From: **8**
Clock To:
1st Value:
2nd Value:
Value Percent:
Step: **NO**
Remarks:

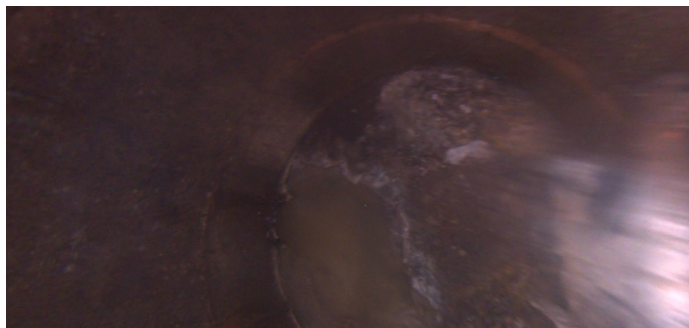
Code: **IS**
Description: **Infil Stain**

Distance (ft): **5.8**
Structural Grade: **0**
O&M Grade: **0**
Clock Start/From: **9**
Clock To:
1st Value:
2nd Value:
Value Percent:
Step: **NO**
Remarks:

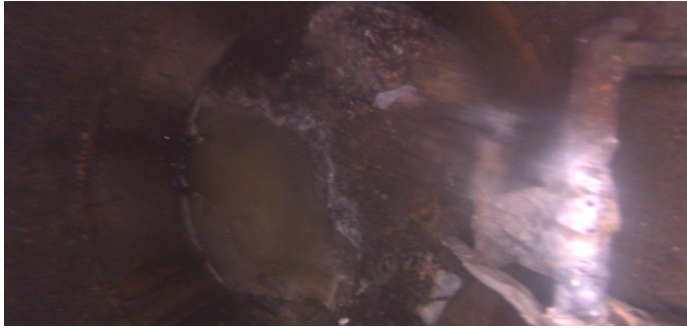
Code: **DAZ**
Description: **Deposits Attached Other**

Distance (ft): **6.0**
Structural Grade: **0**
O&M Grade: **2**
Clock Start/From: **12**
Clock To: **12**
1st Value:
2nd Value:
Value Percent: **10.000**
Step: **NO**
Remarks: **Mixed materials**

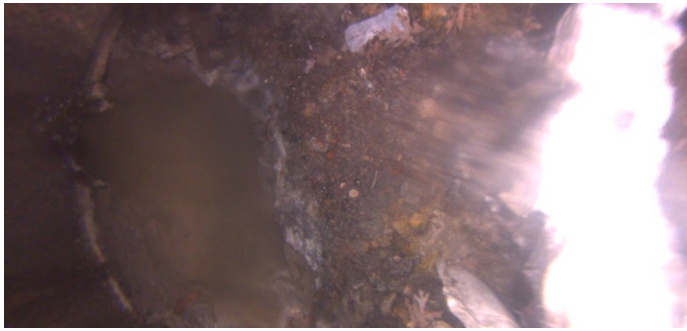
Code: **MGO**
Description: **General Observation**

Distance (ft): **7.4**
Structural Grade: **0**
O&M Grade: **0**
Clock Start/From:
Clock To:
1st Value:
2nd Value:
Value Percent:
Step: **NO**
Remarks: **Ins. Comp.**
