Manhole Inspection Report

Date:	03/26/2018	Weather:		Coding:	RZMACP
MH#:	M-902-022	Owner:	NA	Len. Surveyed:	3.7
P.O.#:		Surveyor:	John Kuglmaier	Rim to Invert:	4.5
Customer:		Cert. #:	U-1215-07002349	Wall Material:	Concrete (reinforced)

Street:	North of 33rd Ln. 207' East of Shelby	Project:	Hobart, IN
City:	Hobart, IN	GPS Northing:	0.0
Location:		GPS Easting:	0.0
Drain Area:	Northeast	GPS Accuracy:	Nearest Meter
Cover Shape:	Circular	Evidence of Surcharge:	Yes
Cover Size:	23.0	Potential for Runoff:	None
Comments:

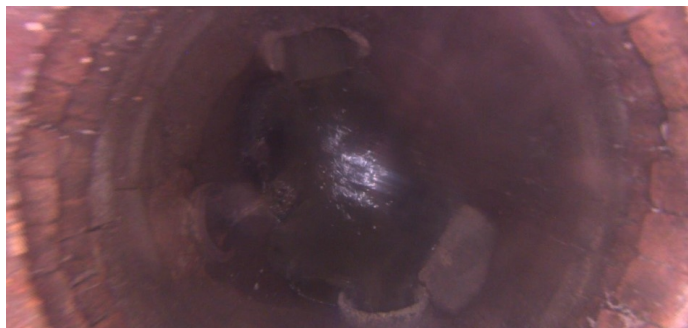
Code: **MGP**
Description: **General Photo**

Distance (ft): **.0**
Structural Grade: **0**
O&M Grade: **0**
Clock Start/From:
Clock To:
1st Value:
2nd Value:
Value Percent:
Step: **NO**
Remarks:

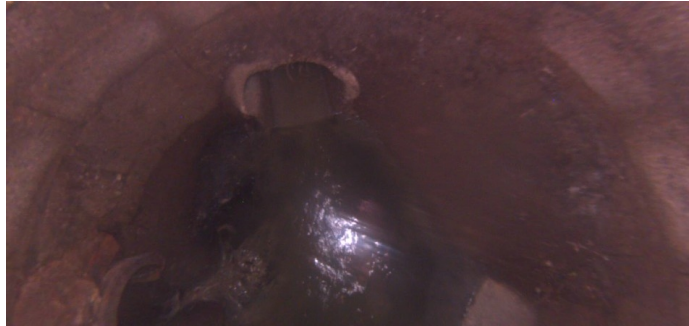
Code: **RFJ**
Description: **Roots Fine Joint**

Distance (ft): **.9**
Structural Grade: **0**
O&M Grade: **1**
Clock Start/From: **12**
Clock To: **3**
1st Value:
2nd Value:
Value Percent:
Step: **NO**
Remarks:

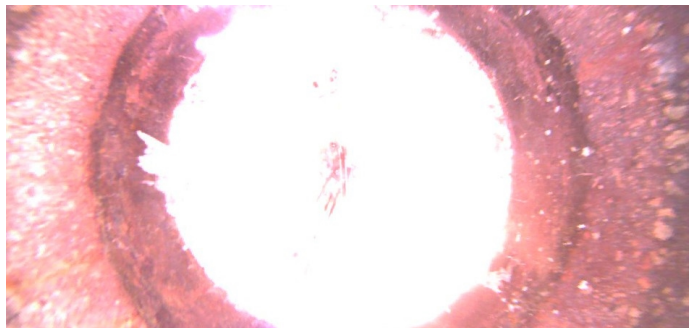
Code: **MGP**
Description: **General Photo**

Distance (ft): **1.7**
Structural Grade: **0**
O&M Grade: **0**
Clock Start/From:
Clock To:
1st Value:
2nd Value:
Value Percent:
Step: **NO**
Remarks:

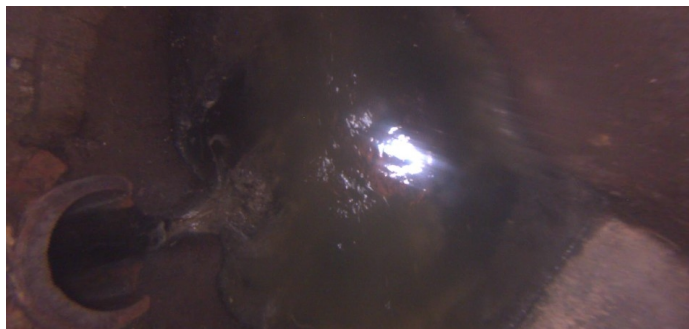
Code: **MGO**
Description: **General Observation**

Distance (ft): **2.1**
Structural Grade: **0**
O&M Grade: **0**
Clock Start/From:
Clock To:
1st Value:
2nd Value:
Value Percent:
Step: **NO**
Remarks: **Surcharge**

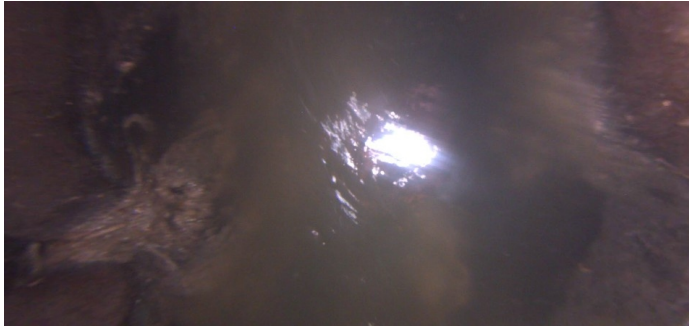
Code:	MGO
Description:	General Observation
Distance (ft):	3.0
Structural Grade:	0
O&M Grade:	0
Clock Start/From:	
Clock To:	
1st Value:	
2nd Value:	
Value Percent:	
Step:	NO
Remarks:	Ins. Comp.
