Manhole Inspection Report

Date:	03/24/2018	Weather:		Coding:	RZMACP
MH#:	M-902-023	Owner:	NA	Len. Surveyed:	16.3
P.O.#:		Surveyor:	John Kuglmaier	Rim to Invert:	17.6
Customer:		Cert. #:	U-1215-07002349	Wall Material:	Concrete (reinforced)

Street:	North of 33rd Ln. 146' West of Shelb	Project:	Hobart, IN
City:	Hobart, IN	GPS Northing:	0.0
Location:		GPS Easting:	0.0
Drain Area:	Northeast	GPS Accuracy:	Nearest Meter
Cover Shape:	Circular	Evidence of Surcharge:	Yes
Cover Size:	23.0	Potential for Runoff:	None
Comments:

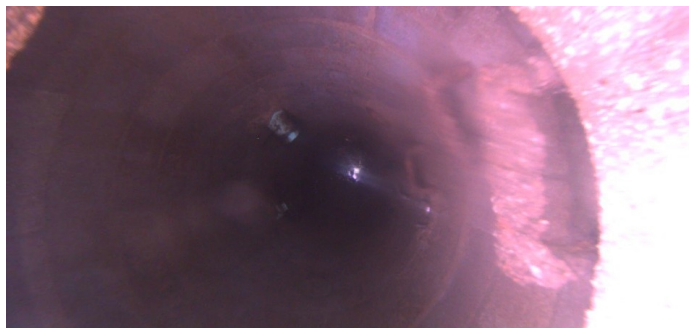
Code: **MGP**
Description: **General Photo**

Distance (ft): **.0**
Structural Grade: **0**
O&M Grade: **0**
Clock Start/From:
Clock To:
1st Value:
2nd Value:
Value Percent:
Step: **NO**
Remarks:

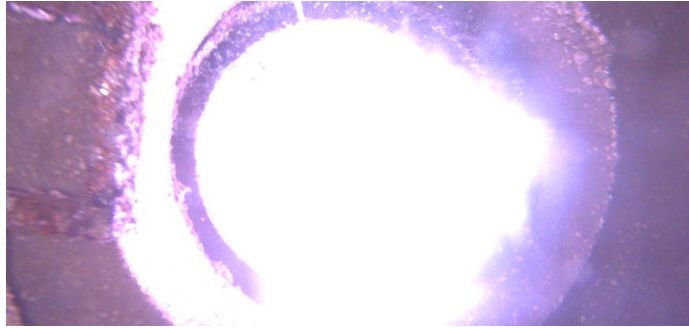
Code: **MGP**
Description: **General Photo**

Distance (ft): **1.9**
Structural Grade: **0**
O&M Grade: **0**
Clock Start/From:
Clock To:
1st Value:
2nd Value:
Value Percent:
Step: **NO**
Remarks:

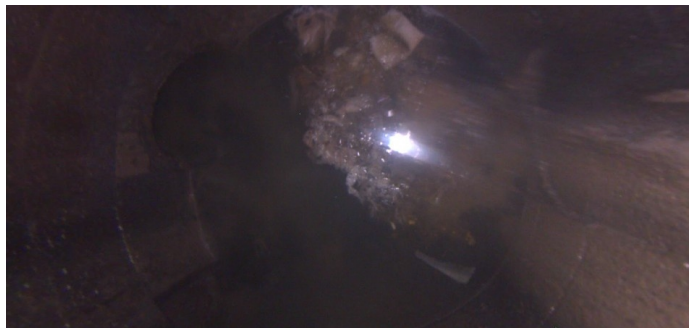
Code: **MGO**
Description: **General Observation**

Distance (ft): **13.9**
Structural Grade: **0**
O&M Grade: **0**
Clock Start/From:
Clock To:
1st Value:
2nd Value:
Value Percent:
Step: **NO**
Remarks: **Surcharge**

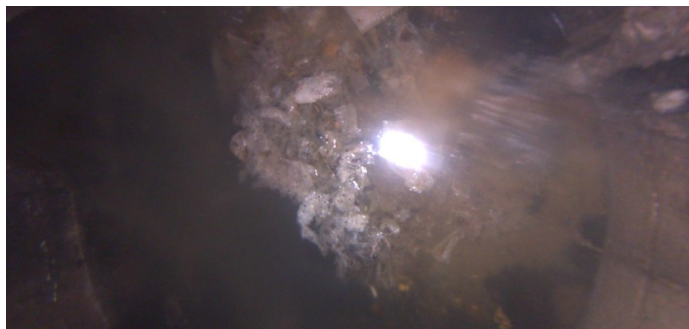
Code: **MGO**
Description: **General Observation**

Distance (ft): **15.2**
Structural Grade: **0**
O&M Grade: **0**
Clock Start/From:
Clock To:
1st Value:
2nd Value:
Value Percent:
Step: **NO**
Remarks: **Ins. Comp.**
