Manhole Inspection Report

Date:	03/24/2018	Weather:		Coding:	RZMACP
MH#:	M-902-025	Owner:	NA	Len. Surveyed:	7.4
P.O.#:		Surveyor:	John Kuglmaier	Rim to Invert:	8.5
Customer:		Cert. #:	U-1215-07002349	Wall Material:	Concrete (reinforced)

Street:	33rd Pl. 161' West of 33rd Ln.	Project:	Hobart, IN
City:	Hobart, IN	GPS Northing:	0.0
Location:		GPS Easting:	0.0
Drain Area:	Northeast	GPS Accuracy:	Nearest Meter
Cover Shape:	Circular	Evidence of Surcharge:	Yes
Cover Size:	23.0	Potential for Runoff:	None
Comments:

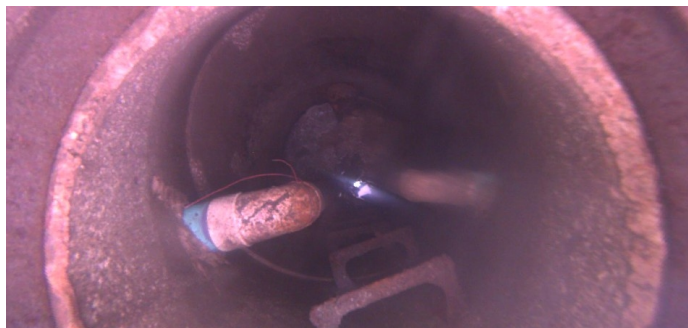
Code: **MGP**
Description: **General Photo**

Distance (ft): **.0**
Structural Grade: **0**
O&M Grade: **0**
Clock Start/From:
Clock To:
1st Value:
2nd Value:
Value Percent:
Step: **NO**
Remarks:

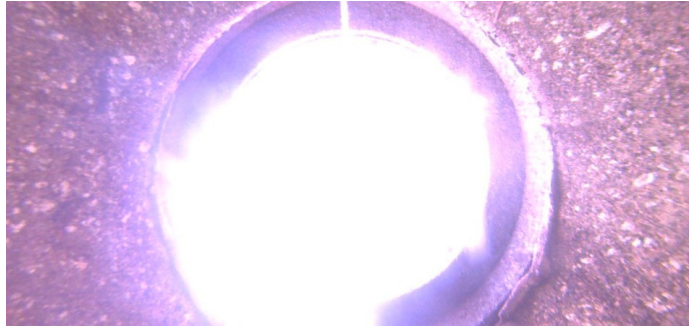
Code: **MGP**
Description: **General Photo**

Distance (ft): **2.3**
Structural Grade: **0**
O&M Grade: **0**
Clock Start/From:
Clock To:
1st Value:
2nd Value:
Value Percent:
Step: **NO**
Remarks:

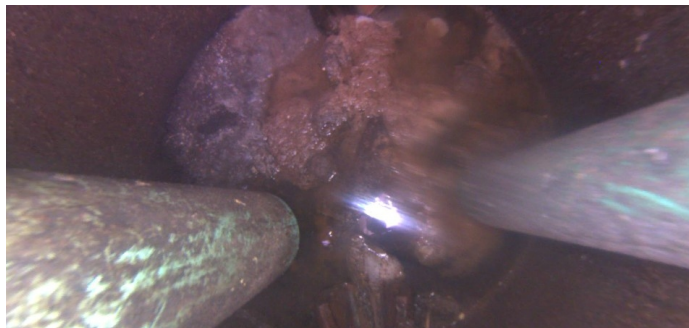
Code: **MGO**
Description: **General Observation**

Distance (ft): **5.5**
Structural Grade: **0**
O&M Grade: **0**
Clock Start/From:
Clock To:
1st Value:
2nd Value:
Value Percent:
Step: **NO**
Remarks: **Surcharge**

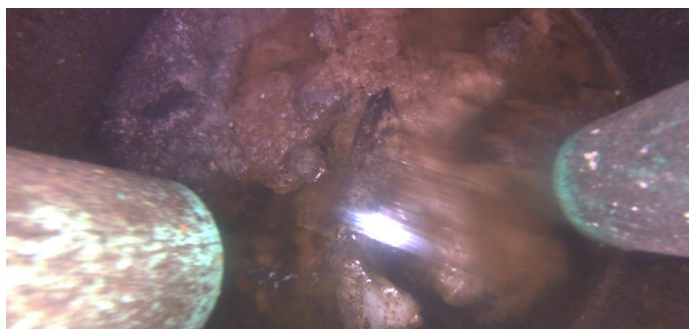
Code: **MGO**
Description: **General Observation**

Distance (ft): **6.4**
Structural Grade: **0**
O&M Grade: **0**
Clock Start/From:
Clock To:
1st Value:
2nd Value:
Value Percent:
Step: **NO**
Remarks: **Ins. Comp.**
