Manhole Inspection Report

Date:	03/24/2018	Weather:		Coding:	RZMACP
MH#:	M-902-026	Owner:	NA	Len. Surveyed:	7.1
P.O.#:		Surveyor:	John Kuglmaier	Rim to Invert:	8.0
Customer:		Cert. #:	U-1215-07002349	Wall Material:	Concrete (reinforced)

Street:	33rd Pl. 302' West of 33rd Ln.	Project:	Hobart, IN
City:	Hobart, IN	GPS Northing:	0.0
Location:		GPS Easting:	0.0
Drain Area:	Northeast	GPS Accuracy:	Nearest Meter
Cover Shape:	Circular	Evidence of Surcharge:	No
Cover Size:	23.0	Potential for Runoff:	None
Comments:

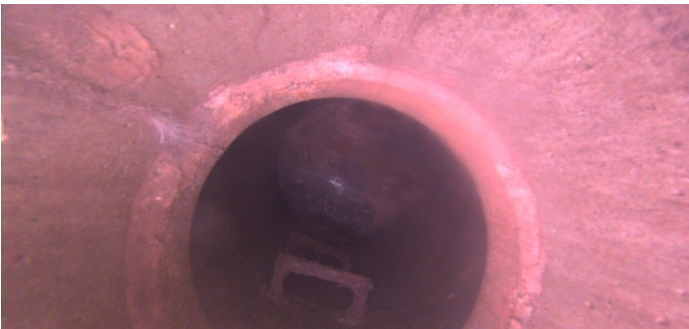
Code: **MGP**
 Description: **General Photo**

Distance (ft): **.0**
 Structural Grade: **0**
 O&M Grade: **0**
 Clock Start/From:
 Clock To:
 1st Value:
 2nd Value:
 Value Percent:
 Step: **NO**
 Remarks:

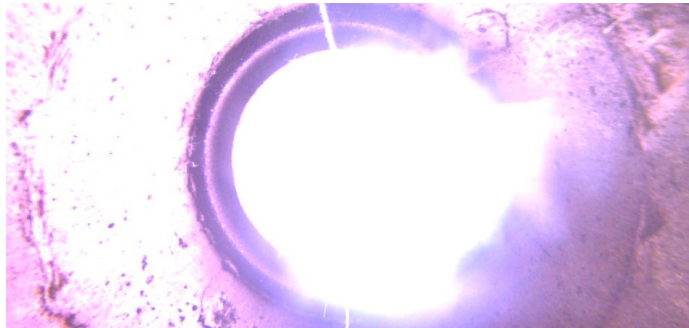
Code: **MGP**
Description: **General Photo**

Distance (ft): **2.3**
Structural Grade: **0**
O&M Grade: **0**
Clock Start/From:
Clock To:
1st Value:
2nd Value:
Value Percent:
Step: **NO**
Remarks:

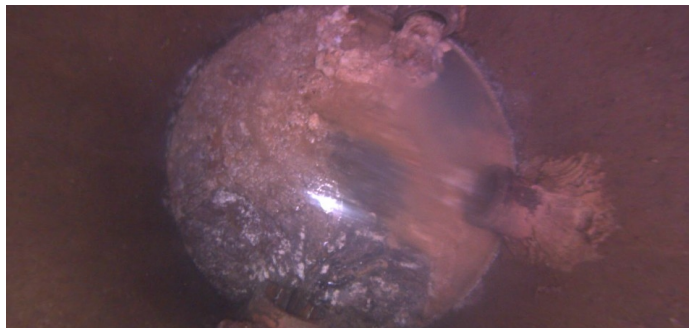
Code: **DAZ**
Description: **Deposits Attached Other**

Distance (ft): **4.7**
Structural Grade: **0**
O&M Grade: **2**
Clock Start/From: **12**
Clock To: **12**
1st Value:
2nd Value:
Value Percent: **10.000**
Step: **NO**
Remarks: **Mixed materials**

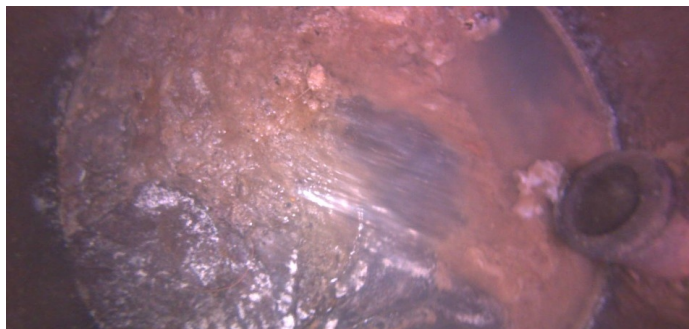
Code: **MGO**
Description: **General Observation**

Distance (ft): **5.9**
Structural Grade: **0**
O&M Grade: **0**
Clock Start/From:
Clock To:
1st Value:
2nd Value:
Value Percent:
Step: **NO**
Remarks: **Ins. Comp.**
