Manhole Inspection Report

Date:	03/25/2018	Weather:		Coding:	RZMACP
MH#:	M-902-027	Owner:	NA	Len. Surveyed:	13.0
P.O.#:		Surveyor:	John Kuglmaier	Rim to Invert:	16.5
Customer:		Cert. #:	U-1215-07002349	Wall Material:	Concrete (reinforced)

Street:	North of 34th Ave. West of Shelby S	Project:	Hobart, IN
City:	Hobart, IN	GPS Northing:	0.0
Location:		GPS Easting:	0.0
Drain Area:	Northeast	GPS Accuracy:	Nearest Meter
Cover Shape:	Circular	Evidence of Surcharge:	Yes
Cover Size:	23.0	Potential for Runoff:	None
Comments:

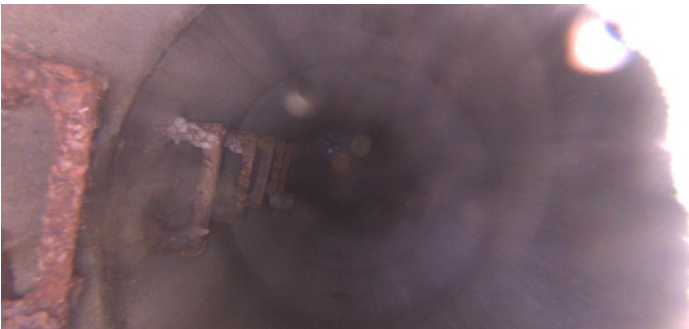
Code:
MGP

Description:
General Photo

Distance (ft):
.0

Structural Grade:
0

O&M Grade:
0

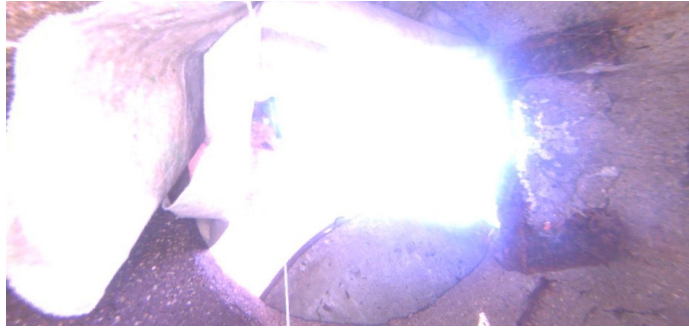
Code: **MGP**
Description: **General Photo**

Distance (ft): **.7**
Structural Grade: **0**
O&M Grade: **0**
Clock Start/From:
Clock To:
1st Value:
2nd Value:
Value Percent:
Step: **NO**
Remarks:

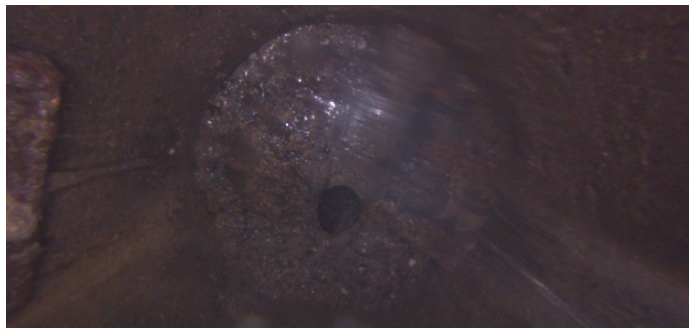
Code: **DAZ**
Description: **Deposits Attached Other**

Distance (ft): **11.2**
Structural Grade: **0**
O&M Grade: **2**
Clock Start/From: **12**
Clock To: **12**
1st Value:
2nd Value:
Value Percent: **10.000**
Step: **NO**
Remarks: **Mixed materials**

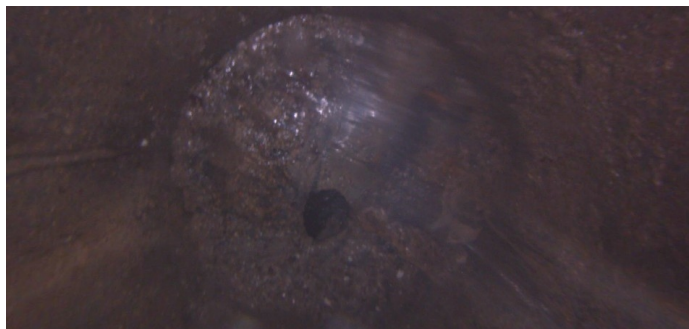
Code: **MGO**
Description: **General Observation**

Distance (ft): **11.6**
Structural Grade: **0**
O&M Grade: **0**
Clock Start/From:
Clock To:
1st Value:
2nd Value:
Value Percent:
Step: **NO**
Remarks: **Ins. Comp.**
