Manhole Inspection Report

Date:	03/24/2018	Weather:		Coding:	RZMACP
MH#:	M-902-030	Owner:	NA	Len. Surveyed:	4.3
P.O.#:		Surveyor:	John Kuglmaier	Rim to Invert:	5.6
Customer:		Cert. #:	U-1215-07002349	Wall Material:	Concrete (reinforced)

Street:	Randolph St. North of 34th Ave.	Project:	Hobart, IN
City:	Hobart, IN	GPS Northing:	0.0
Location:		GPS Easting:	0.0
Drain Area:	Northeast	GPS Accuracy:	Nearest Meter
Cover Shape:	Circular	Evidence of Surcharge:	No
Cover Size:	23.0	Potential for Runoff:	None
Comments:

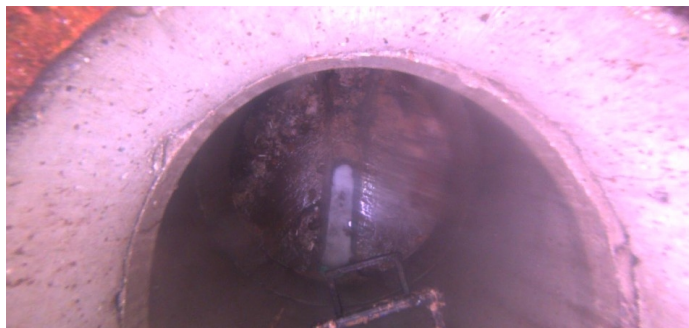
Code: **MGP**
Description: **General Photo**

Distance (ft): **.0**
Structural Grade: **0**
O&M Grade: **0**
Clock Start/From:
Clock To:
1st Value:
2nd Value:
Value Percent:
Step: **NO**
Remarks:

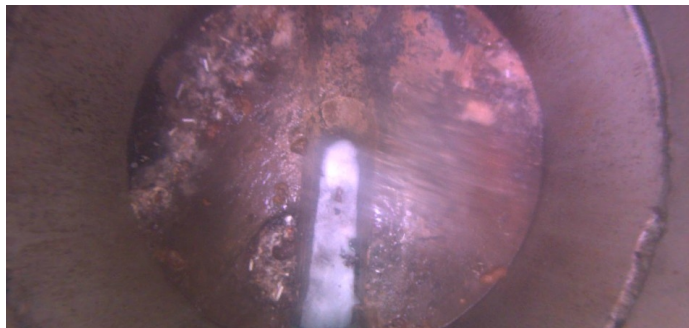
Code: **DAZ**
Description: **Deposits Attached Other**

Distance (ft): **2.3**
Structural Grade: **0**
O&M Grade: **2**
Clock Start/From: **12**
Clock To: **12**
1st Value:
2nd Value:
Value Percent: **5.000**
Step: **NO**
Remarks: **Mixed materials**

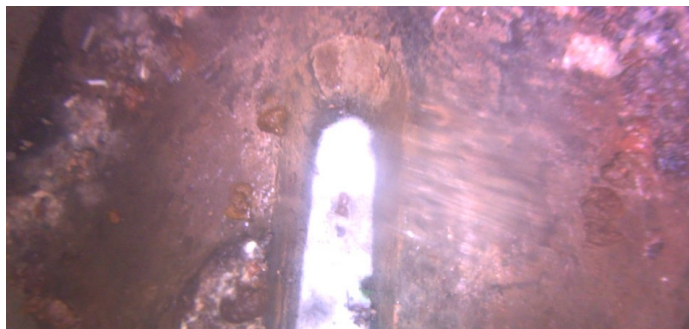
Code: **MGO**
Description: **General Observation**

Distance (ft): **3.4**
Structural Grade: **0**
O&M Grade: **0**
Clock Start/From:
Clock To:
1st Value:
2nd Value:
Value Percent:
Step: **NO**
Remarks: **Ins. Comp.**
