Manhole Inspection Report

Date:	03/25/2018	Weather:		Coding:	RZMACP
MH#:	M-902-031	Owner:	NA	Len. Surveyed:	8.8
P.O.#:		Surveyor:	John Kuglmaier	Rim to Invert:	9.8
Customer:		Cert. #:	U-1215-07002349	Wall Material:	Concrete (reinforced)

Street:	256' East of Hwy 51. South of 34th L	Project:	Hobart, IN
City:	Hobart, IN	GPS Northing:	0.0
Location:		GPS Easting:	0.0
Drain Area:	Northeast	GPS Accuracy:	Nearest Meter
Cover Shape:	Circular	Evidence of Surcharge:	Yes
Cover Size:	23.0	Potential for Runoff:	None
Comments:

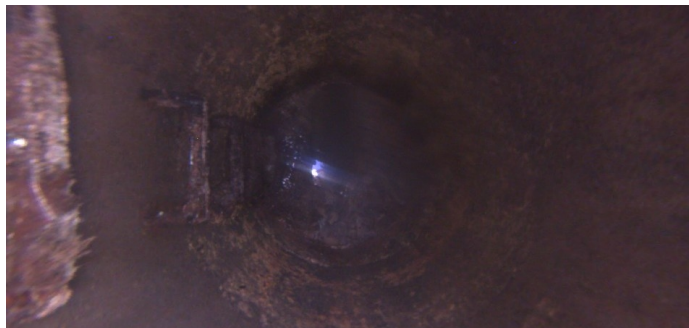
Code: **DAZ**
Description: **Deposits Attached Other**

Distance (ft): **3.3**
Structural Grade: **0**
O&M Grade: **2**
Clock Start/From: **12**
Clock To: **12**
1st Value:
2nd Value:
Value Percent: **5.000**
Step: **NO**
Remarks: **Mixed materials**

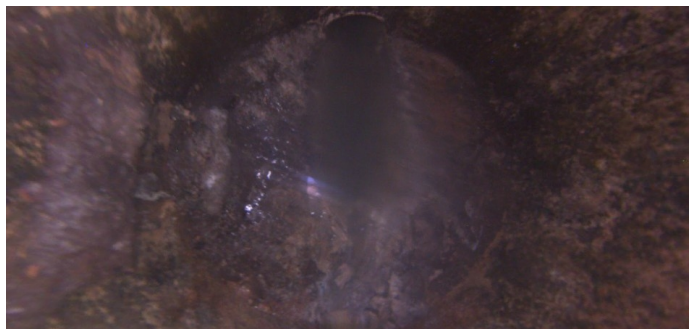
Code: **DAZ**
Description: **Deposits Attached Other**

Distance (ft): **6.3**
Structural Grade: **0**
O&M Grade: **3**
Clock Start/From: **12**
Clock To: **12**
1st Value:
2nd Value:
Value Percent: **15.000**
Step: **NO**
Remarks: **Mixed materials**

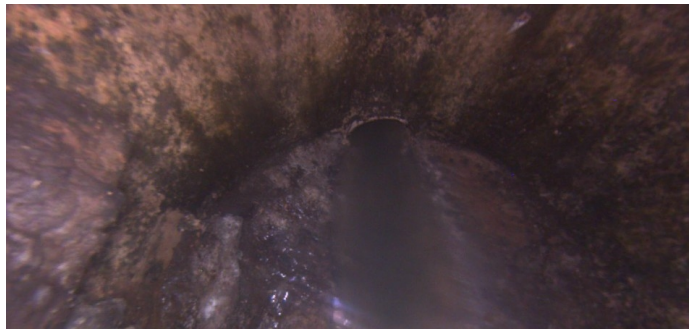
Code:	DAZ
Description:	Deposits Attached Other
Distance (ft):	6.8
Structural Grade:	0
O&M Grade:	2
Clock Start/From:	12
Clock To:	12
1st Value:	
2nd Value:	
Value Percent:	5.000
Step:	NO
Remarks:	Mixed materials

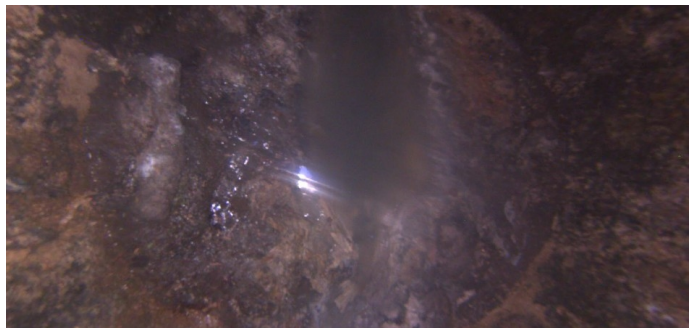
Code:	MGO
Description:	General Observation
Distance (ft):	7.3
Structural Grade:	0
O&M Grade:	0
Clock Start/From:	
Clock To:	
1st Value:	
2nd Value:	
Value Percent:	
Step:	NO
Remarks:	Ins. Comp.
