Manhole Inspection Report

Date:	03/25/2018	Weather:		Coding:	RZMACP
MH#:	M-902-032	Owner:	NA	Len. Surveyed:	12.0
P.O.#:		Surveyor:	John Kuglmaier	Rim to Invert:	14.0
Customer:		Cert. #:	U-1215-07002349	Wall Material:	Concrete (reinforced)

Street:	Shelby St. and 34th Ct. to the West.	Project:	Hobart, IN
City:	Hobart, IN	GPS Northing:	0.0
Location:		GPS Easting:	0.0
Drain Area:	Northeast	GPS Accuracy:	Nearest Meter
Cover Shape:	Circular	Evidence of Surcharge:	Yes
Cover Size:	23.0	Potential for Runoff:	None
Comments:

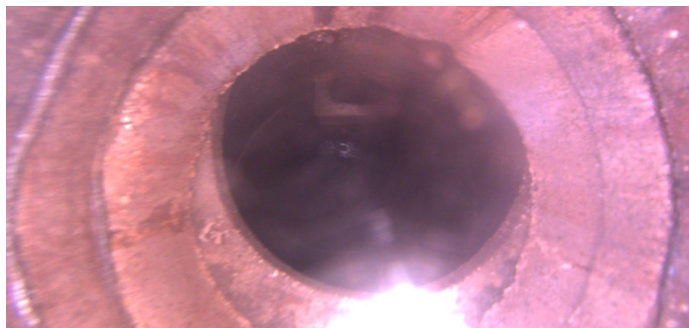
Code: **MGP**
Description: **General Photo**

Distance (ft): **.0**
Structural Grade: **0**
O&M Grade: **0**
Clock Start/From:
Clock To:
1st Value:
2nd Value:
Value Percent:
Step: **NO**
Remarks:

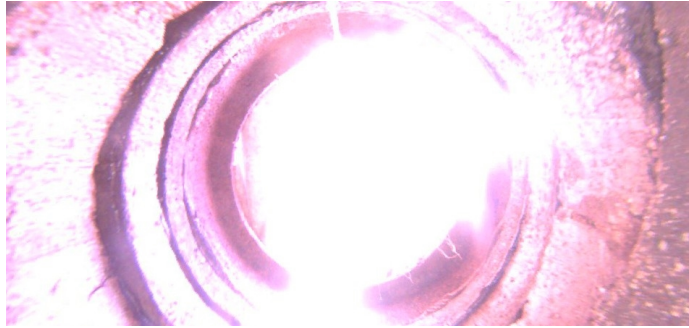
Code: **MGP**
Description: **General Photo**

Distance (ft): **2.4**
Structural Grade: **0**
O&M Grade: **0**
Clock Start/From:
Clock To:
1st Value:
2nd Value:
Value Percent:
Step: **NO**
Remarks:

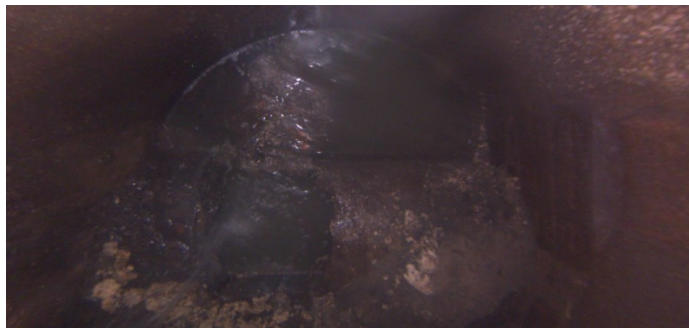
Code: **MGO**
Description: **General Observation**

Distance (ft): **11.2**
Structural Grade: **0**
O&M Grade: **0**
Clock Start/From:
Clock To:
1st Value:
2nd Value:
Value Percent:
Step: **NO**
Remarks: **Surcharge**

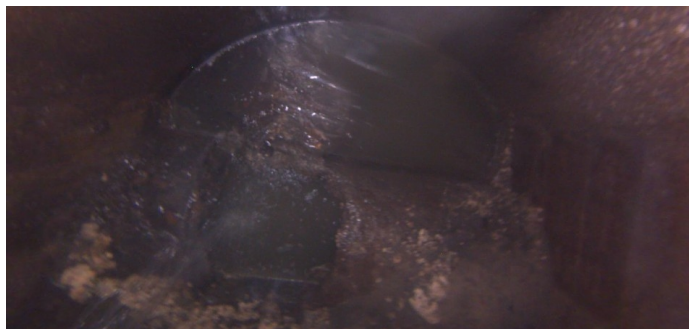
Code: **MGO**
Description: **General Observation**

Distance (ft): **11.5**
Structural Grade: **0**
O&M Grade: **0**
Clock Start/From:
Clock To:
1st Value:
2nd Value:
Value Percent:
Step: **NO**
Remarks: **Ins. Comp.**
