Manhole Inspection Report

| MH#: | M-902-042 | Owner: | NA | Len. Surveyed: | 6.9 |

| Street: | North of 34th Ln. 275' East of Rando | Project: | Hobart, IN |

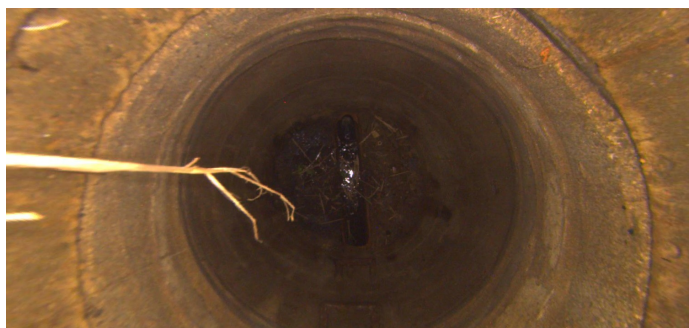
Code: **MGO**
Description: **General Observation**

Distance (ft): **.0**
Structural Grade: **0**
O&M Grade: **0**
Clock Start/From:
Clock To:
1st Value:
2nd Value:
Value Percent:
Step: **NO**
Remarks: **access mh**

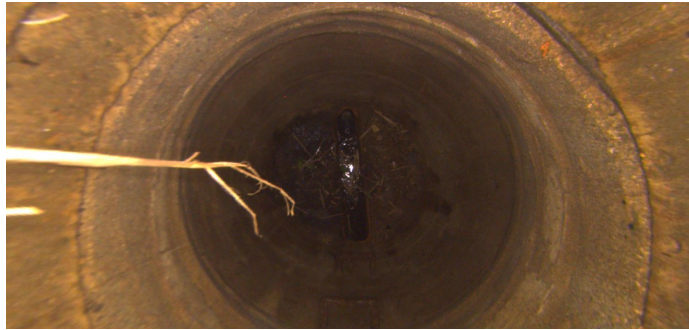
| Code: | SAV |
| Description: | Surface Aggregate Visible |
| Distance (ft): | .0 |
| Structural Grade: | 3 |

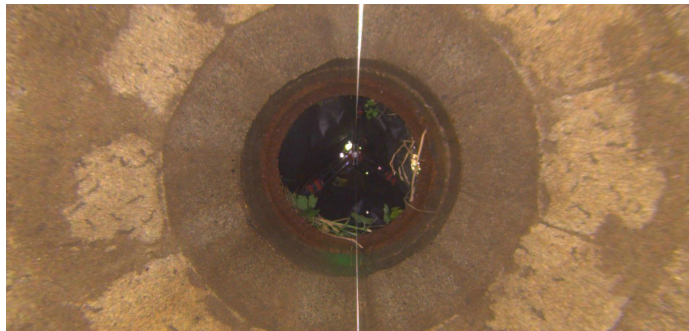
| Code: | MGO |
| Description: | General Observation |
| Remarks: | underside of frame |

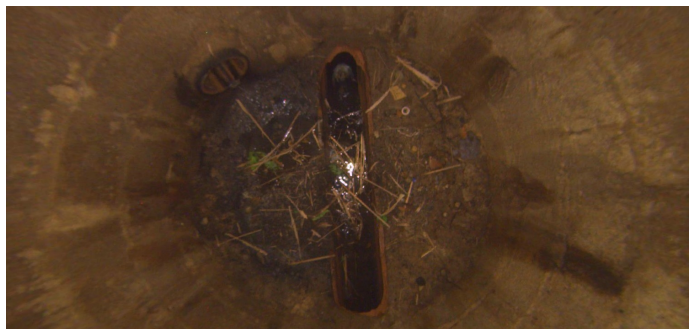
| Code: | IW |
| Description: | Infil Weeper |
| Distance (ft): | 3.7 |
| O&M Grade: | 2 |

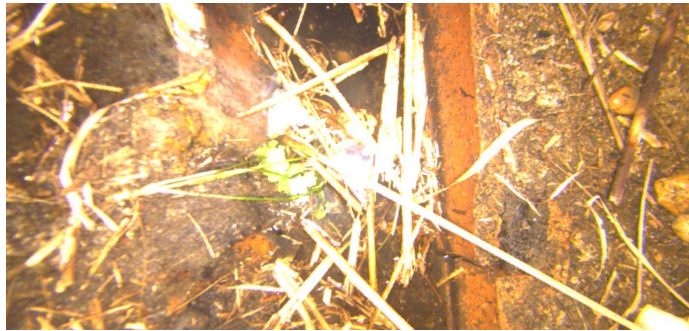
Code: **DSGV**
Description: **Deposits Settled Gravel**

Distance (ft): **6.9**
Structural Grade: **0**
O&M Grade: **2**
Clock Start/From: **12**
Clock To: **12**
1st Value:
2nd Value:
Value Percent: **5.000**
Step: **NO**
Remarks:

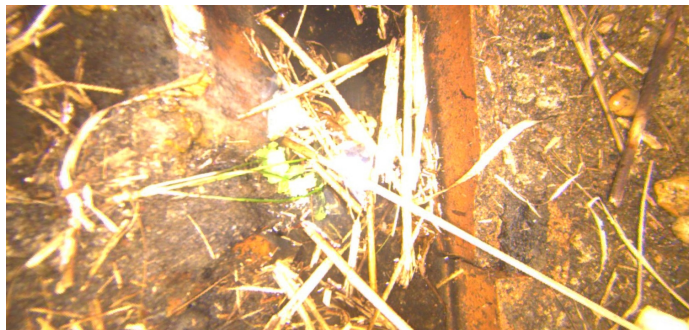
Code: **OBZ**
Description: **Obstacle Other**

Distance (ft): **6.9**
Structural Grade: **0**
O&M Grade: **2**
Clock Start/From: **12**
Clock To: **12**
1st Value:
2nd Value:
Value Percent: **5.000**
Step: **NO**
Remarks: **misc**

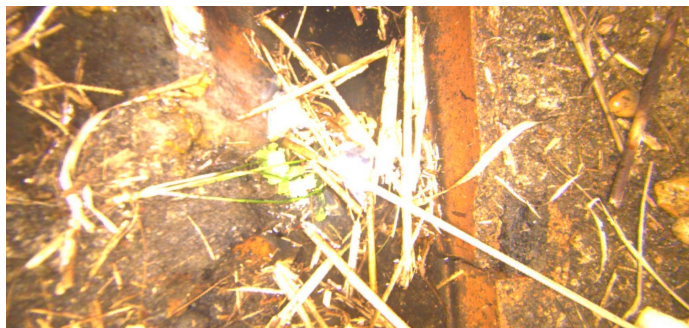
Code: **SAV**
Description: **Surface Aggregate Visible**

Distance (ft): **6.9**
Structural Grade: **3**
O&M Grade: **0**
Clock Start/From: **12**
Clock To: **12**
1st Value:
2nd Value:
Value Percent:
Step: **NO**
Remarks:

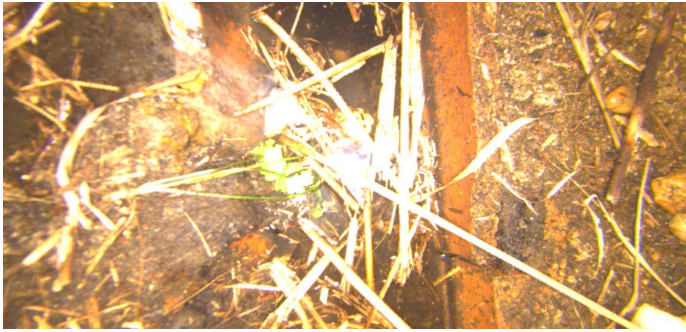
| Code: | MGO |
| Description: | General Observation |
| Remarks: | end of survey |
