Manhole Inspection Report

Date:	03/25/2018	Weather:		Coding:	RZMACP
MH#:	M-902-043	Owner:	NA	Len. Surveyed:	7.8
P.O.#:		Surveyor:	John Kuglmaier	Rim to Invert:	8.7
Customer:		Cert. #:	U-1215-07002349	Wall Material:	Concrete (reinforced)

Street:	North of 34th Ln. 101' East of Rando	Project:	Hobart, IN
City:	Hobart, IN	GPS Northing:	0.0
Location:		GPS Easting:	0.0
Drain Area:	Northeast	GPS Accuracy:	Nearest Meter
Cover Shape:	Circular	Evidence of Surcharge:	Yes
Cover Size:	23.0	Potential for Runoff:	None
Comments:

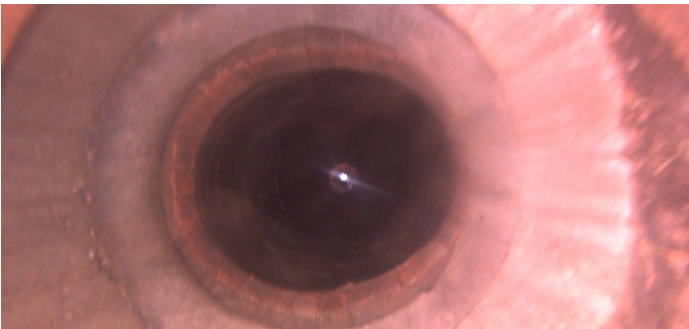
Code: **MGP**
 Description: **General Photo**

Distance (ft): **.0**
 Structural Grade: **0**
 O&M Grade: **0**
 Clock Start/From:
 Clock To:
 1st Value:
 2nd Value:
 Value Percent:
 Step: **NO**
 Remarks:

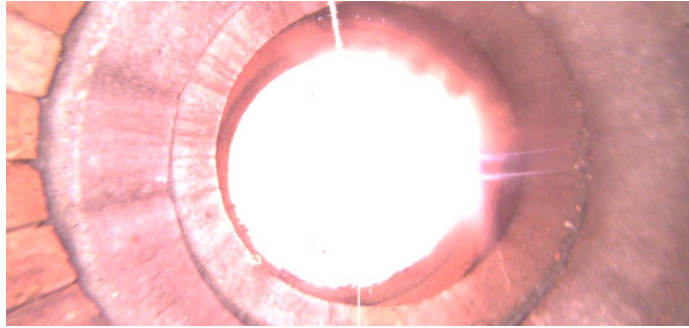
Code: **MGP**
Description: **General Photo**

Distance (ft): **2.8**
Structural Grade: **0**
O&M Grade: **0**
Clock Start/From:
Clock To:
1st Value:
2nd Value:
Value Percent:
Step: **NO**
Remarks:

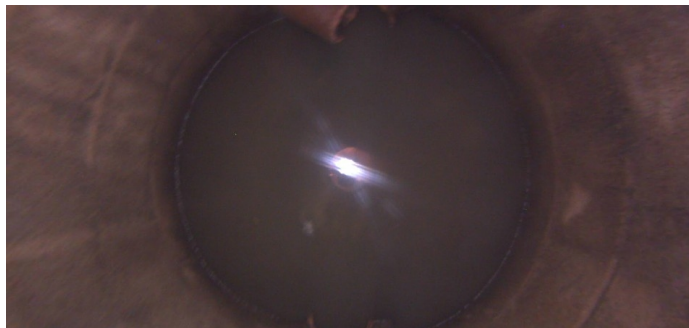
Code: **MGO**
Description: **General Observation**

Distance (ft): **5.5**
Structural Grade: **0**
O&M Grade: **0**
Clock Start/From:
Clock To:
1st Value:
2nd Value:
Value Percent:
Step: **NO**
Remarks: **Surcharge**

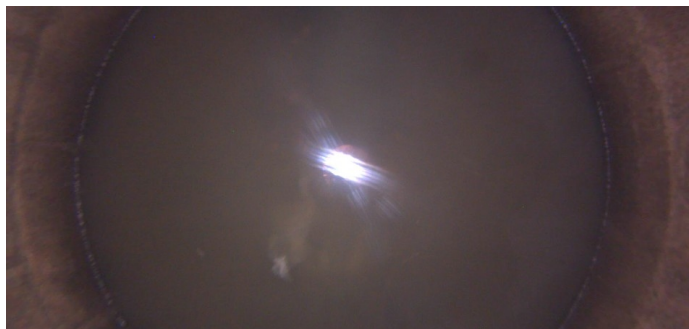
Code: **MGO**
Description: **General Observation**

Distance (ft): **6.5**
Structural Grade: **0**
O&M Grade: **0**
Clock Start/From:
Clock To:
1st Value:
2nd Value:
Value Percent:
Step: **NO**
Remarks: **Ins. Comp.**
