Manhole Inspection Report

Date:	03/24/2018	Weather:		Coding:	RZMACP
MH#:	M-902-044	Owner:	NA	Len. Surveyed:	5.5
P.O.#:		Surveyor:	John Kuglmaier	Rim to Invert:	8.6
Customer:		Cert. #:	U-1215-07002349	Wall Material:	Concrete (reinforced)

Street:	Randolph St. South of 34th PL.	Project:	Hobart, IN
City:	Hobart, IN	GPS Northing:	0.0
Location:		GPS Easting:	0.0
Drain Area:	Northeast	GPS Accuracy:	Nearest Meter
Cover Shape:	Circular	Evidence of Surcharge:	Yes
Cover Size:	23.0	Potential for Runoff:	None
Comments:

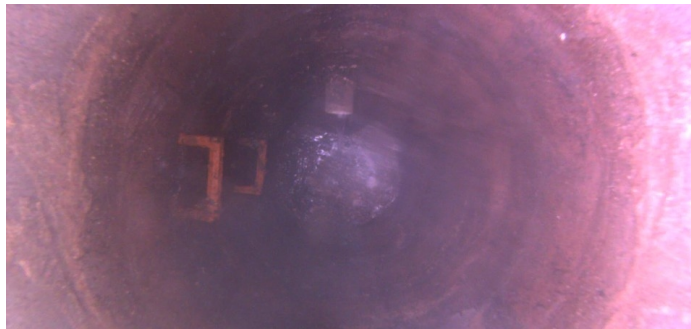
Code: **MGP**
Description: **General Photo**

Distance (ft): **.0**
Structural Grade: **0**
O&M Grade: **0**
Clock Start/From:
Clock To:
1st Value:
2nd Value:
Value Percent:
Step: **NO**
Remarks:

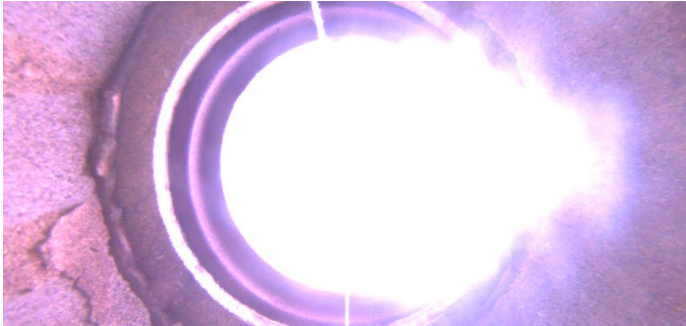
Code: **MGP**
Description: **General Photo**

Distance (ft): **2.2**
Structural Grade: **0**
O&M Grade: **0**
Clock Start/From:
Clock To:
1st Value:
2nd Value:
Value Percent:
Step: **NO**
Remarks:

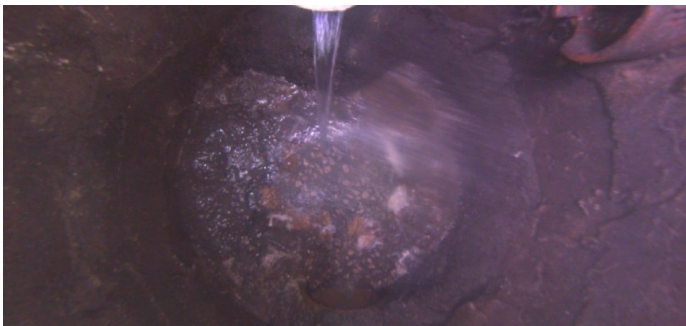
Code: **DSF**
Description: **Deposits Settled Fine**

Distance (ft): **3.5**
Structural Grade: **0**
O&M Grade: **3**
Clock Start/From: **12**
Clock To: **12**
1st Value:
2nd Value:
Value Percent: **15.000**
Step: **NO**
Remarks:

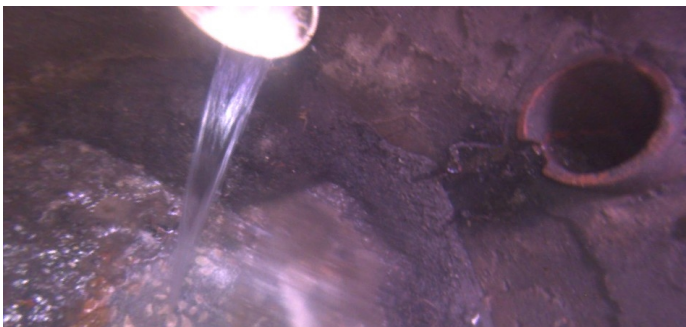
Code: **RFC**
Description: **Roots Fine Connection**

Distance (ft): **4.5**
Structural Grade: **0**
O&M Grade: **1**
Clock Start/From: **2**
Clock To:
1st Value:
2nd Value:
Value Percent:
Step: **NO**
Remarks:

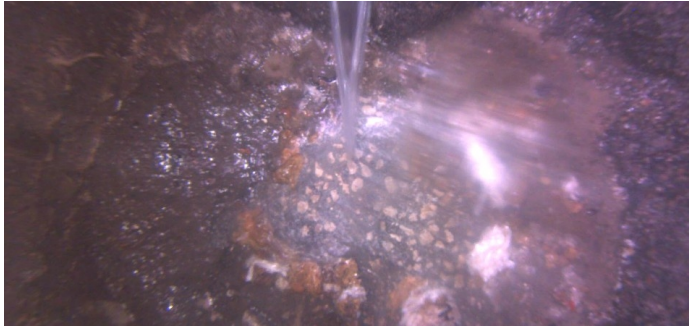
Code:	MGO
Description:	General Observation
Distance (ft):	4.9
Structural Grade:	0
O&M Grade:	0
Clock Start/From:	
Clock To:	
1st Value:	
2nd Value:	
Value Percent:	
Step:	NO
Remarks:	Ins. Comp.
